**LAKE ROSALIND WELL 3
REHABILITATION AND
WELL 1 TESTING**

**THE CORPORATION OF THE
MUNICIPALITY OF BROCKTON**

Date: December 19, 2018

Reference: 248-026

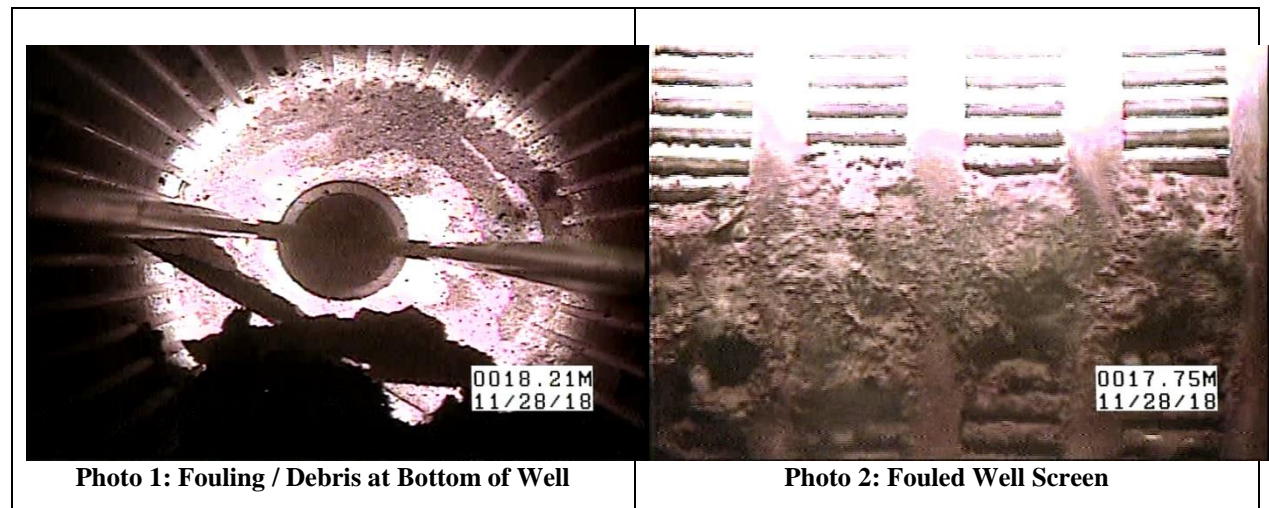
A pre-rehabilitation static video was completed November 28, 2018, with significant well construction details noted in **Table 2**. A DVD copy of the video has been enclosed with the original hard copy of this report. The video showed significant fouling of the casing and screen with debris filling the bottom of the well (**Photos 1 to 4**).

- Pre inspection video showed corrosion and buildup covering the screen and casing which was removed by rehabilitation.
- The post rehabilitation video identified a hole in the casing, but there were no obvious signs of leaking water, sand or sediment entering through the hole.

The well rehabilitation was performed to remove the buildup on the screen and casing. The rehabilitation program utilized a dual tube airlift assembly and high pressure jetting system. The well was initially airlifted off bottom using a 50 mm x 10 mm dual airlift to remove sediment and debris in preparation of the jetting. After the initial airlift, the well was jetted with a high pressure rotating head jetting tool. The tool was raised and lowered over the casing and screen while jetting at 7,500psi @ 1.0 L/s, while simultaneously airlifting the well at a 1.0 L/s rate to remove material dislodged during jetting. The well was jetted and airlifted in this manner for two hours and produced a dark red to reddish brown discharge with some fine silt and sand. After the jetting, the well was airlifted off bottom until the discharge was clear and sediment free. Some photos of the rehabilitation setup and equipment are shown in (**Photos 5 to 8**).

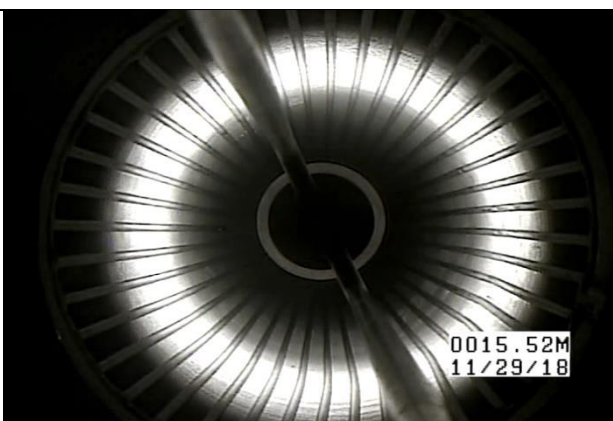
Photo 9: Clean Well Screen

A post-rehabilitation video was completed November 29, 2018, with significant well construction details noted in **Table 3**. A DVD copy of the video has been enclosed with the original hard copy of this report. The video showed the well screen had been successfully cleaned and the debris noted in the previous video removed (**Photos 9 to 11**). The video inspection identified a hole in the well casing following cleaning as shown in **Photo 12**. There were no indications of any leaking or sediment entering the well through the hole during the video.

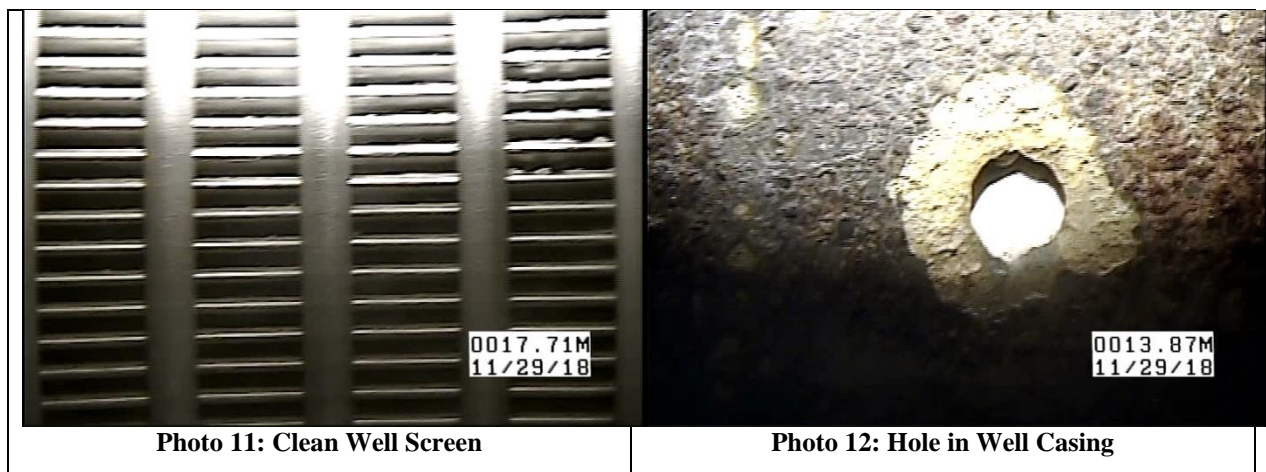
- The casing thickness log showed no overall casing thinning. The hole is believed to be isolated to one small spot of the casing, which is outside the resolution of the casing thickness tool, so it was not seen in the casing thickness log.

- Install a new stainless steel liner in Well 3 to repair the hole in the well casing. At the same time, raise the well casing and ground level to facilitate easier access and maintenance.

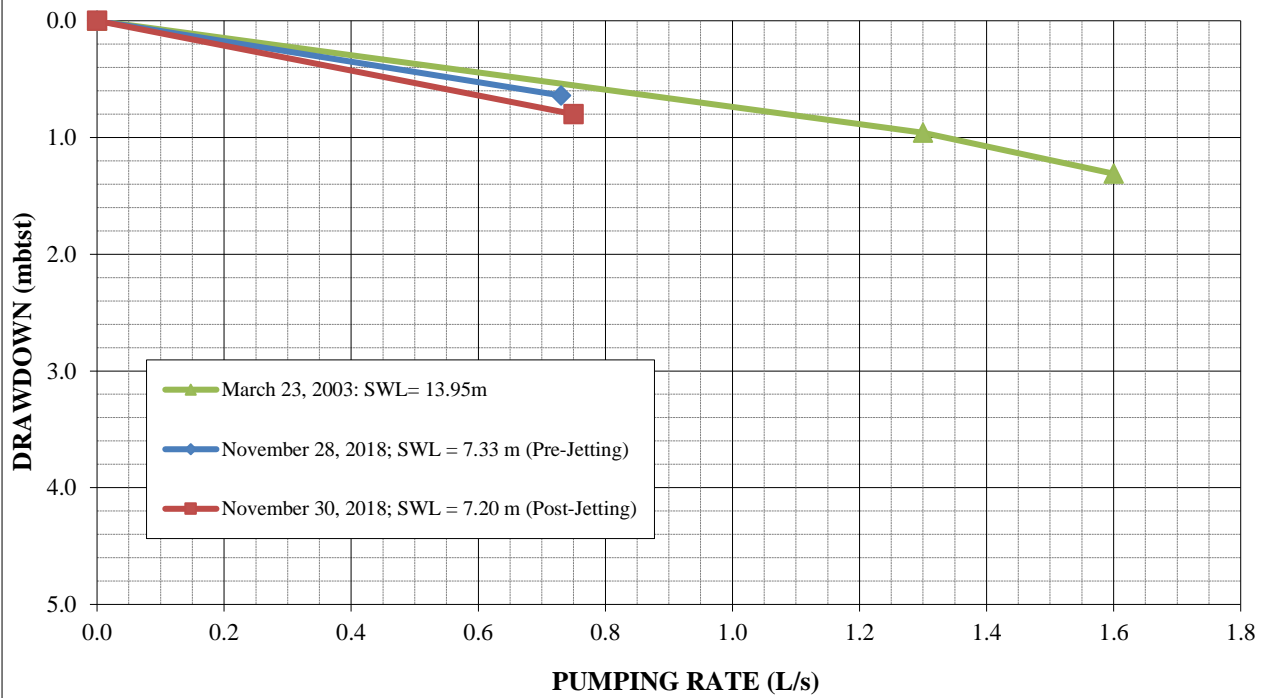
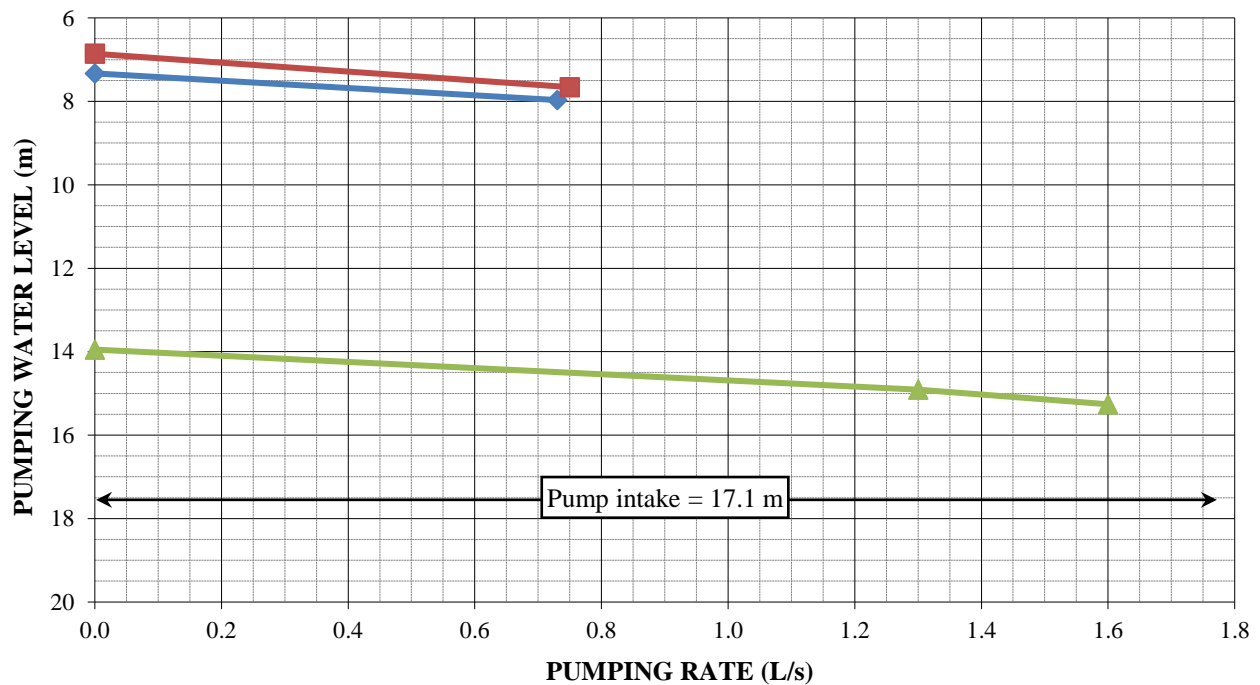
Figure 1

A pre-rehabilitation well step test was conducted on November 28, 2018. The data collected is provided in **Table 1** and was plotted graphically and compared against historical pumping levels on **Figure 1**. Static levels are well above levels measured during the last step test in 2003. Drawdowns, however, appear similar and indicate no significant loss in well performance due to plugging.

A post-rehabilitation well performance test was conducted on November 30, 2018. The data collected is provided in **Table 4** and was plotted graphically and compared against historical pumping levels on **Figure 1**. The post-rehabilitation test results indicated a similar performance when compared to the pre-rehabilitation data. The well is more than capable of producing the normal operating flow rate in the short term. The testing indicates that there is no significant plugging of the well screen.

- Pre rehabilitation performance testing showed well performance was similar to the last performance test in 2003, and that, despite the buildup seen on the screen, plugging was not having a significant impact on the wells performance.

- Post rehabilitation testing showed similar performance to the pre rehabilitation testing. The well can easily be pumped up to its equipped capacity, at least for the short term.

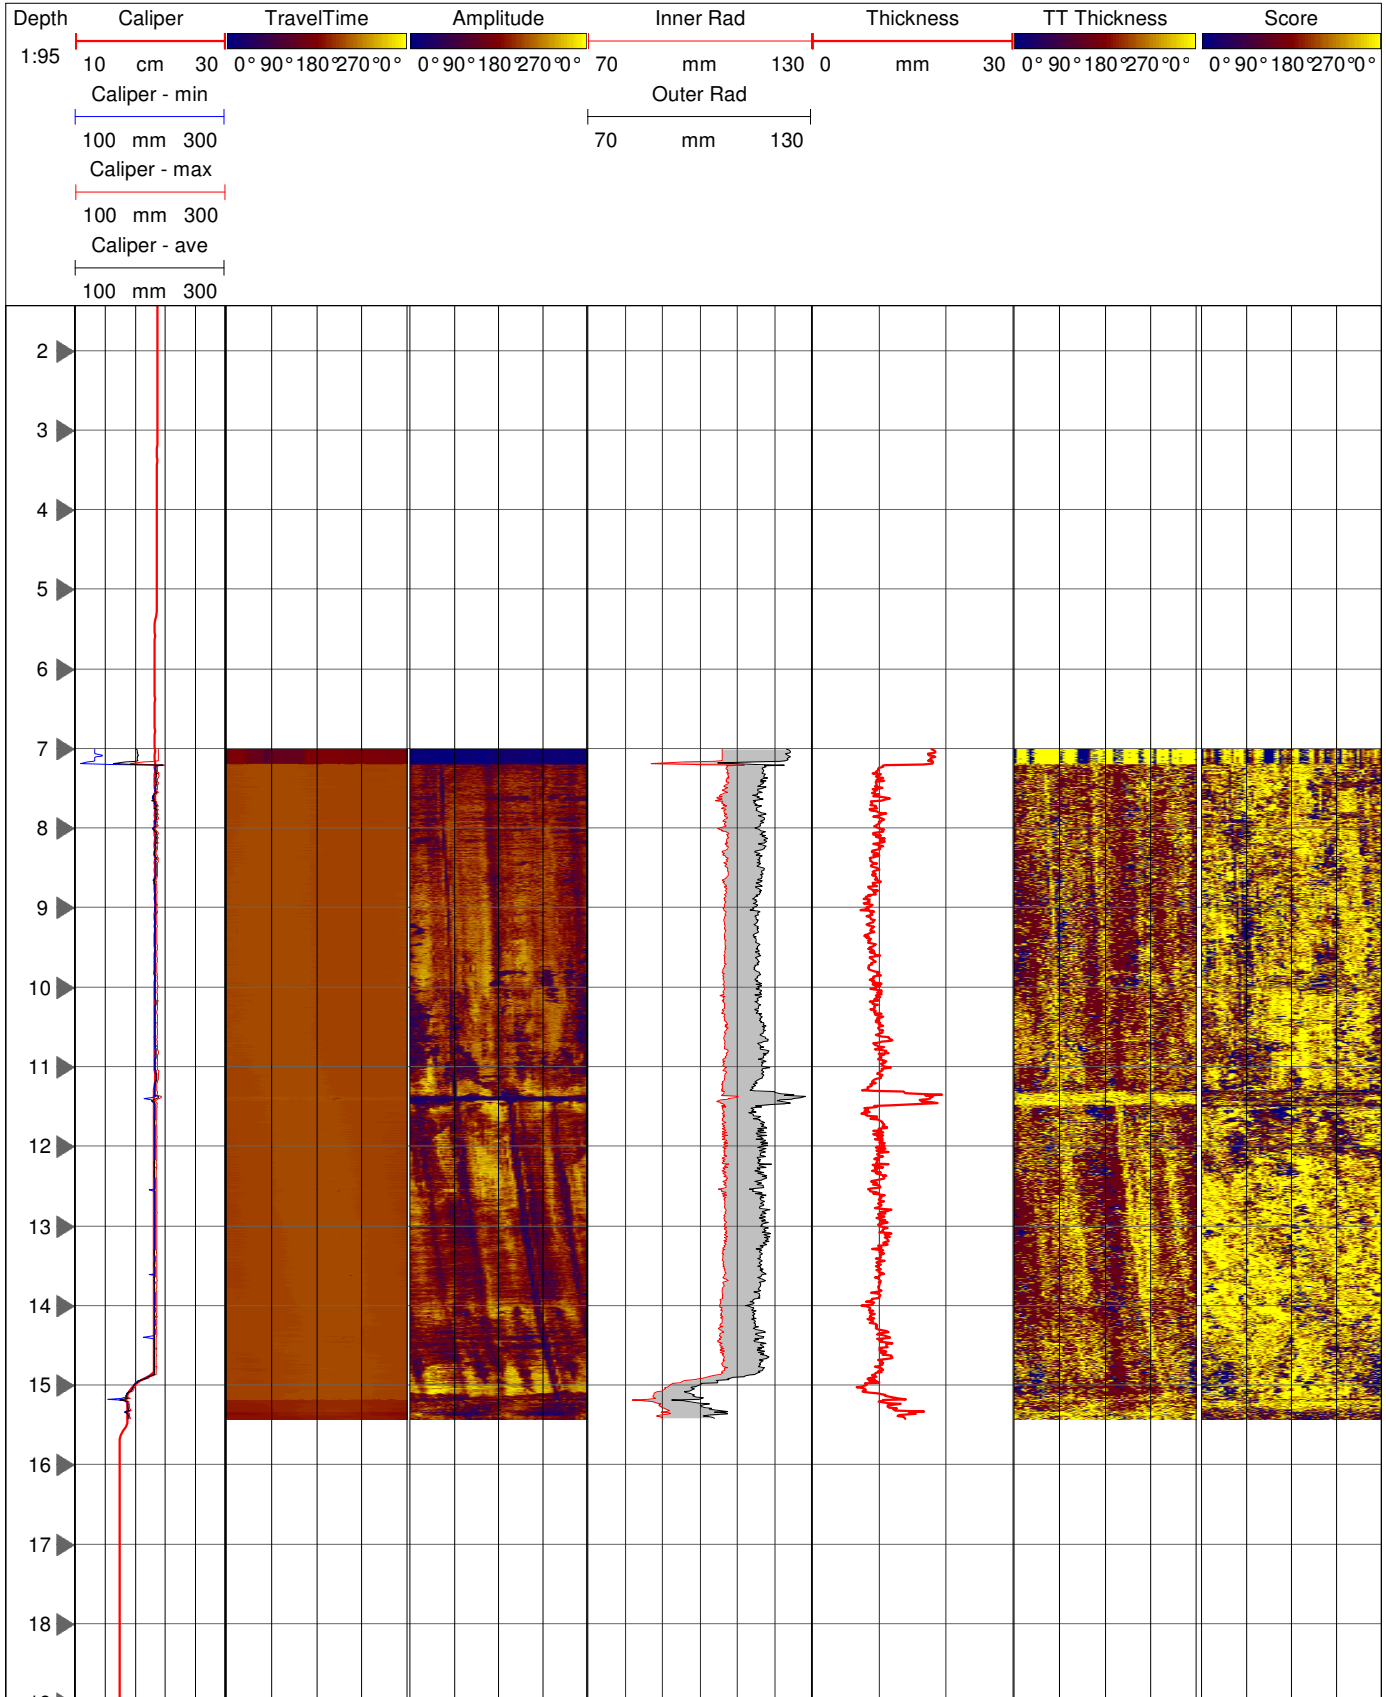
Figure 2

A casing thickness log was completed November 29, 2018. The results of the log are presented as **Figure 2** and show some variability in overall casing thickness, but no overall signs of thinning. Note however, the casing thickness log did not identify the small hole in the casing; as the log was outside resolution of the thickness tool.

A three arm caliper log was also run, which indicated a 200 mm nominal diameter casing which appears to decrease slightly in diameter with depth. At the k-packer and screen, the diameter decreases significantly to 159 mm interior diameter.

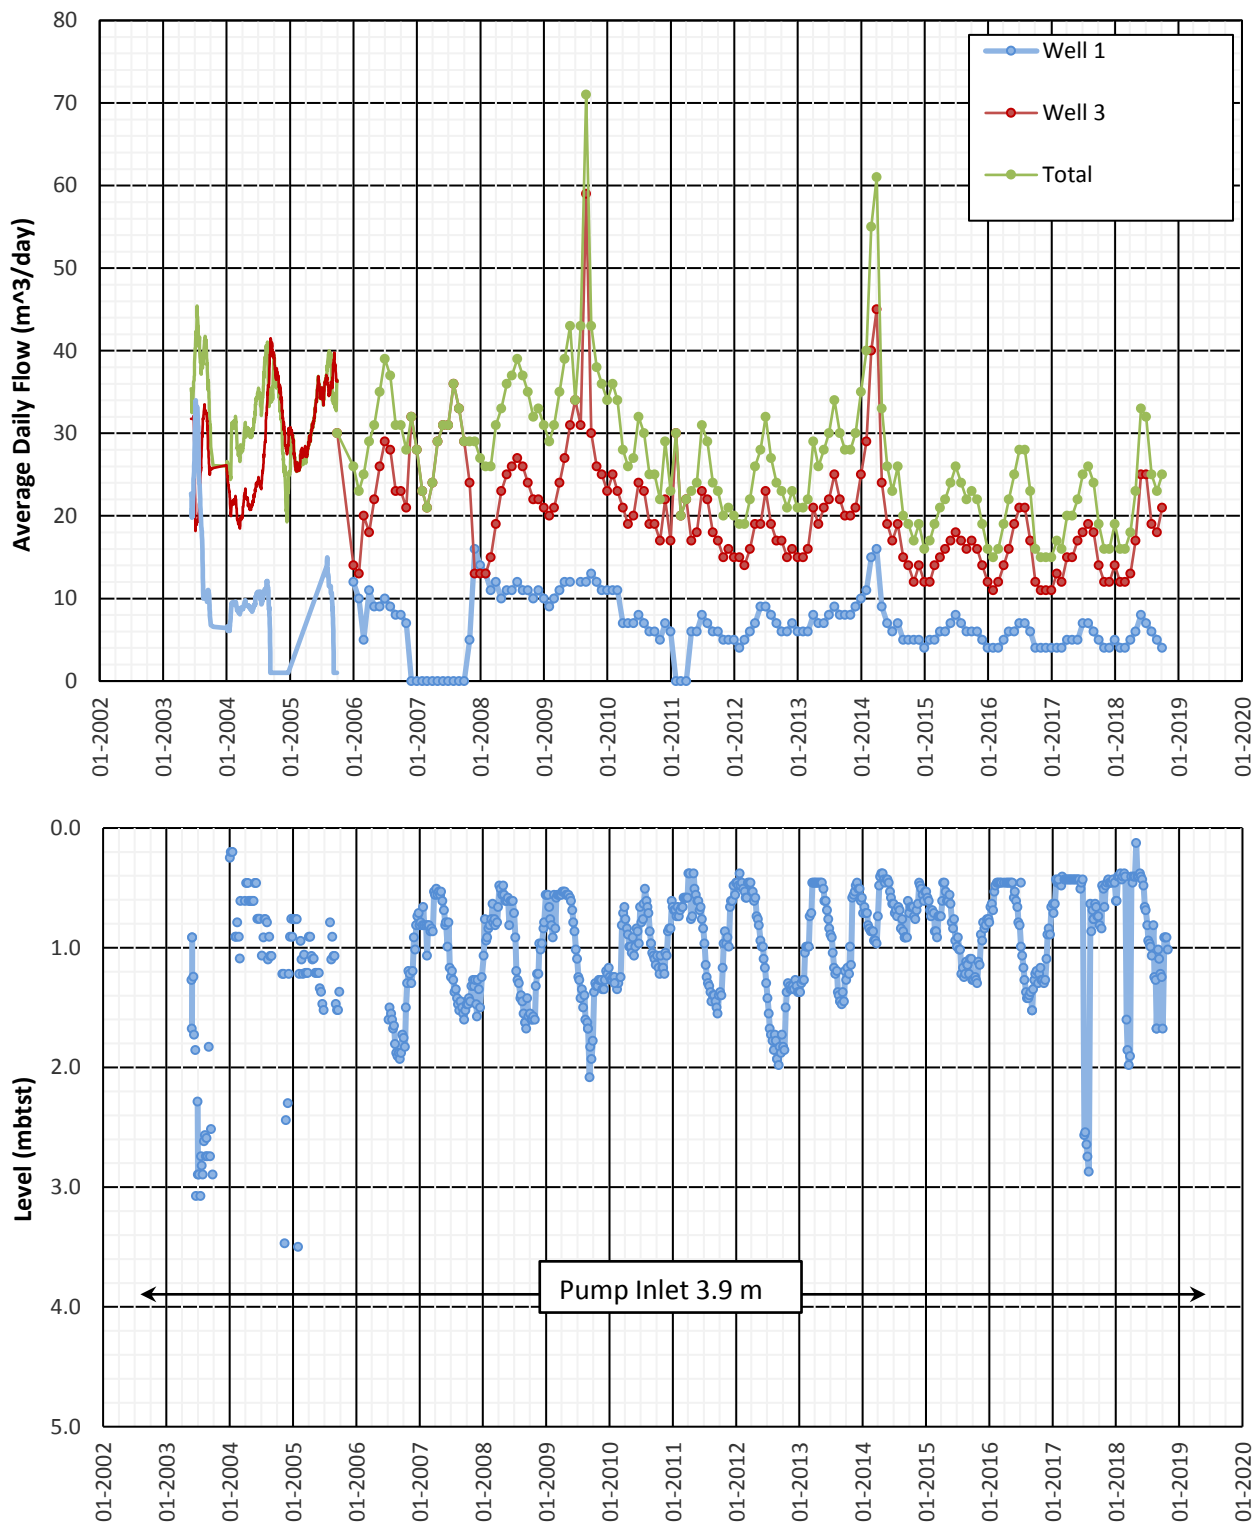
Figure 5

Well 1 levels fluctuated from 0.4 - 2.9 m over the past 15 years with levels generally not going below 2.0 m, except for July of 2017. It appears that levels are generally lowest in the summer and highest in the early spring. Well levels don't necessarily correlate with pumping as there are times with increased pumping and high water levels in the spring on 2016. Conversely, there was a period of no pumping in the spring and summer of 2007 where levels were low. Although pumping may be a contributing factor to Well 1 level declines, it appears that there are other factors that have a more significant impact on levels. These could be due to changes in precipitation, recharge or pumping from other nearby wells.

- Well 1 levels fluctuate but have never reached the pump inlet like at Well 3.
- Well 1 had a period of low levels recently in July of 2017 and the cause of this is not clear.
- Long term review of level and pumping history doesn't show a strong correlation with pumping and well levels. Levels appear more affected by other factors, such as precipitation and recharge.

- If levels drop below 2.5 m in Well 1, and levels are above 13 m in Well 3, decrease pumping at Well 1 by 50% and increase pumping correspondingly at Well 3 to make up the difference. Return to the existing pumping configuration when levels in Well 1 recover to 2.0m.

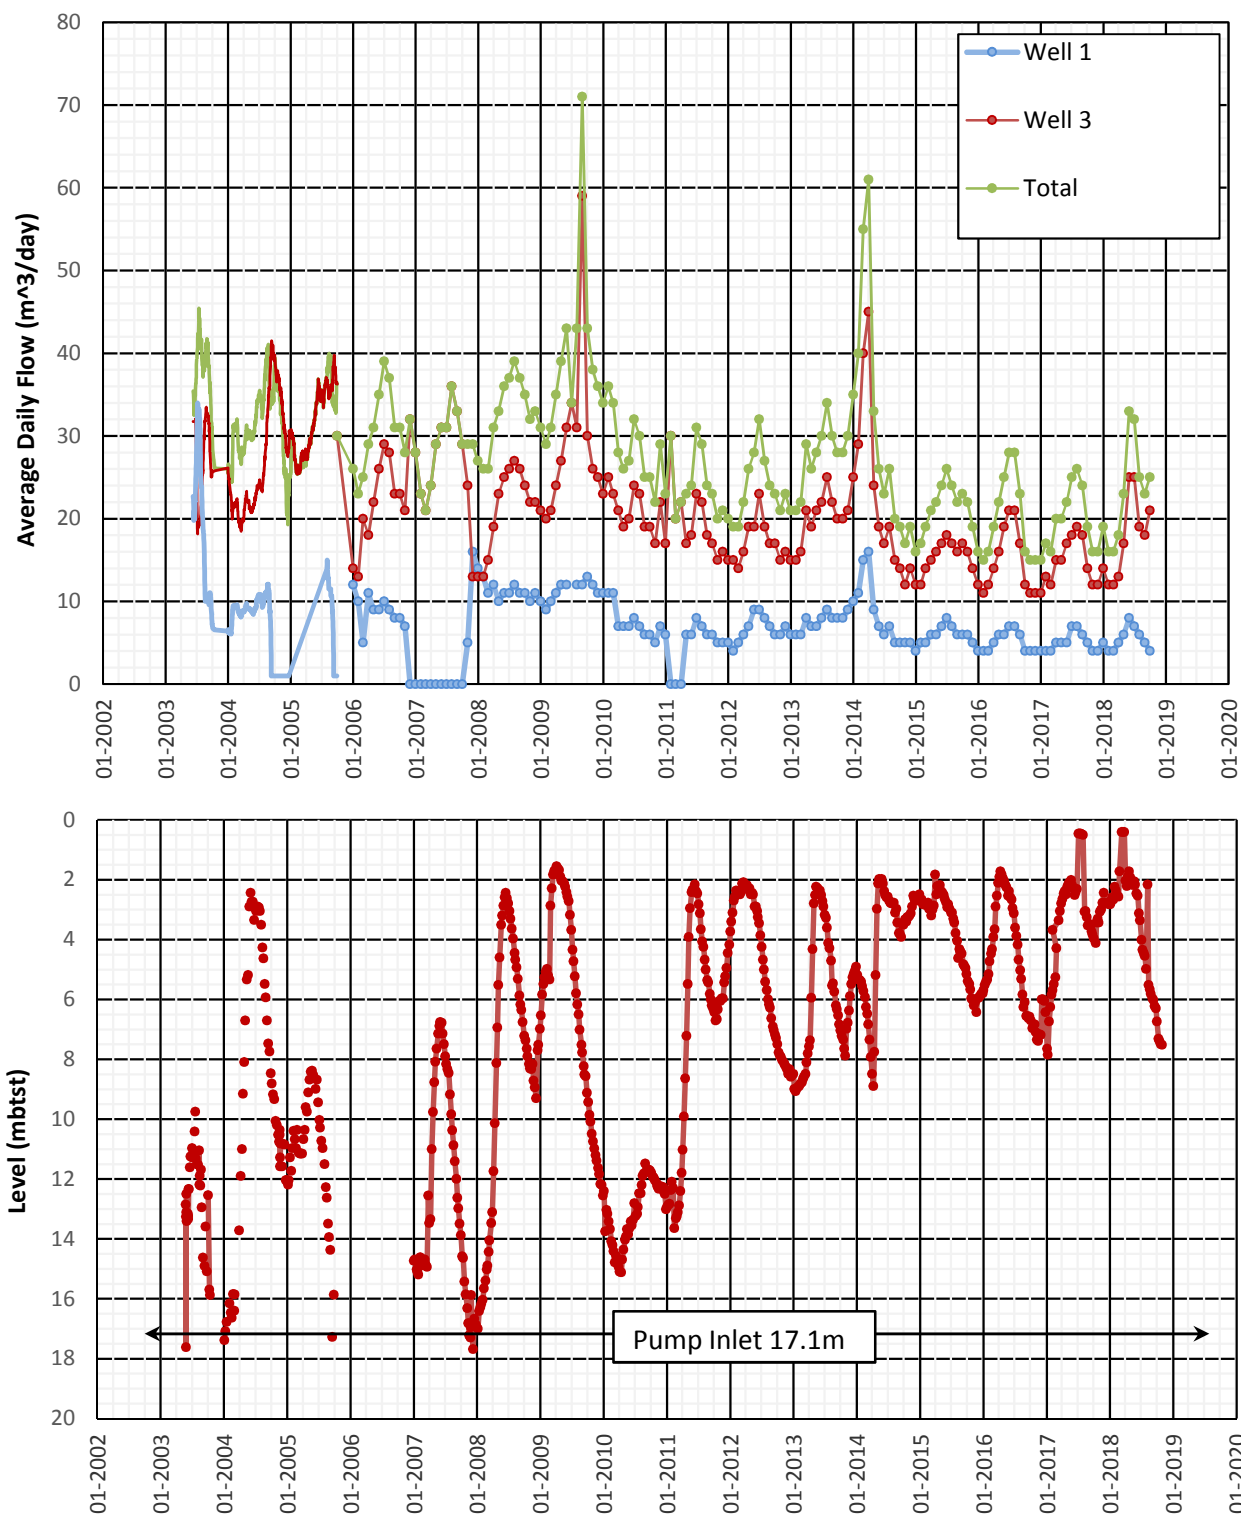
Figure 6

Well 3 had extreme fluctuations of levels over the same 15 year period. Levels have been very near the well head such that the well was nearly overflowing to as low as the pump inlet at 17.1 m. Levels appear to be the lowest in late fall to early winter, and highest in spring. Years of low well levels where the pump was likely cavitating, were in 2003, 2005 & 2007. Similar to Well 1, low levels in the well don't always correlate to high periods of pumping, and there are likely other factors that are contributing to these severe level declines. Over the last 7 years, well levels have never approached the pump inlet.

- Plugging of the well screen here is not a significant contributor to historic low water levels in this well.
- Long term review of level and pumping history shows that levels in the well can change relatively quickly, even drawing levels down to the pump, and reasons for this are not clear. Increased seasonal pumping from the well is likely contributing to these declines, but other factors such as precipitation, recharge and potentially, pumping from other nearby wells, are likely having significant impacts as well.

- If levels drop below 12 m in Well 3, and levels are above 2.5 m in Well 1, decrease pumping at Well 3 by 50% and increase pumping correspondingly at Well 1 to make up the difference. Return to the existing pumping configuration when levels in Well 3 recover to 10.0m.
