BRIDGE REVIEW REPORT

<u>Structure No.:</u>	0013
<u>MTO Site No.:</u>	N/A
<u>Location:</u>	Lot 23A, Concession 8, Greenock Survey
<u>Date of Review:</u>	May 29, 2018
<u>Inspector:</u>	Jesse Borges, EIT
<u>Estimated Safe Loading:</u>	No posting required.

**BRIDGE/CULVERT REVIEW REPORT– 2018
MUNICIPALITY OF BROCKTON
GREENOCK SURVEY**

Structure No. 0013

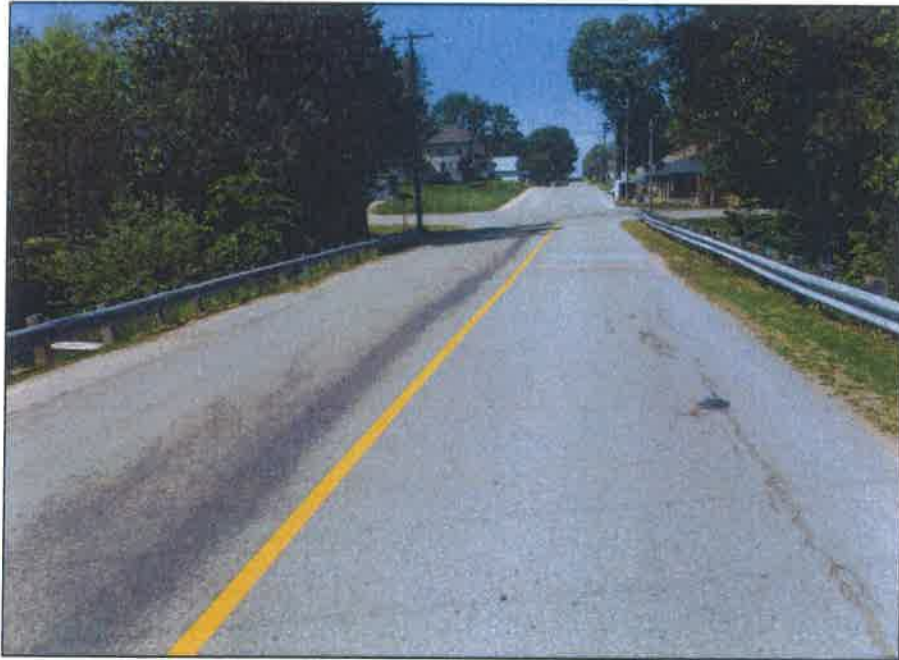
Photo 1 - View of structure from east.

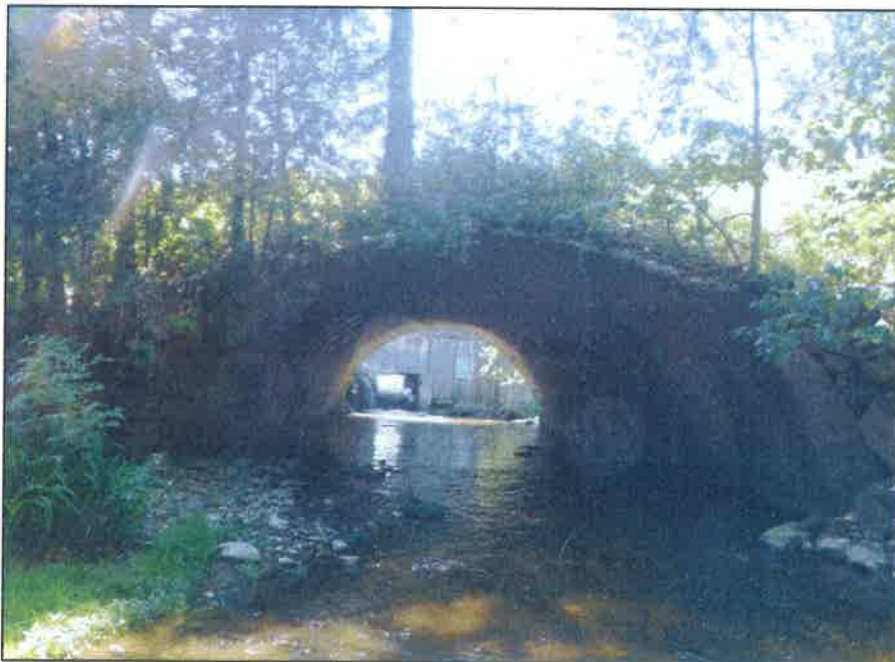
Photo 2 - View of structure from northwest.

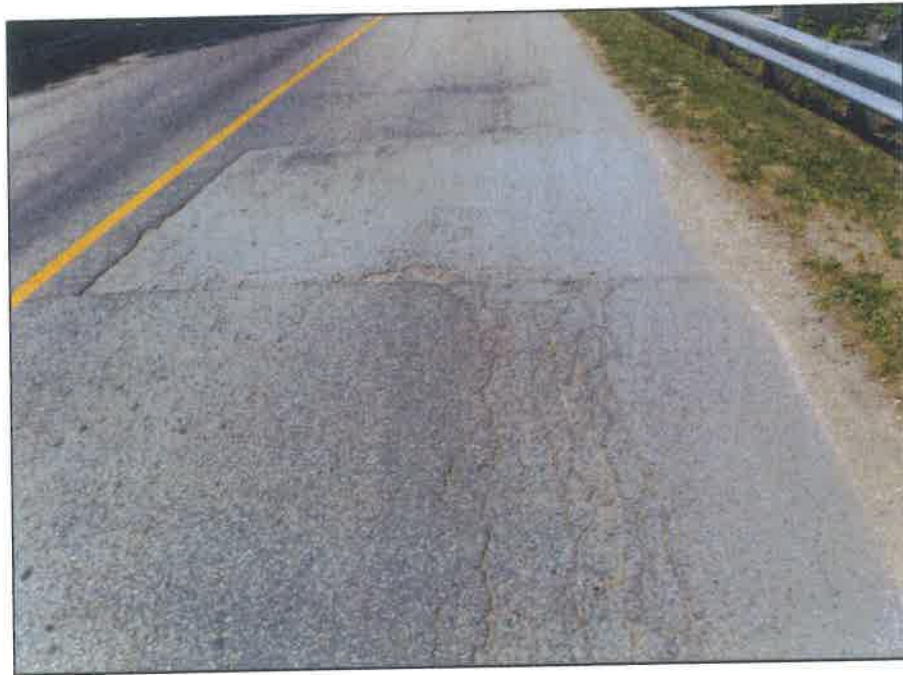
- Asphalt wearing surface is in fair to poor condition with longitudinal and transverse cracks. Asphalt at north has been patched.
- There is a steel beam guiderail on the structure and off the approaches.

Photo 3 - View of cracks and patch in asphalt.

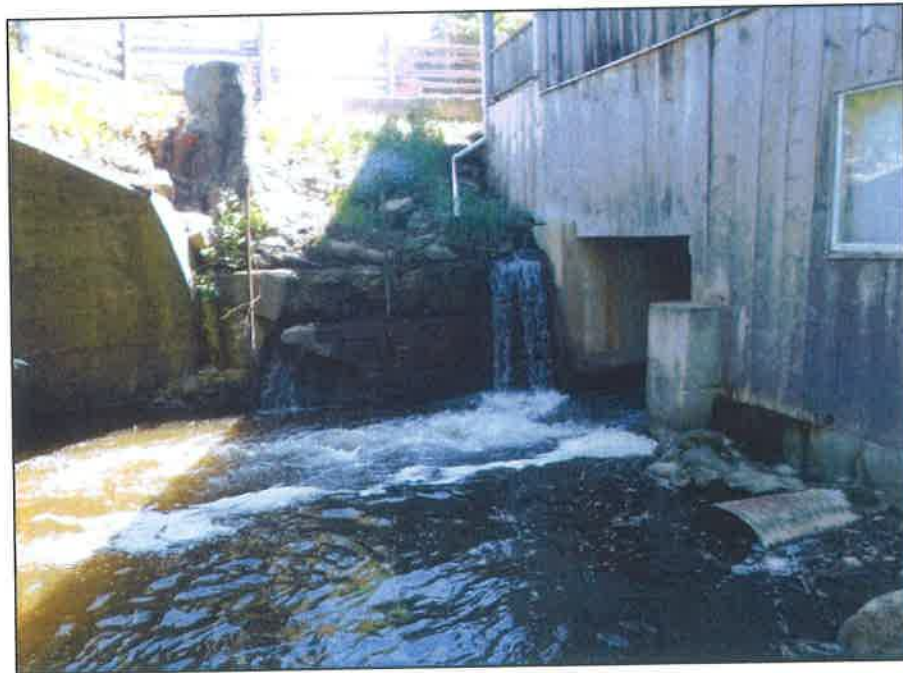
- Several guiderail posts and bearing blocks are damaged in the southwest and northeast approaches.
- The southeast retaining wall is not part of the structure but does have severe deterioration and water leaking. Failure of the following wall could cause problems for the culvert.

Photo 4 - View of southeast retaining wall.

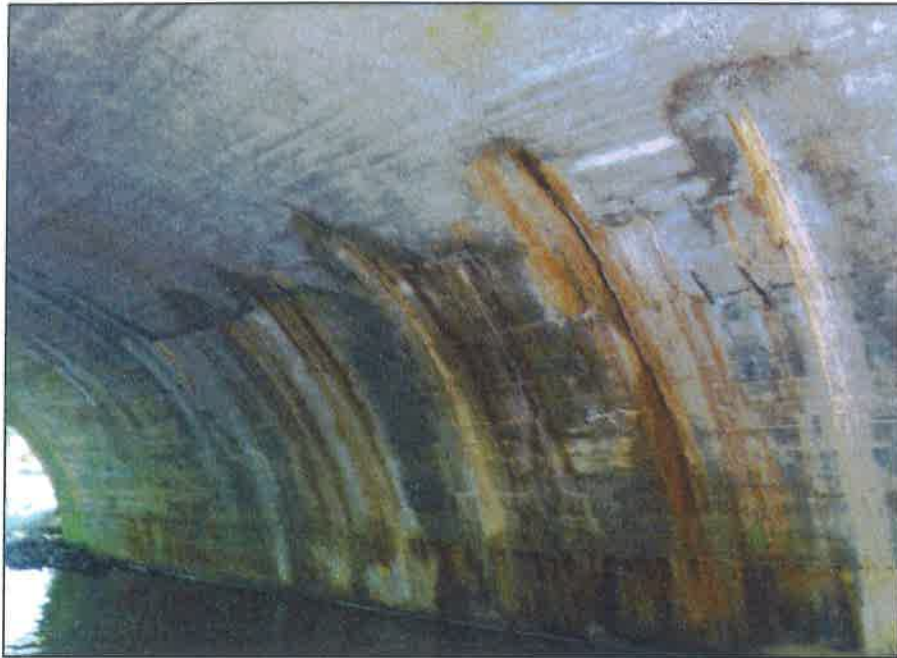
- There are numerous hairline to medium longitudinal and transverse cracks throughout the structure with efflorescence indicating water is leaking through the entire structure.

Photo 5 - View of typical staining and leaking in barrel wall.

1. Continue to monitor condition of soffit with reviews every two years.
2. Budget for replacement in 5 to 8 years.

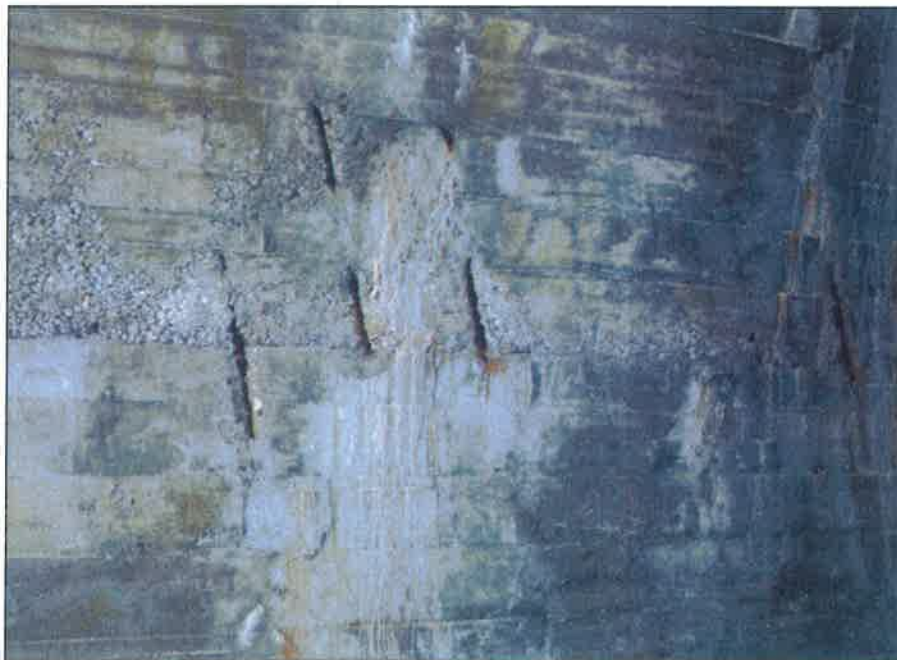
- There is some spalling at the south soffit and the northwest wall exposing reinforcing steel.
- South embankment is failing, causing the guiderail to be pulled down and away from the roadway.

Photo 6 - View of typical efflorescence and exposed rebar in barrel wall.
