FINAL
Building Condition Assessment
1 James Street, Walkerton, Ontario

Corporation of the Municipality of Brockton
Box 68, 100 Scott Street,
Walkerton, ON

July 31, 2019

Pinchin Ltd. File: 238064

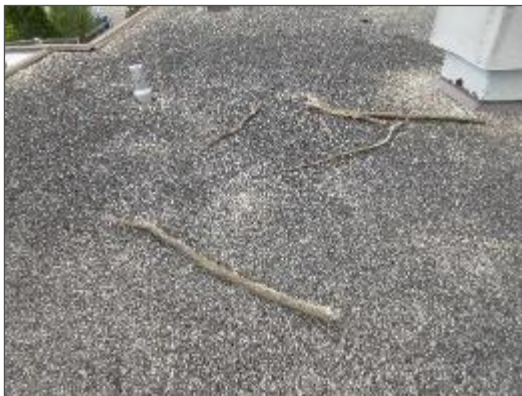
View of debris noted atop the BUR system at the Site Building.

It is recommended to clean vegetation growth atop the roof systems as well as remove debris at roof drains on a seasonal basis as part of regular maintenance. Any miscellaneous debris should also be removed to prevent damage to the roofing systems. Annual walk-on inspections are recommended as part of regular maintenance to ensure the integrity of the roof systems and to extend their service life.

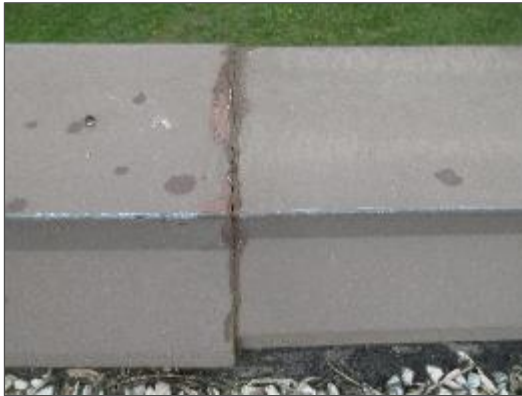
View of deteriorated sealants noted at perimeter metal flashing.

A short-term comprehensive replacement of the sealants throughout the Site Building is recommended and falls below the reporting threshold. Sealant materials should be checked annually for pliability and cracking as part of a preventative maintenance plan.

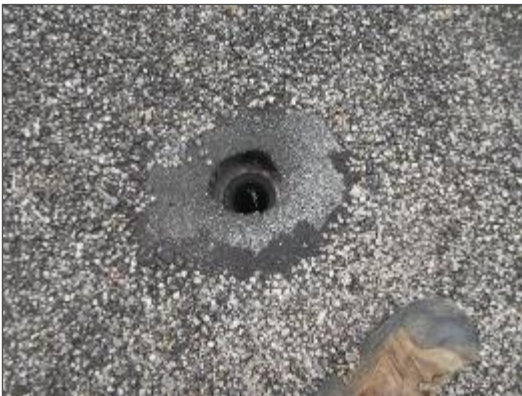
View of a missing roof drain strainer atop the BUR system.

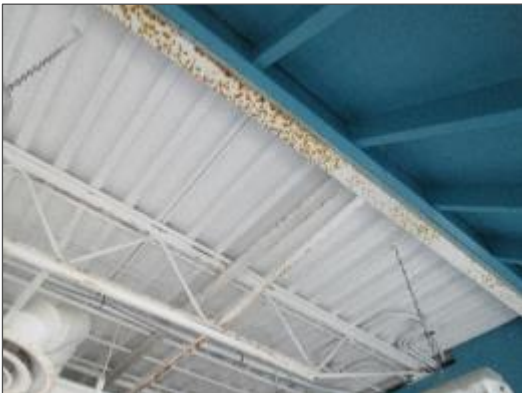
View of corrosion noted at the underside of the metal roof deck serving the Site Building.

- Further review by a Structural Engineer to determine the overall section loss of the corroded areas of steel roof decking and structure within the Site Building.
- Repair and repaint areas of the steel roof deck where corrosion is present.

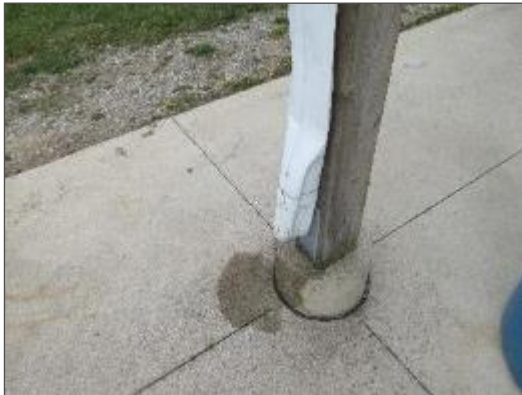
View of a damaged downspout noted at the pavilion outbuilding.

The sloped metal roof systems appear to be in satisfactory condition. Repairs to the damaged downspout should be completed as part of regular maintenance.

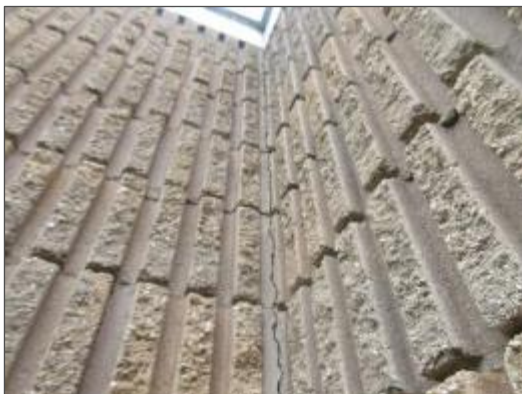
The mortar was noted to generally be in satisfactory condition with localized areas of deteriorated mortar that will require repointing. Localized areas of staining were also noted.

View of cracked mortar noted at the northwest portion of the Site Building.

We have included a localized repair allowance for the wall systems for completing repointing, removing staining and miscellaneous repairs to the cladding.

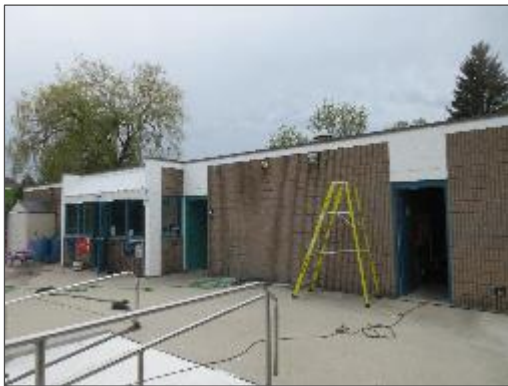
The window assemblies of the Site Building consist of fixed single glazed (SG) units within metal frames. The exact age and condition could not be confirmed; however, these units appear to be original to construction in 1981 (i.e., ~ 38 years old). The window assemblies are set within punched openings and are located on the east elevation. The windows appeared to be in generally poor condition with missing sealants, peeling paint, and corrosion at the window frames. The outbuildings do not possess window systems. Window assemblies will typically have a service life in the order of 30 to 35 years provided that regular maintenance is carried out as required.

General view of the original window units serving the east elevation of the Site Building.

Pinchin recommends replacement of the original windows within the term. An allowance to replace the windows is included. No other major expenditures related to the window assemblies are expected to be required within the term of this analysis.

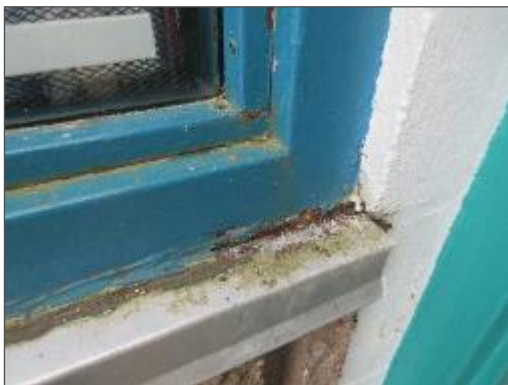
General view of the typical corrosion and peeling paint noted at the window frames.

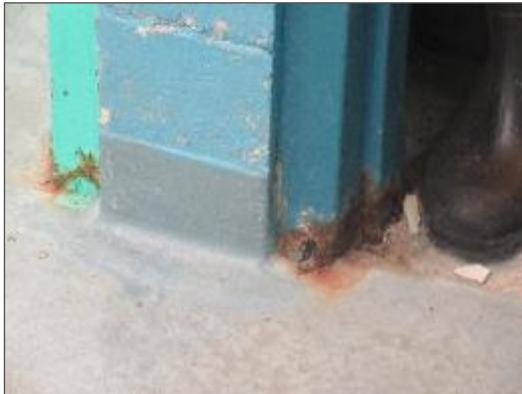
The exterior doors of the Site Building appeared to be in fair condition with peeling paint and surface corrosion noted at the base of the door frames in isolated areas. Doors at the splash pad outbuilding appeared to be in good condition. It is recommended to sand and repaint the deteriorated areas as part of regular maintenance.

View of corrosion noted at a door.

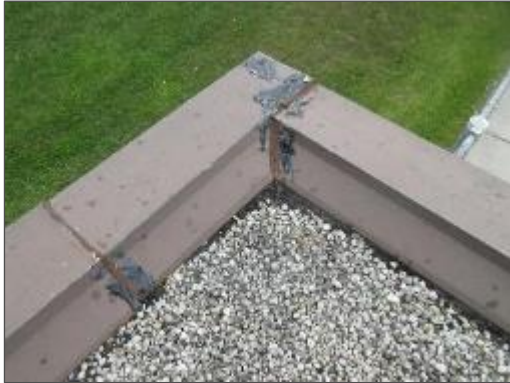
Sealants at the Site Building were observed to be deteriorated, debonded from the substrate, split, cracked, and missing in isolated locations.

View of deteriorated sealants atop the perimeter roof flashing.

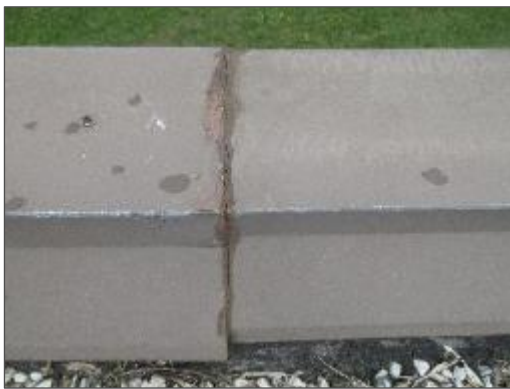
View of deteriorated sealants atop the perimeter roof flashing.

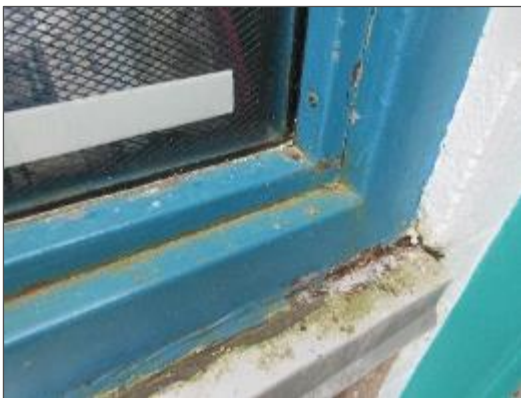
View of missing sealant noted at the SG window systems.

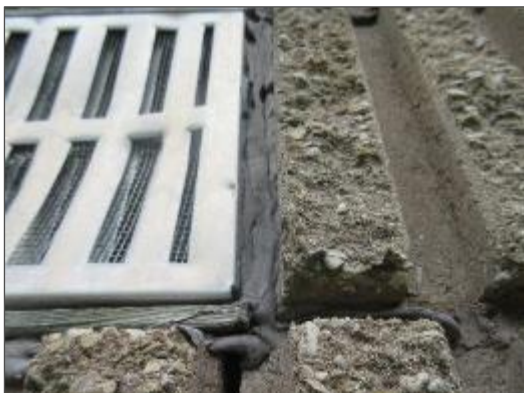
View of deteriorated sealants noted at a wall vent.

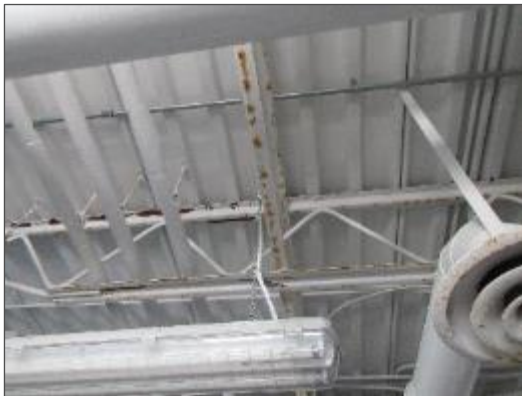
View of the underside of the steel decking with visible corrosion noted.

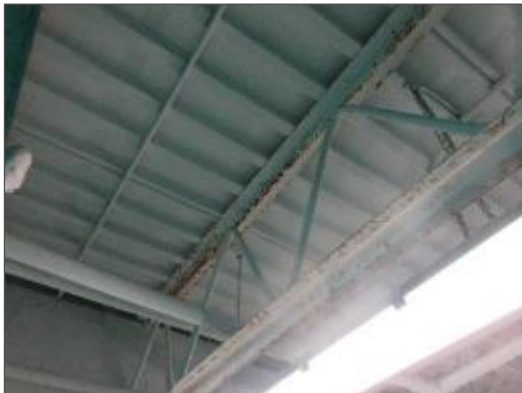
View of the underside of the steel decking with visible corrosion noted.

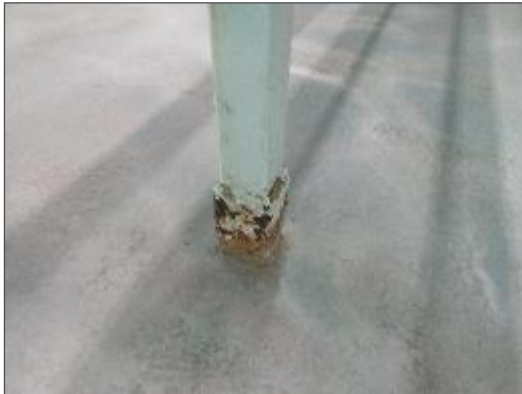
View of corrosion noted at a steel column.

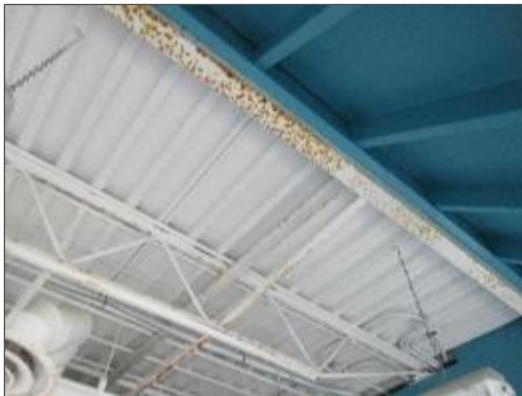
View of corrosion noted at the underside of the steel decking of the Site Building.

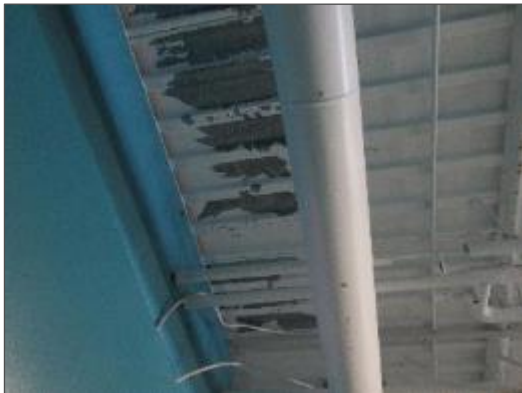
View of peeling paint noted at the underside of the steel decking of the Site Building.

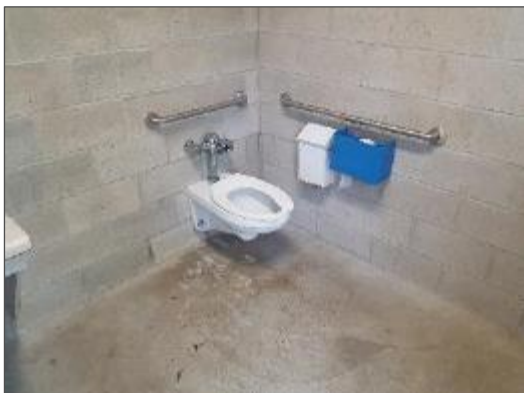
View of staining at the cast-in-place concrete slab noted within the washroom spaces of the splash pad outbuilding.

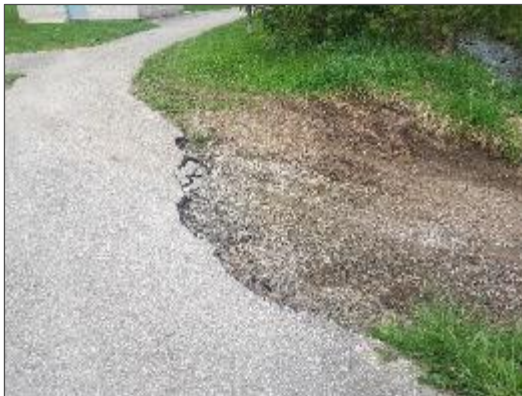
View of deteriorated asphalt pavement walkway within the central portion of the Site.

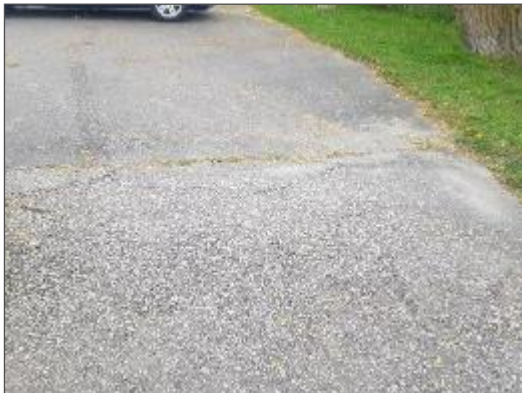
View of cracking noted within the asphalt paved parking areas on the lower, central portion of the Site.

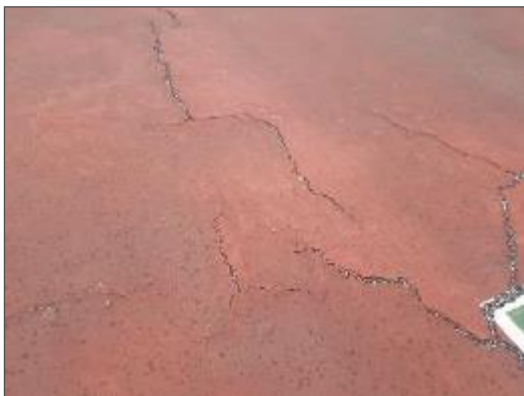
View of typical damaged rubber acrylic base surface at the tennis court of the Site.

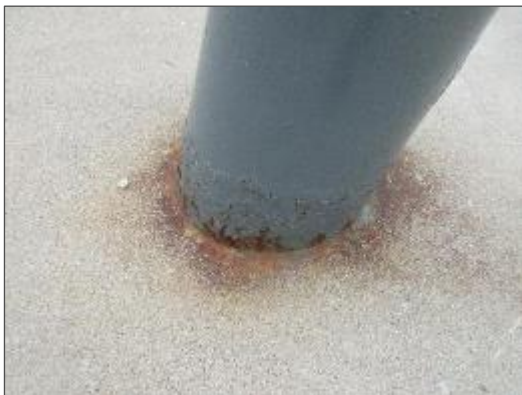
View of minor corrosion noted at the base of the diving boards.

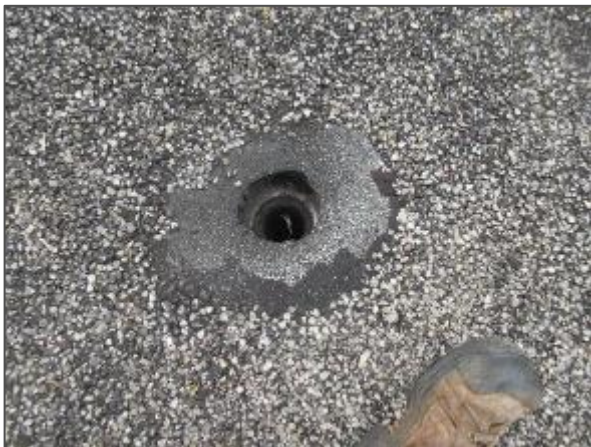
Typical roof drain missing roof drain strainer.
