Accessibility Audit

1 James Street, Walkerton, Ontario

June 26, 2019

Pinchin File: 238064.001

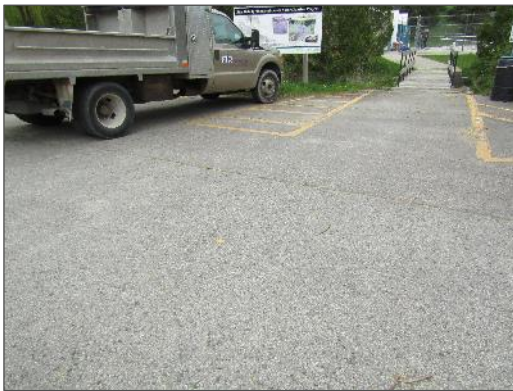
There are currently no accessibility surface parking spots located at the Site.

View of parking area closest to the pool building main entrance.

It is recommended that accessibility parking spots be added in order to meet current AODA AccessON requirements; this item can be completed when pavement line markings require renewal. The AODA AccessON requirements for parking will be triggered if the parking area is redeveloped, or if newly constructed parking areas are added to the Site.

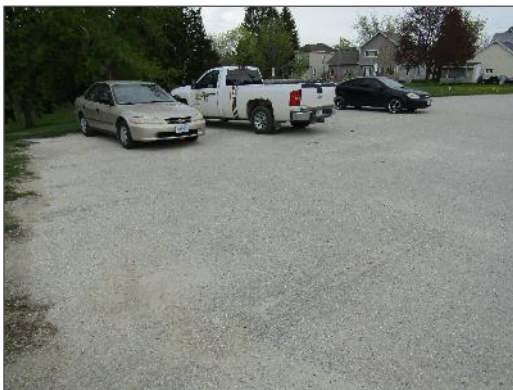
General view of parking area at the South end of the park.

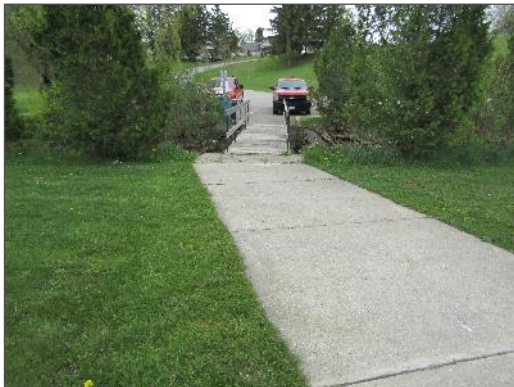
View of the concrete walkway and wood bridge that leads to the pool area of the park.

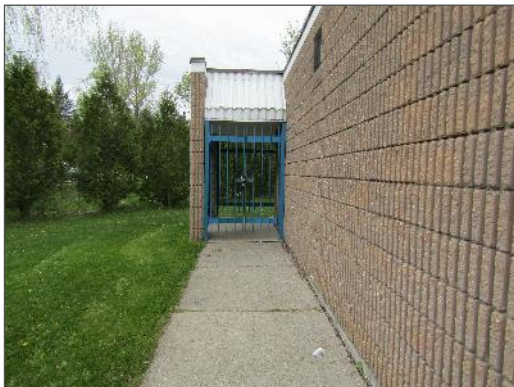
View of the concrete walkway at the main accessibility entrance of the pool building.

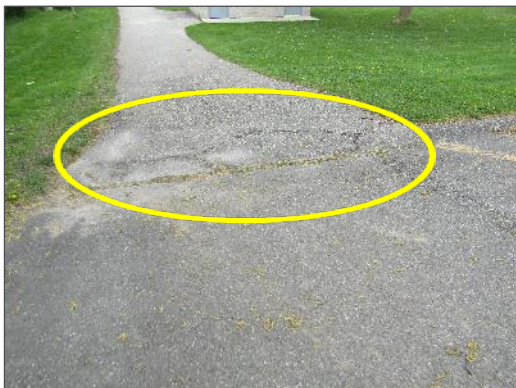
park including an uneven portion at the accessibility route from the lower parking area to the splash pad area and washroom building. As well, there was a damaged portion of the asphalt walkway North of the splash pad. There are exterior concrete walkways that lead to the pool building that generally appeared to be level and in good condition.

View of the asphalt paved walkway which is uneven at the pathway to the splash pad.

It is recommended to repair the asphalt pavement where it is uneven or damaged so that the exterior accessible route is level and in a state of good repair.

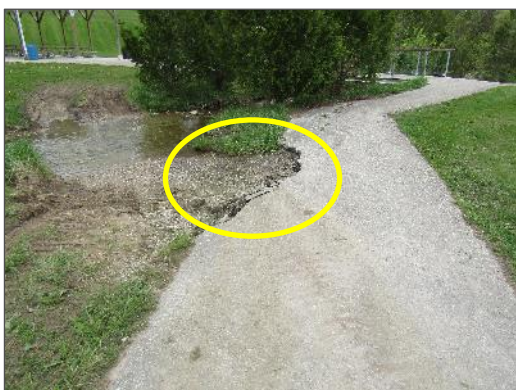
View of damaged asphalt paved walkway within the park.

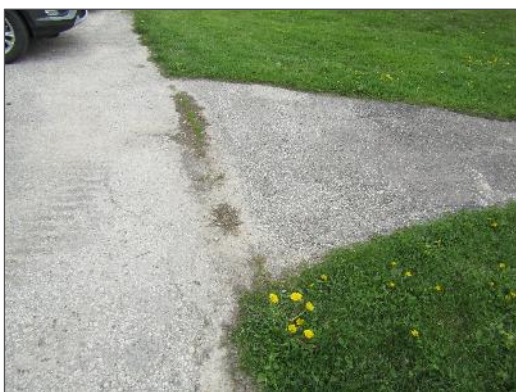
View of uneven asphalt paving that leads to the tennis courts at the park.

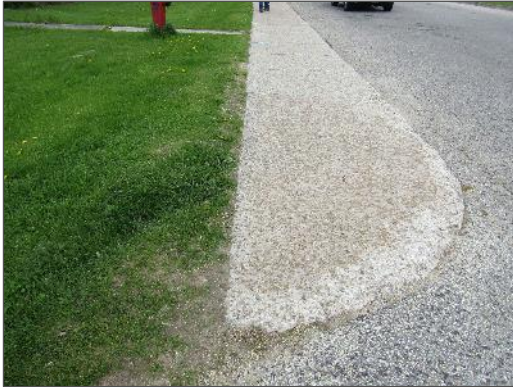
View of the municipal sidewalk at the park entrance driveway.

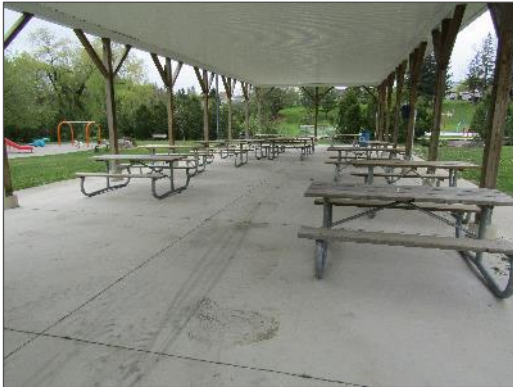
The park was noted to have a covered picnic area at the North portion of the Site that was accessible but did not include dedicated accessibility furnishings; the picnic tables were found to generally not allow for the roll under space and did not meet the minimum height for accessibility clearance requirements (29").

View of the covered picnic area at the park.

It is recommended to include a minimum of one (1) table at the picnic area which will meet the minimum height for accessibility under table clearance requirements (29") in order to improve the accessibility of the park amenities for any guests which may visit this common area as per AODA AccessON requirements. If there are more than ten (10) tables in the outdoor eating area, then two (2) accessible tables will be required.

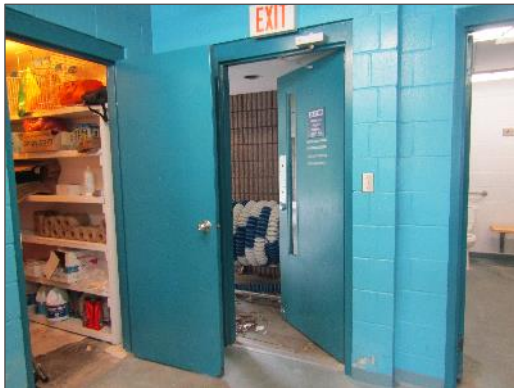
View of the main entrance door at the pool building viewed from the interior.

There were no automatic door openers installed on any of the exterior accessibility doors. It is recommended to install automatic door openers on exterior pool building accessible doors and washroom building accessible doors.

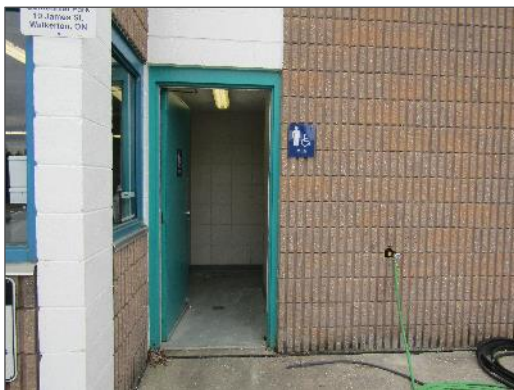
View of the exterior door from the pool area to the change rooms in the pool building.

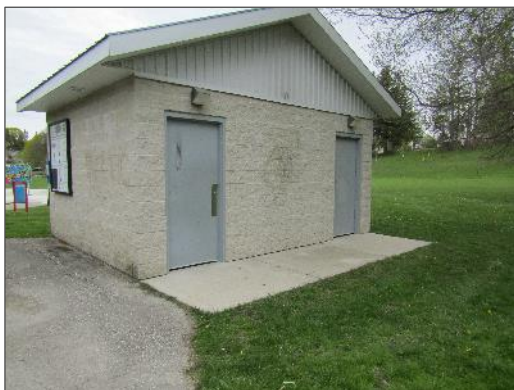
View of the doors for the washrooms adjacent to the splash pad.

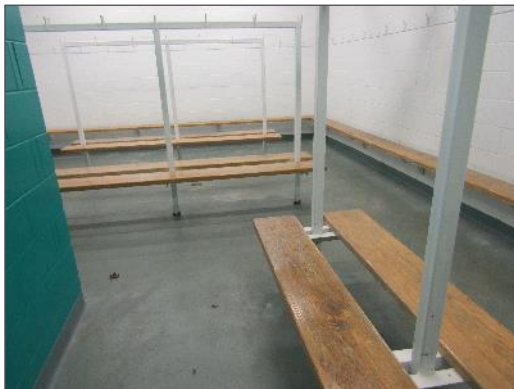
View of the change room space for the pool area.

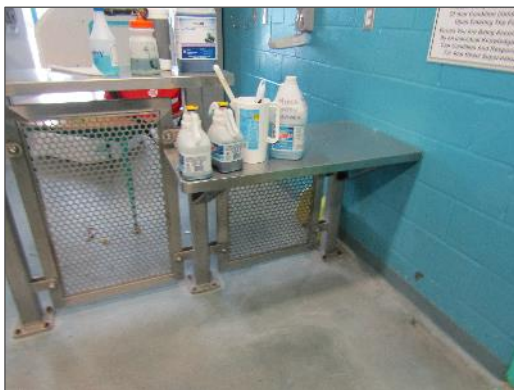
View of the lower service counter at the pool entrance area.

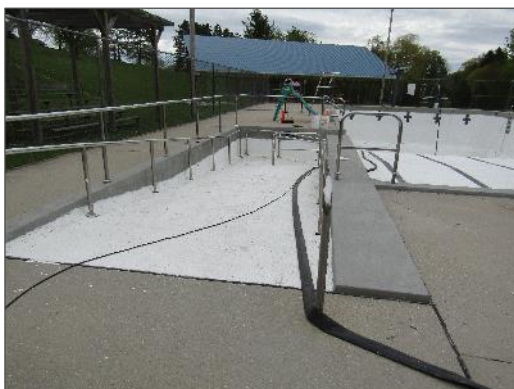
View of the accessible ramp into the pool.

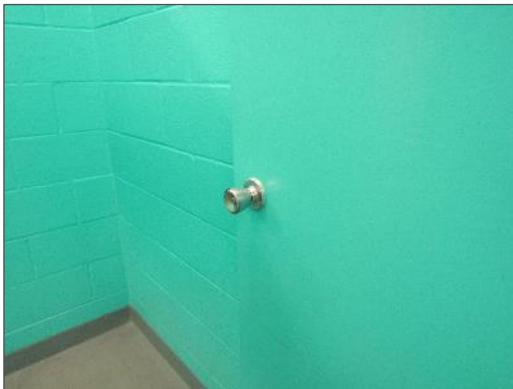
The interior doors within the pool building at interior accessible routes generally were observed to be compliant with clear floor areas on either side of the doors. The doors along main routes of travel within the pool building had twisting style or push/pull style door hardware installed. The twisting style hardware does not comply with accessibility requirements. Doors where tested qualitatively appeared to be compliant with accessible opening force requirements. All doors appeared to be in compliance with minimum clear opening width accessibility requirements (32").

Typical interior door in the pool building with twist style hardware.

It is recommended that all the door hardware be updated to lever style to be compliant with accessibility requirements.

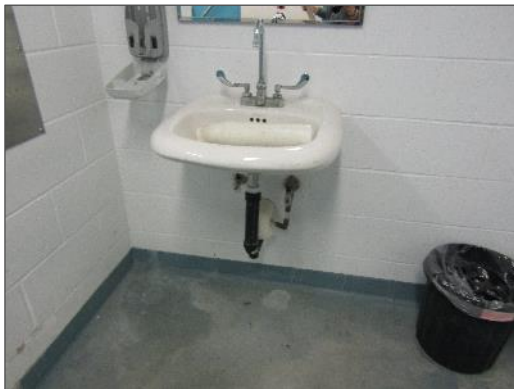
The under countertop/under sink clearance appeared to generally meet minimum requirements (29"). Sinks were observed to have automatic motion sensor hardware or lever style hardware, which meets accessibility requirements. The plumbing under sinks was not insulated against contact in any of the

washrooms at the time of the Site inspection and is not in compliance with accessibility requirements. It was reported by the Site Representative that the pool building washroom was undergoing plumbing repairs and required the temporary removal of the insulated cover on the under-sink plumbing.

View of the sink within the accessibility washroom at the pool building.

It is recommended to install accessibility signage on all accessible washroom doors and visual strobe fire alarm devices in the pool building washrooms. It is recommended to insulate plumbing under designated accessible sinks against contact in all washrooms.

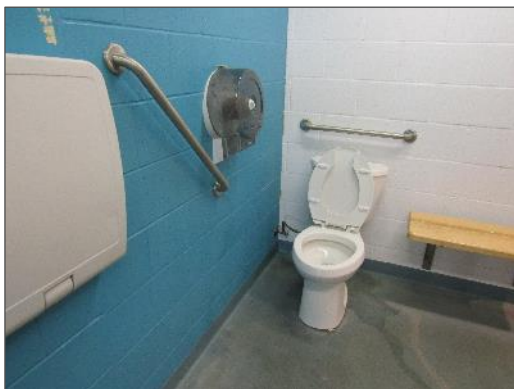
View of the accessible washroom within the pool building.

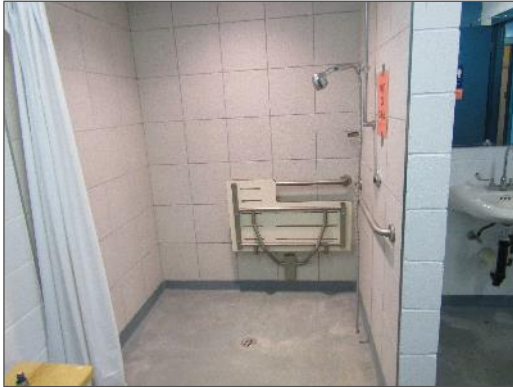
View of the accessible shower in the pool building.

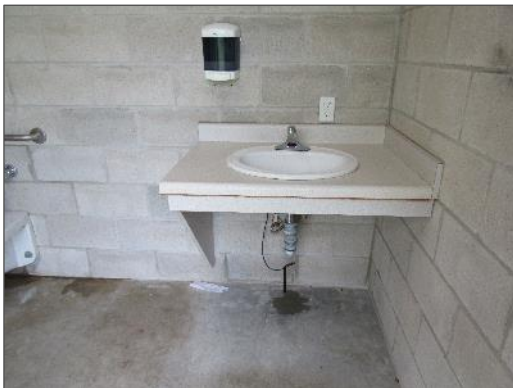
View of the sink within the park washrooms adjacent to the splash pad.

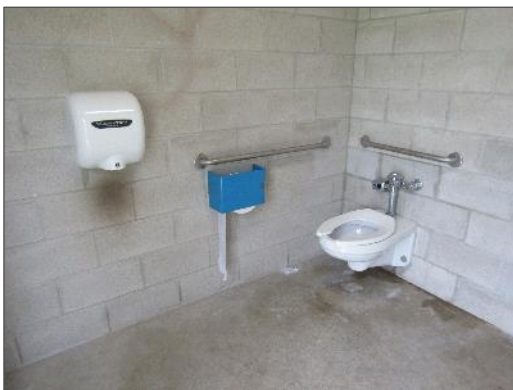
View of the park washroom adjacent to the splash pad.
