Hazardous Building Materials Assessment

Pool House
1 James Street, Walkerton,
Ontario

June 25, 2019

Pinchin File: 238554

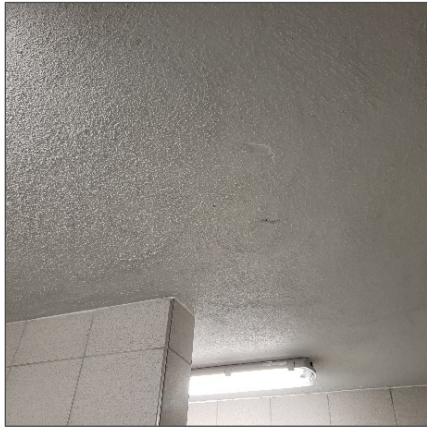
Stippled texture finish present on the ceiling in the men's washroom shower, location 3 does not contain asbestos (samples 0004A-C).

Non-asbestos stippled texture finish present on the ceiling in the men's washroom shower, location 3.

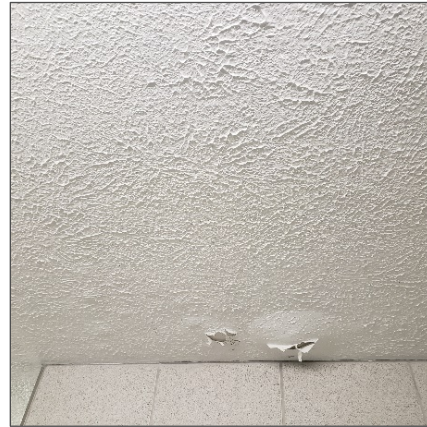
Swirling texture finish present on the ceiling in the women's washroom shower, location 7 does not contain asbestos (samples 0007A-C).

Non-asbestos swirling texture finish present on the ceiling in the women's washroom shower, location 7.

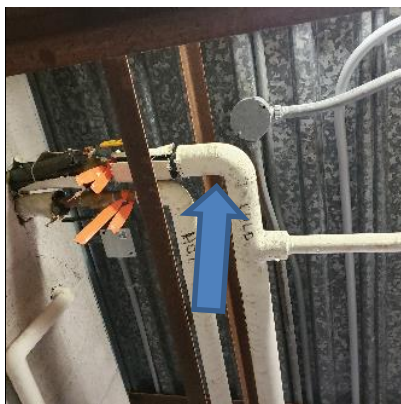
Black insulation present on pipe straights and pipe fittings in the boiler room, location 1 does not contain asbestos (samples 0002A-C).

Non-asbestos pipe insulation present in the boiler room, location 1.

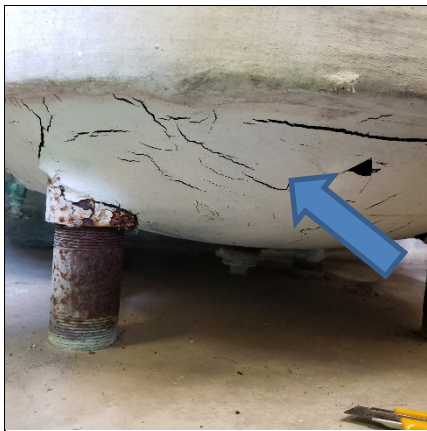
Black insulation present on the underside of the boiler in the boiler room, location 1, does not contain asbestos (samples 0002A-C). The boiler is also insulated with non-asbestos fibreglass insulation covered in canvas.

Non-asbestos black insulation present on underside of the boiler, location 1.

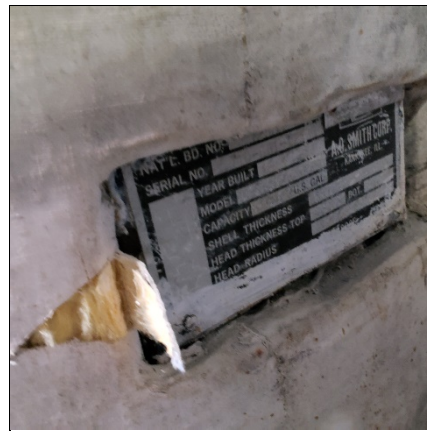
Non-asbestos fibreglass insulation present on face of boiler, location 1.

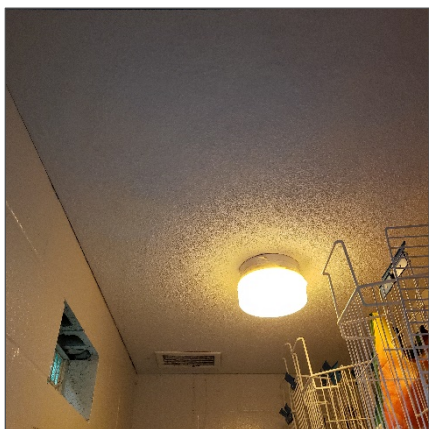
Textured plaster, presumed to contain asbestos, is present as a ceiling finish in the janitor's closet, location 6. Plaster is a non-friable material which may become friable upon removal and is in good condition. There is approximately 25 square feet of plaster ceiling.

Presumed asbestos-containing plaster ceiling present in the janitor's closet, location 6.

Remove asbestos-containing materials (ACM) prior to alteration or maintenance work if ACM may be disturbed by the work. Follow appropriate asbestos precautions for the classification of work being performed.

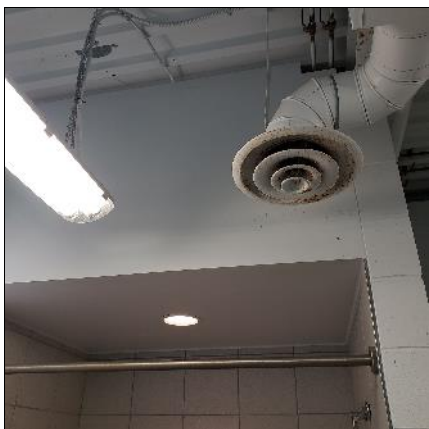
Drywall joint compound present on the walls and bulkhead in the family change room, location 4 does not contain asbestos (samples 0005A-C).

Non-asbestos drywall wall/bulkhead in the family change room, location 4.

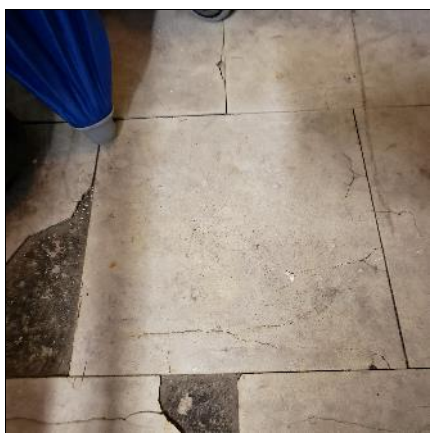
Size, Pattern, Colour	Locations, Location # (Quantity)	Sample Number	Asbestos Type (tile)	Asbestos Type (mastic)
12"x12 off-white	Janitor's closet, location 6 (25 square feet).	0006A-C	Chrysotile	None detected

The vinyl floor tiles are non-friable and are in fair condition.

Asbestos-containing 12"x12" off-white vinyl floor tiles present in the janitor's closet, location 6.

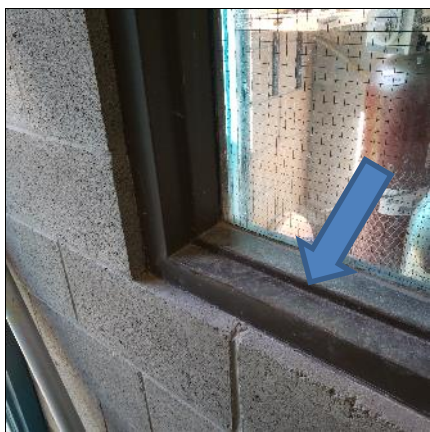
Material and Colour	Location, Location #	Quantity	Sample Number	Asbestos Type
Butyl tape, grey/black	Boiler room window pane, location 1	16 LF	0003A-C	Chrysotile
Caulking, black	Around exterior window frames of the guard house, location 10	N/A.	0008A-C	None detected

Butyl tape is a non-friable material and is in good condition.

Asbestos-containing grey/black butyl tape present around the boiler room window frame, location 1.

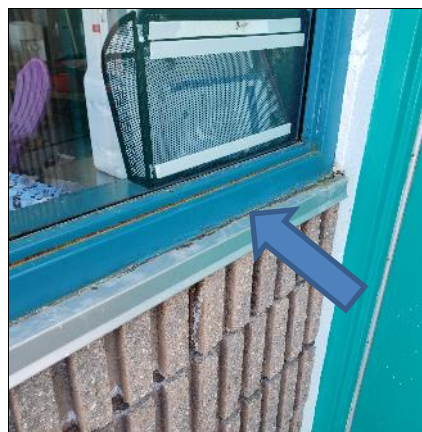
Non-asbestos black caulking present around the exterior window frames of the guard house, location 10.

Material and Colour	Location	Sample Number	PCB concentration (ppm)
Caulking, black	Around the exterior window frames of the guard house, location 10	P01	<0.5

Caulking in the table above is considered a non-PCB solid based on the threshold (50 ppm).

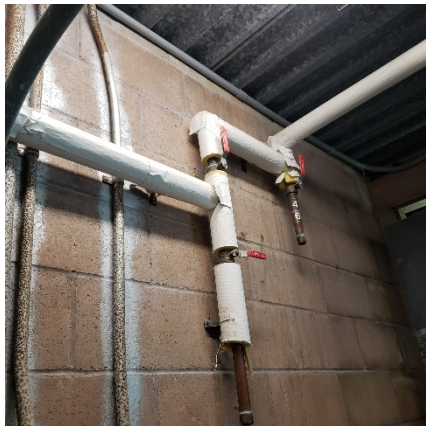
Mortar present in the concrete block masonry throughout the building does not contain asbestos (samples 0001A-C).

Non-asbestos concrete block mortar present in the boiler room, location 1.

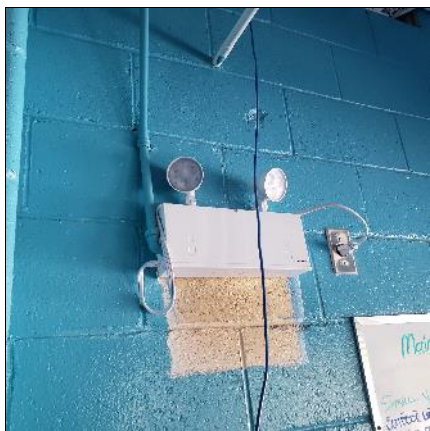
Lead-containing batteries are presumed present in emergency lighting.

Lead-containing batteries are presumed present in the emergency lighting in the family change room, location 4.

Lead-containing items should be recycled when taken out of service.

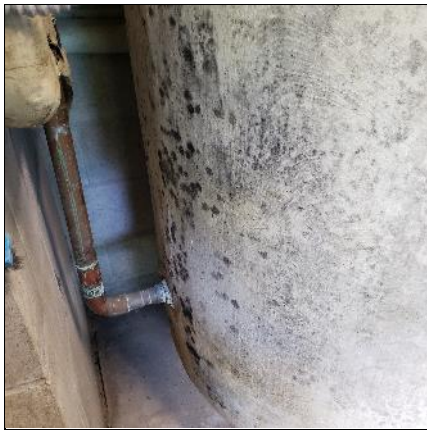
Visible mould growth is present on the boiler canvas and pipe canvas in the boiler room, location 1. There is approximately 30 square feet of visible mould growth.

Visible mould growth present on the boiler canvas in the boiler room, location 1.

Material, Quantity	Location, Location #	Recommended Procedure
Visible mould growth on boiler and pipe canvas, 30 square feet	Boiler room, location 1	Remove in accordance with Level 2 EACO mould abatement procedures.

Use appropriate precautions and protect workers during removal, using methods that comply with provincial guidelines. A qualified consultant should specify, inspect and verify the successful removal of mould-impacted finishes.

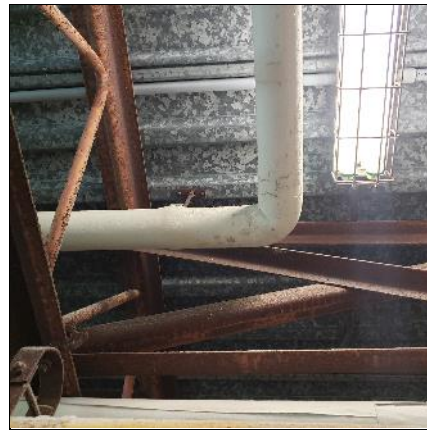
Visible mould growth present on the pipe canvas in the boiler room, location 1.
