**FINAL**  
**Building Condition Assessment**  
290 Durham Street West, Walkerton, Ontario

**Corporation of the Municipality of Brockton**  
Box 68, 100 Scott Street,  
Walkerton, ON

July 31, 2019

Pinchin Ltd. File: 238065

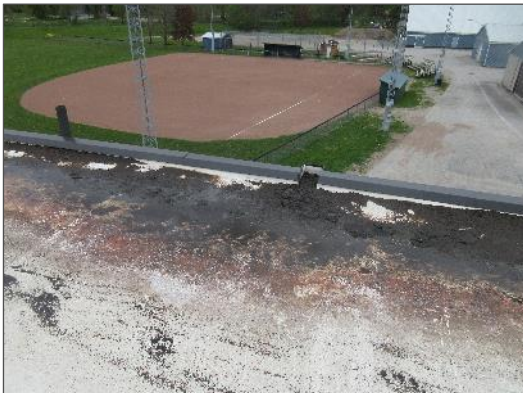
View of typical organic growth noted throughout the roof.

It is recommended to clean growth atop the roof systems as well as remove debris at roof drains on a seasonal basis as part of regular maintenance. Any miscellaneous debris should also be removed to prevent damage to the roofing systems. Annual walk-on inspections are recommended as part of regular maintenance to ensure the integrity of the roof systems and to extend their service life.

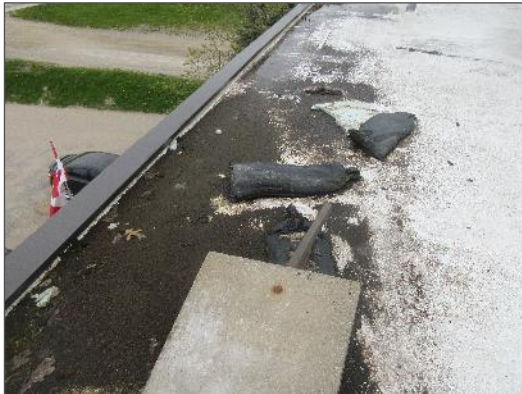
View of debris noted atop the roof system.

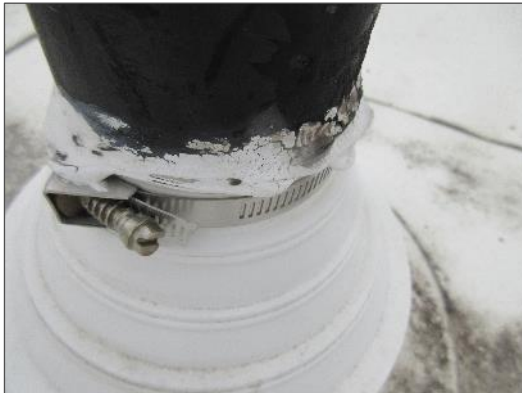
View of deteriorating sealants at roof penetrations.

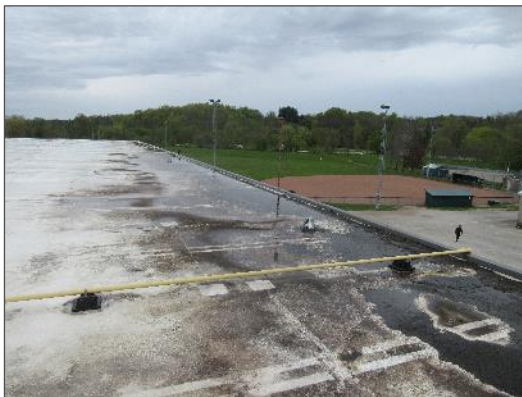
View of water ponding noted along the east perimeter of the TPO roof system.

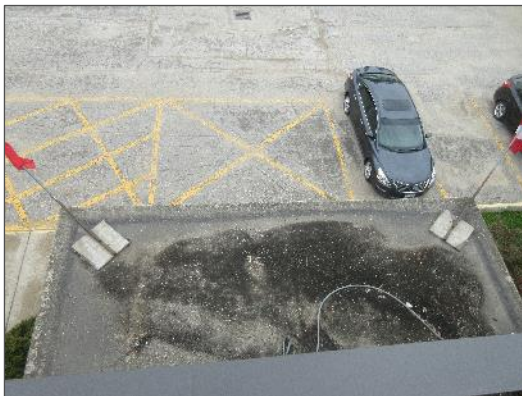
View of the concrete canopy serving the south entrance of the Site Building.

Note: Missing or deteriorated roofing membrane, debris, growth.

The sloped metal canopy appears to be in satisfactory condition, repairs to the damaged and lifting roofing should be completed as part of regular maintenance. In addition, Pinchin recommends installation of a protective roofing membrane atop the south concrete canopy. Pinchin has added a project to complete roofing at this canopy as well as repairs to the metal roofing system.

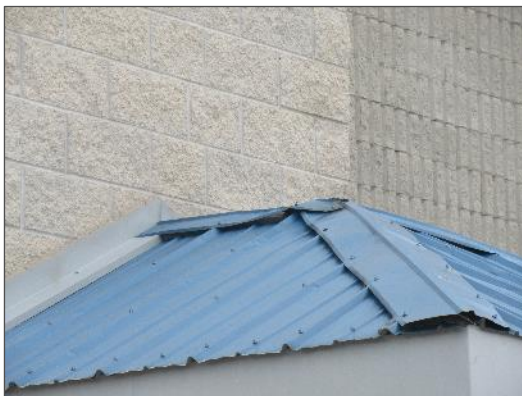
View of the bent/damaged capping noted atop the sloped metal canopy.

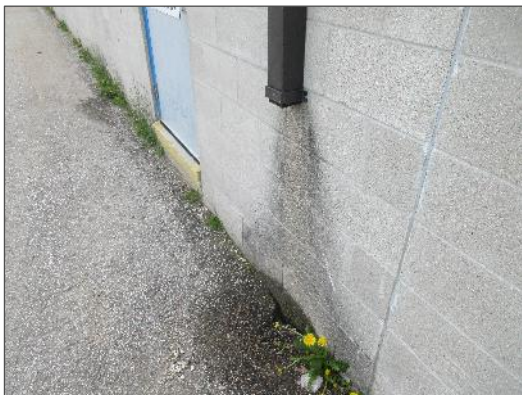
View of a damaged downspout and missing splash pad noted at the east elevation of the Site Building.

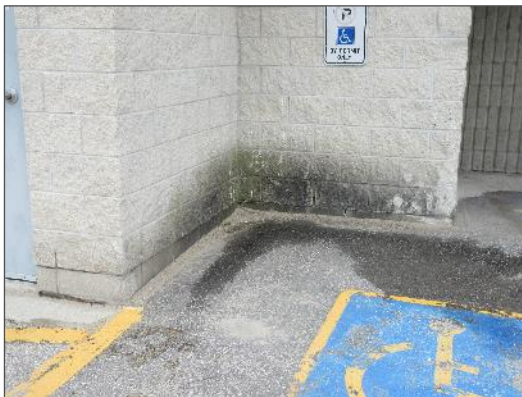
View of staining to the concrete block masonry noted at the southeast portion of the Site Building.

We have noted miscellaneous damage and deterioration that would generally be completed by building maintenance. We have included a project to remove staining, replace damaged masonry block and a general allowance for repointing at localized areas. We have included a project to install a protective sealer on the exposed concrete block walls to increase the longevity and service life of the masonry walls.

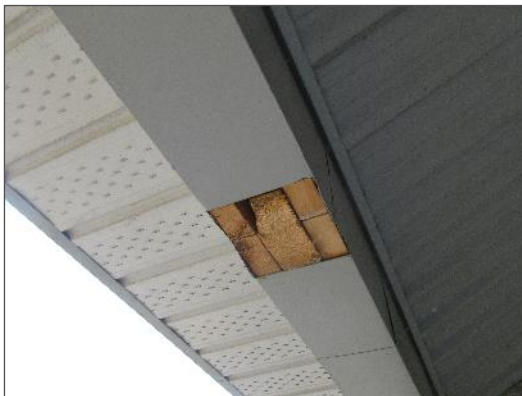
View of missing soffit at the east metal canopy.

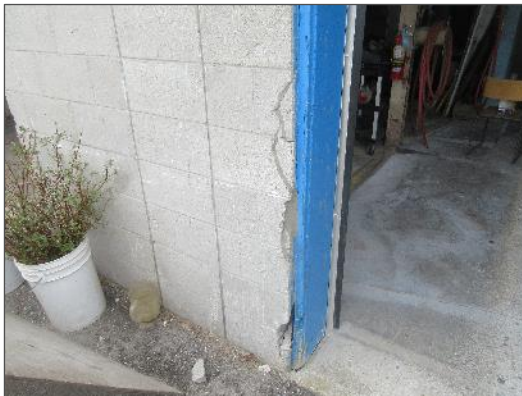
View of impact damaged concrete block masonry noted at the east overhead door systems.

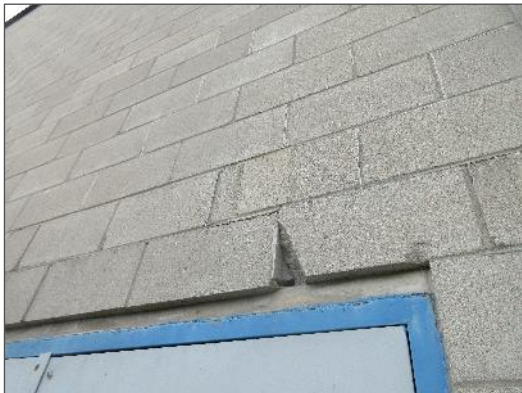
View of damaged concrete block masonry noted at the west elevation.

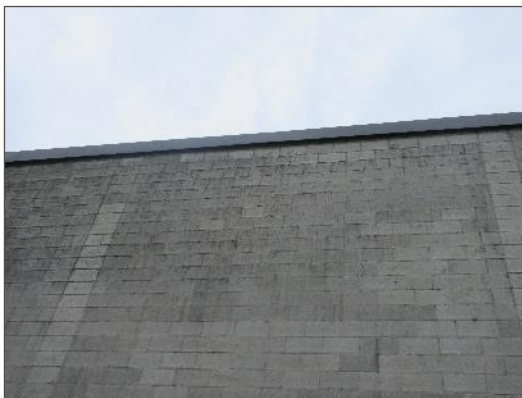
Localized areas of mortar were noted to be deteriorated and will require repointing. Overall the mortar joints appeared to be in satisfactory condition with the exception of the localized areas noted.

View of deteriorated mortar noted throughout the concrete block masonry walls as well as staining.

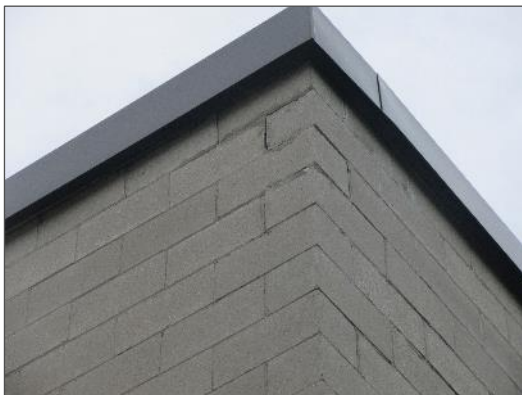
View of deteriorated mortar noted.

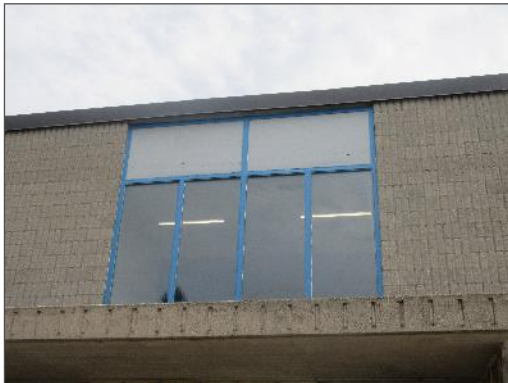
General view of the original window units serving the south elevation of the Site Building.

Pinchin recommends replacement of the original wood framed windows noted at the south elevation. We have included a budget in the report to replace the original windows. Window and door sealants are also anticipated and are included in our sealant replacement project. No major expenditures related to the window assemblies are expected to be required within the term of this analysis.

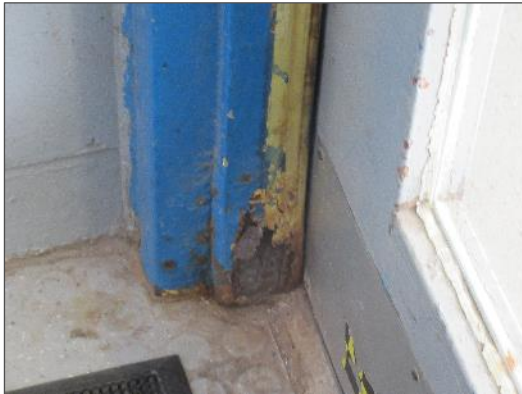
View of typical corrosion noted at the base of the main entrance door frame.

Minor surface corrosion was noted at the base of the exterior door frames. It is recommended to sand and repaint these areas as part of regular maintenance. In addition, the exterior doors appear to be missing or have damaged door sweeps and weather stripping in select locations. We have included an allowance to address door deficiencies and painting to prolong the life of the door systems until replacement is required.

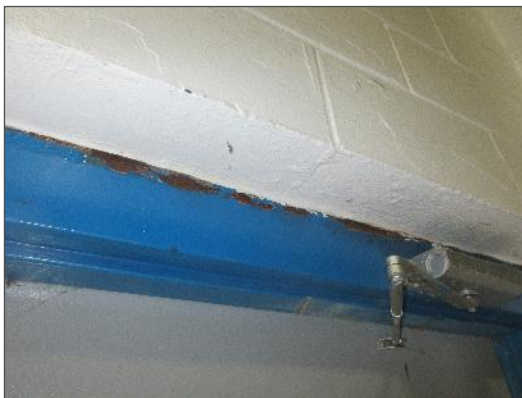
View of typical corrosion noted at a metal door frame.

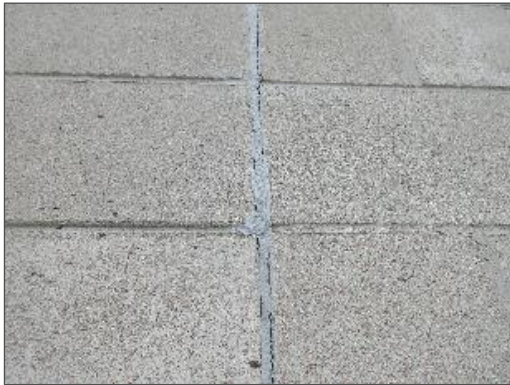
Sealants throughout were observed to be deteriorated, debonded from the substrate, split, cracked, and missing in isolated locations.

View of deteriorated control joint sealant at the masonry walls.

The short-term comprehensive replacement of the sealants throughout the Site Building is recommended. Sealant materials should be checked annually for pliability and cracking as part of a preventative maintenance plan.

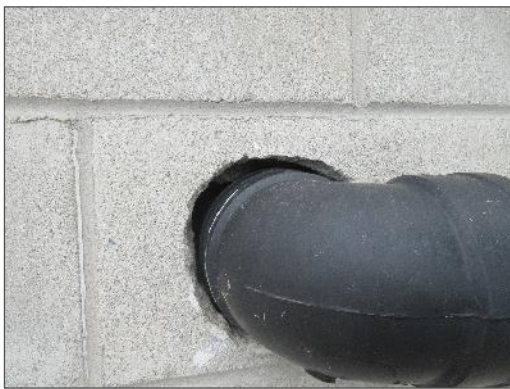
View of a typical missing sealant at a wall penetration.

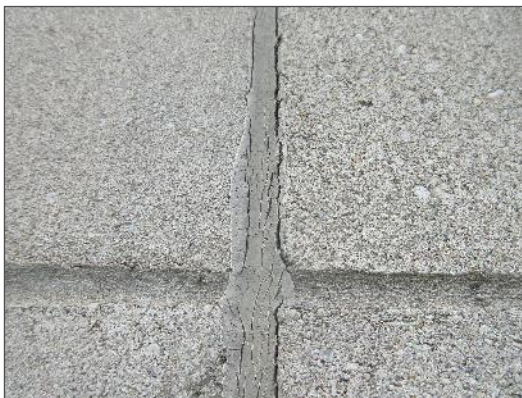
View of the typical deteriorated control joint sealants.

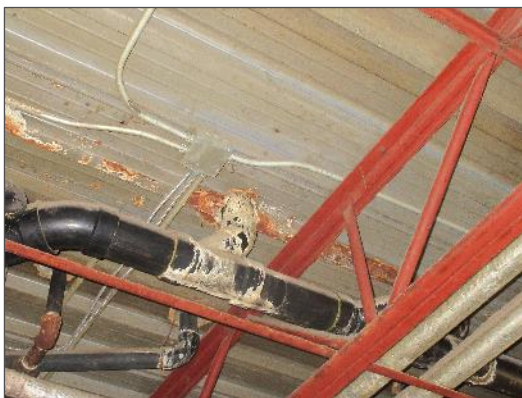
View of an area of isolated corrosion noted within the change room.

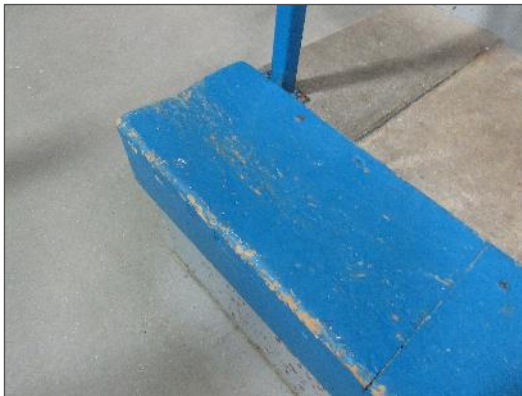
View of peeling paint noted at the wooden bleachers within the rink area.

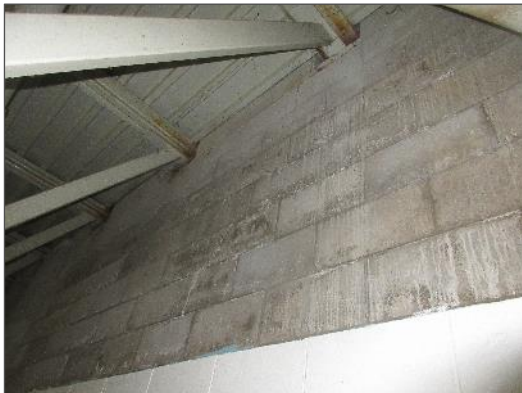
View of efflorescence noted at the upper portions of the walls within the rink areas.

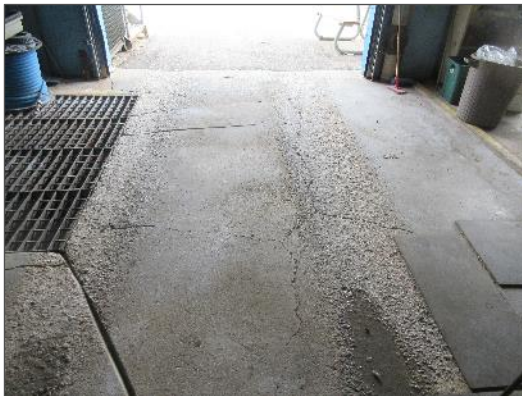
View of deterioration of the cast-in-place concrete slabs within the maintenance areas.

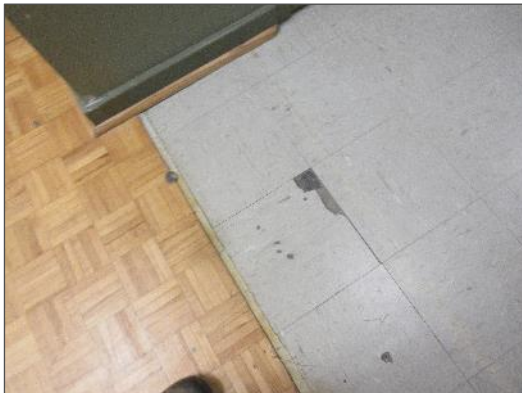
View of minor damages to the vinyl floor tiles within the second-floor area.

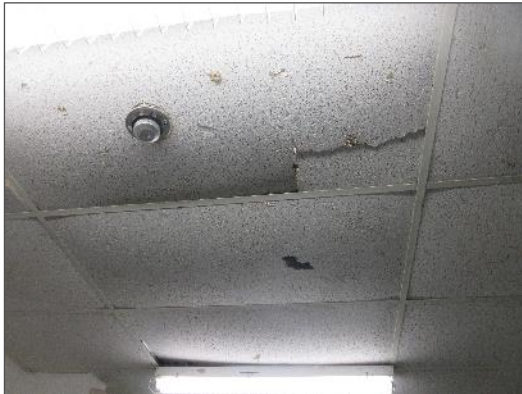
View of typical bowing and damaged ceiling tiles noted within the various change rooms of the Site Building.

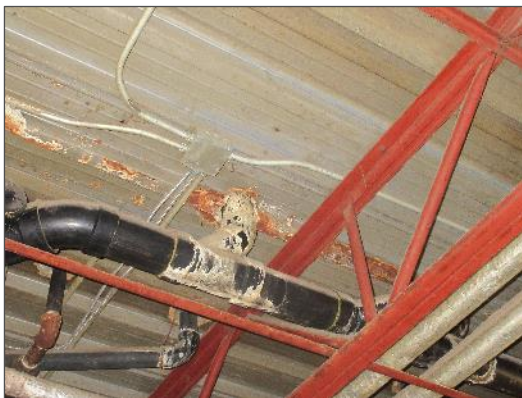
View of corrosion of the steel deck noted at change room 1 & 2 area.

- Inspection and repair of the corroded metal decking noted within Change Rooms 1&2.
- Site management has expressed concern over the 2<sup>nd</sup> floor walkway (hawk's nest) that was constructed. Pinchin has included a project to complete a structural review at this location.

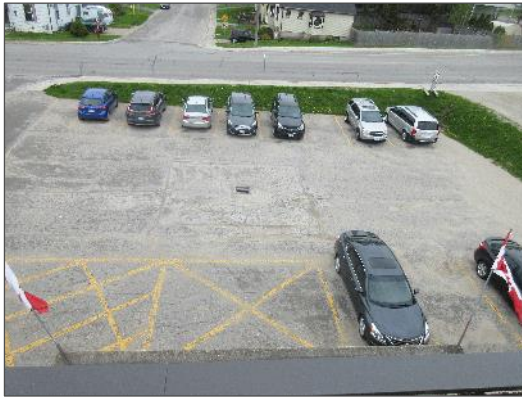
General view of the asphalt paved parking areas on the south portion of the Site.

Note: Cracking and deterioration. Faded lines.

- Repaving of the deteriorated asphalt surfaced parking area at the south portion of the Site with an allowance for concrete replacement.
- Cyclical repairs of the asphalt system throughout the term of analysis to eliminate trip hazards and seasonal deterioration.
- Repaving of the remainder of the site near the horse palace and surrounding buildings at the late portion of the study.

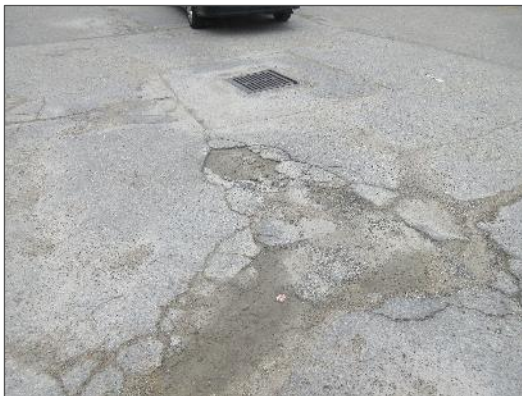
View of alligator cracking and potholes noted within the asphalt pavements on the south portion of the Site.
