Accessibility Audit

290 Durham Street West,
Walkerton, Ontario

June 26, 2019

Pinchin File: 238065.002

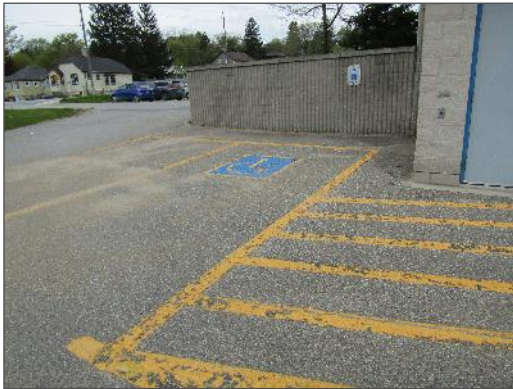
It was noted that based on the number of total parking spots for the Site (i.e. approximately 65 surface parking spots), there should be a total of three (3) accessible parking spots, based on the AODA AccessON “Design of Public Spaces Standard” requirements. Currently, there are two (2) accessible parking spots, therefore; one (1) more spot should be added to the parking areas. The three (3) spots should consist of one (1) van accessible spots, and two (2) regular accessible spots.

Accessibility parking space located at the East surface parking area with one (1) access aisle.

It is recommended that one (1) additional accessible parking spot be added in order to meet current AODA AccessON requirements; this item can be completed when pavement line markings require renewal. The AODA AccessON requirements for additional parking will be triggered if the parking area is redeveloped, or if newly constructed parking areas are added to the Site.

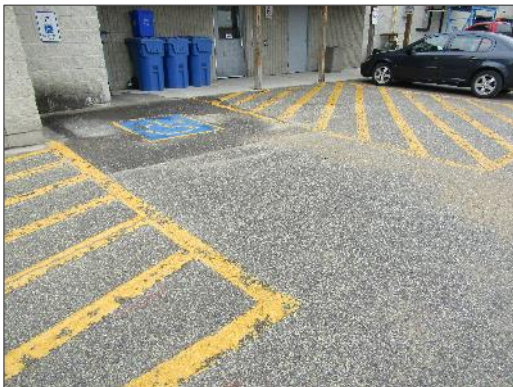
Accessibility parking space located at the East surface parking area with two (2) access aisles.

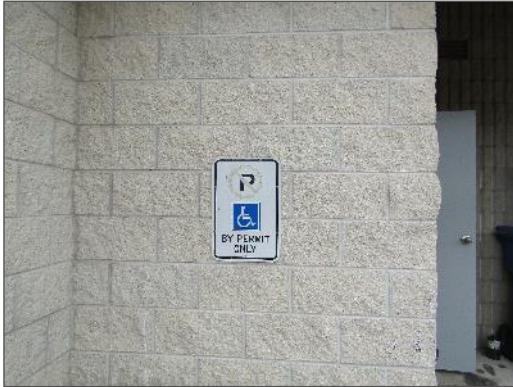
Accessible parking space sign located at the East surface parking area.

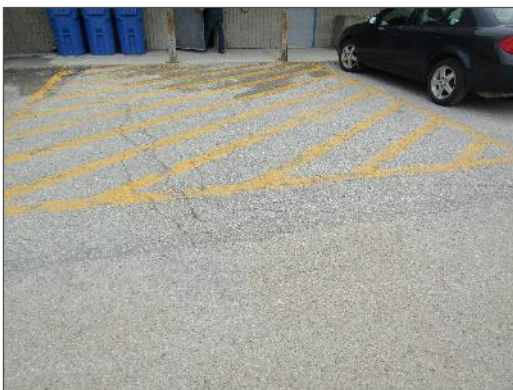
The accessible path of travel present from the municipal sidewalk from Durham Street West, to the East main accessibility entrance of the building consists of the asphalt pavement of the surface parking area and concrete walkways. There was signage indicating where the accessibility entrance is, in the surface parking lot or which may result in confusion as to the location of the accessible entrance.

View of the accessible path of travel from the East surface parking area to the main accessibility entrance.

It is recommended to install signage to indicate where the exterior accessibility route is and to create curb cuts where required in order to improve the route from municipal sidewalks to the main accessible entrance. The AODA AccessON requirements for exterior accessible route improvements will be triggered if the exterior path of travel is significantly renovated or if a new exterior path of travel is installed.

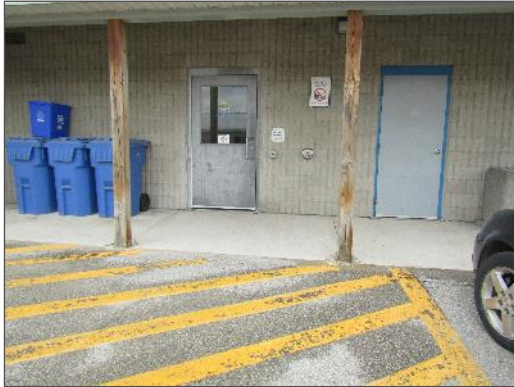
View of the concrete walkway at the main accessibility entrance.

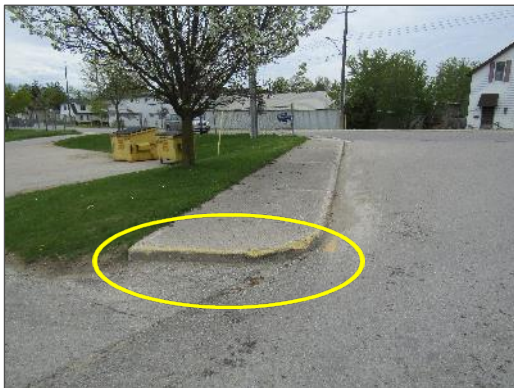
Along the accessible path of travel, there was a curb ramp from the paved roadway and parking area, allowing access to the South concrete walkway along Durham Street West located on the West side of the main entrance driveway. The concrete walkway on the East side of the main entrance driveway did not have lowered concrete curb ramps from the paved parking area, making it not an accessible route. Additionally, there is a concrete walkway located at the main accessibility entrance that is level with the asphalt parking area acting as the accessible path of travel.

Missing curb cut leading from parking area to the concrete walkway at the East side of the main entrance driveway.

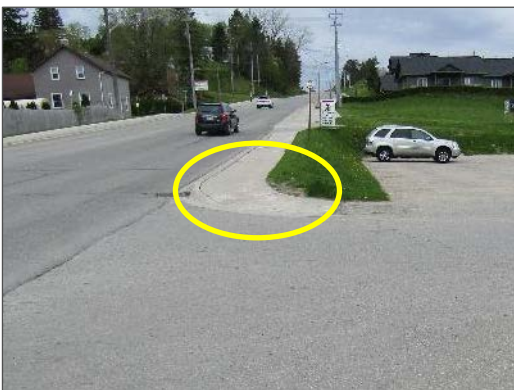
Asphalt paving curb ramp leading from parking area to the concrete walkway on the West side of the main entrance driveway.

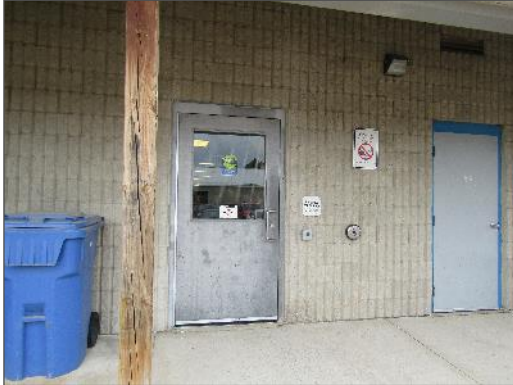
The accessibility entrance door appeared to be compliant with clear floor area on each side of the door, and was measured to be 41" wide, which is compliant with the minimum clear opening width (32"). The accessible entrance door was equipped with power door operator hardware, which was functioning at the time of the Site inspection. The door hardware did not require twisting, and is in compliance with

General view of East elevation with main accessible entrance door.

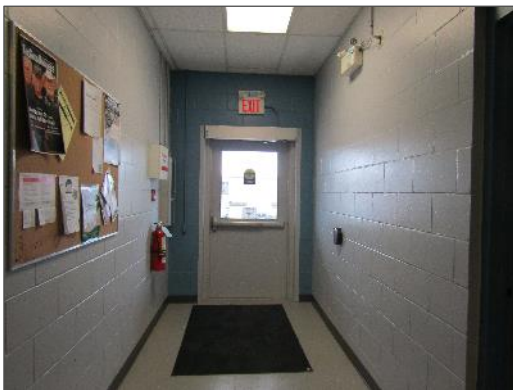
Interior view of main accessible entrance.

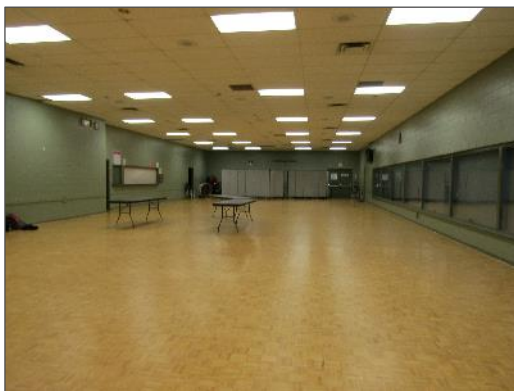
There are viewing areas, event space, and counter service areas on the first and second floors of the Site Building. Additionally, there is a second floor kitchen adjacent to the event space. The tables throughout the event space were observed to have a clearance height in general conformance with minimum height for accessibility under counter clearance requirements (29"). The kitchen area adjacent to the event space did not include dedicated accessibility furnishings or sink access. The food booth service areas

View of second floor event space.

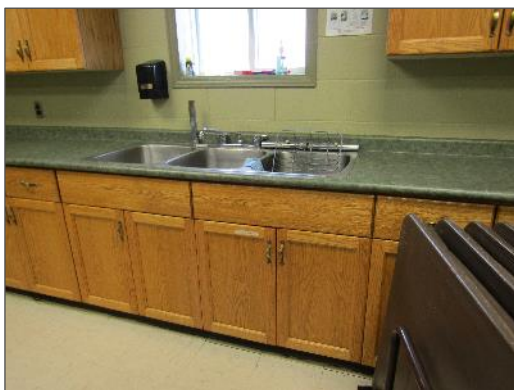
View of second floor kitchen sink area.

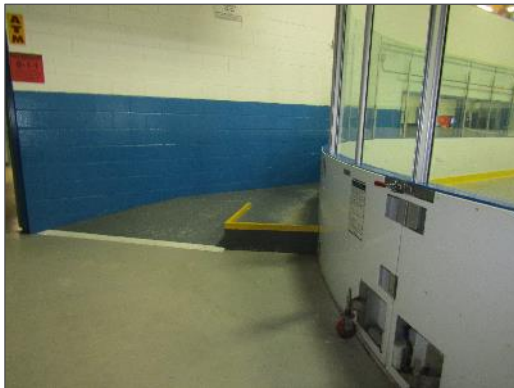
The Site Building has two (2) interior ramps, one (1) in the rink area and another within the main corridor of the community centre. The rink side interior ramp leads to an accessible viewing area and it has a slope of approximately 1:4 (ramp rise to run ratio). The slope for the interior ramp that leads to the viewing area in the main corridor of the community centre was observed to have a slope of approximately 1:10. The ramps do not meet slope requirements of 1:15 or less in accordance with AODA AccessON requirements. The ramp widths were measured and are compliant to minimum width accessibility requirements (36" clear width). There are no handrails on either ramp.

View of accessibility viewing area at the arena.

It is recommended to renovate the food service counters to provide a lowered counter area for accessibility with a clearance of 29" below. It is also recommended that the slope of the interior ramps for the viewing areas be improved to a slope of 1:15 or less (This item can be completed and included in the overall cost at the time of major renovation to the interior finishes and ramps). It is recommended that signage be installed near the stairs to the second floor directing persons to the alternate accessible route which uses the lift from the exterior.

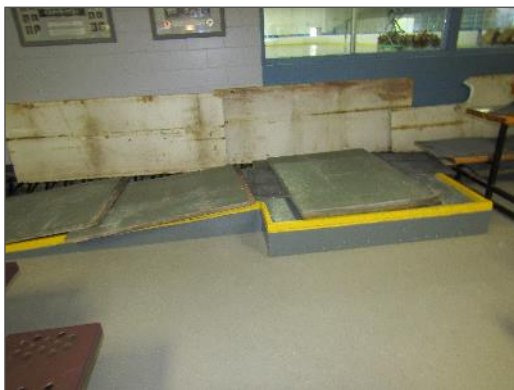
View of an accessibility viewing area within the community centre.

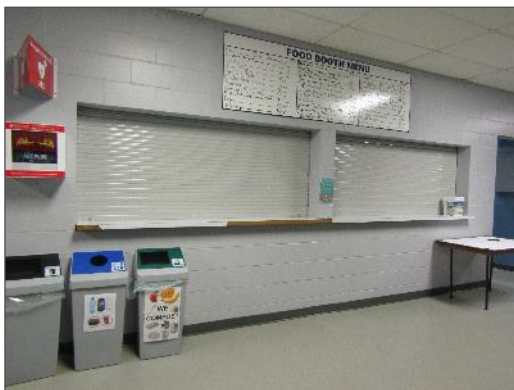
were observed to have counters that are too high for a person seated in mobility aid to obtain service and no alternative service area was noted.

View of the service counter for the food booth on the ground floor.

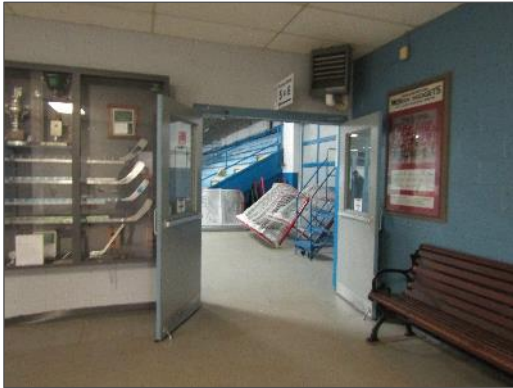
View of an accessible interior door.

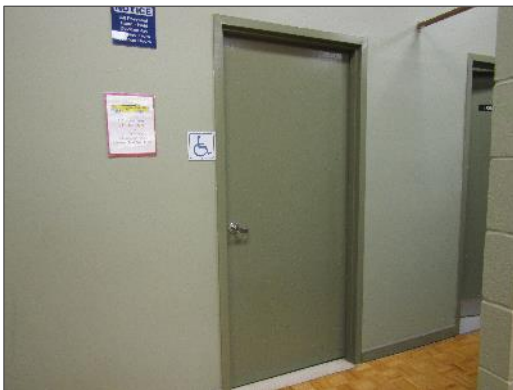
Typical interior door with lever style hardware.

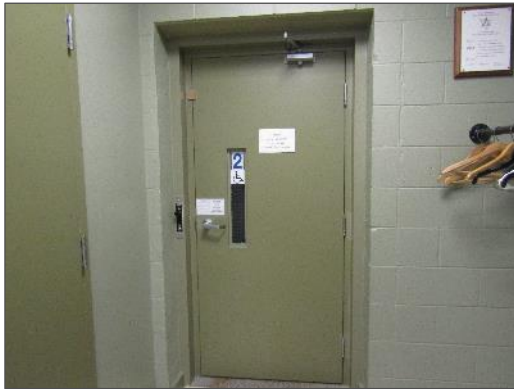
All hallway call buttons were observed to be configured with one (1) "call" button. The lift was noted to not have any audible or visual call indicators upon arrival to each floor, at the lift entrances. As well, it did not have audible or visual floor position indicators within the cab. The lift appeared to not have the minimum compliant clear floor area to meet accessibility standards. The lift doors do not have functioning re-opening devices to prevent closure on obstructions in the door opening. The lift control button heights were measured and found to be in compliance with maximum height requirements for accessibility standards (48"). Tactile and Braille characters were not observed to be included to the left of each lift car control button. There is no emergency call system located within the lift cab.

General view of lift.

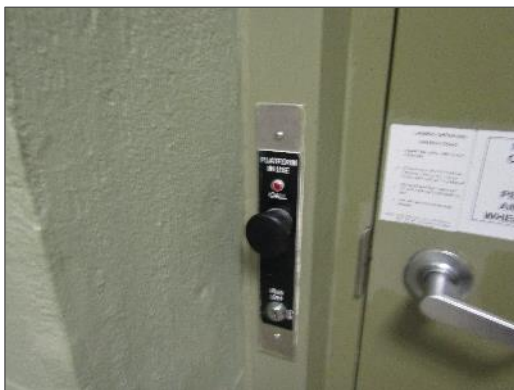
View of the lift call button on the exterior.

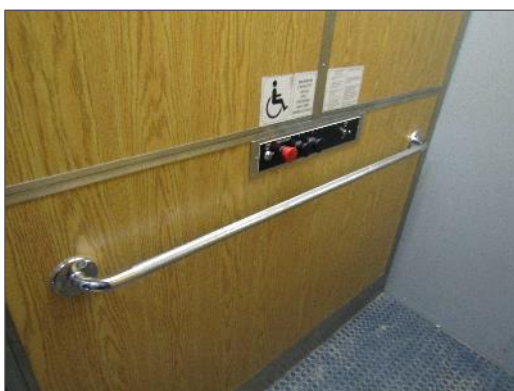
View of the lift controls within the cab.

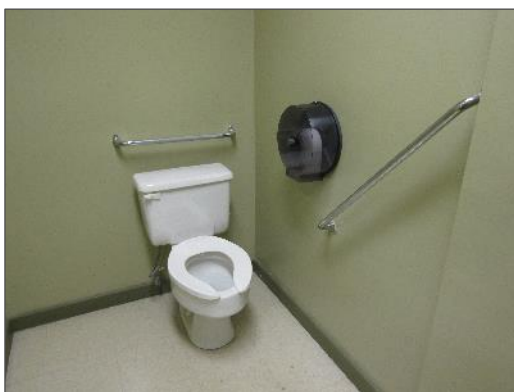
General view of second floor accessible washroom.

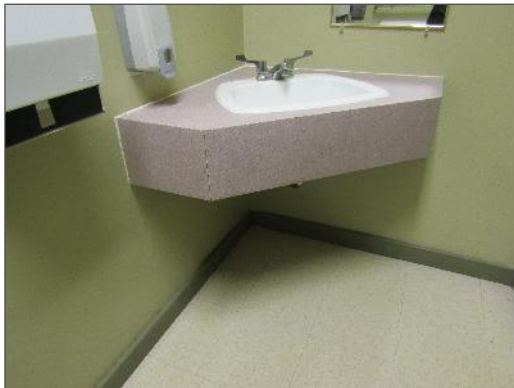
The toilet rooms appeared to generally meet minimum requirements for compliant floor area, with respect to turning radius required for accessibility. The under countertop/under sink clearance appeared to generally meet minimum requirements (29"). Sinks were observed to have automatic motion sensor hardware, which meets accessibility requirements. The plumbing piping under sinks was not insulated against contact in any of the washrooms, and is not in compliance with accessibility requirements.

View of the sink and countertop within second floor washroom.

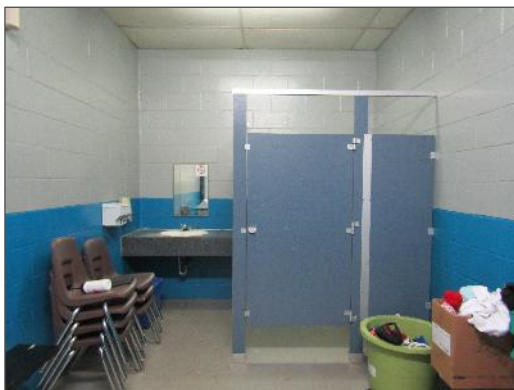
General view of first floor accessibility washroom and dressing room, showing partially blocked path of travel to the sink area.

It was noted that the path to the sink in the first floor accessible washroom was blocked by stored items. It is recommended to remove these items to allow clear path of travel to the sink area. This is considered to be a housekeeping item.

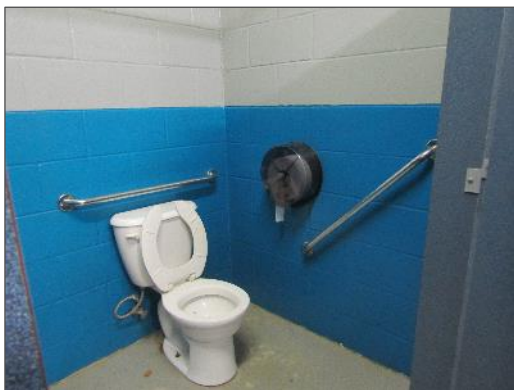
Grab bars were noted to be provided in the accessibility washrooms and appeared to be installed at appropriate heights and locations. The accessible stall door width was measured and meets the minimum compliant clear width requirements (32"). The accessibility toilet stall appeared to provide sufficient compliant clear floor area. Soap dispenser and air dryers were measured for mounted height of controls and dispensing components and were found to be installed in compliance with maximum height requirements (48"). Hooks in the washroom stall were found to be mounted in compliance with maximum height requirements (48") while the hooks for the dressing room area were higher than the maximum height requirement.

View of the accessible washroom stall with grab bars on the first floor.

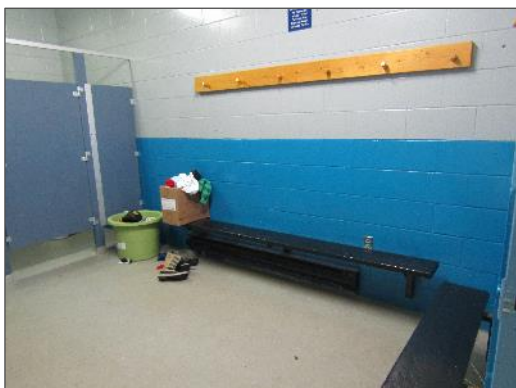
View of hooks within the accessible dressing room that are placed too high.

It was noted that there was no accessibility shower area within the building as all the current showers feature a concrete curb at the base. It is recommended to renovate a dressing room to include an accessible shower stall, including bench seating, grab bars, and appropriate height mounted controls and shower hardware. It is recommended to install visual strobe fire alarm devices in the washrooms. Further, it is recommended to insulate plumbing under designated accessible sinks against contact and lower the dressing room hooks or install additional hooks at heights in compliance with accessibility requirements.

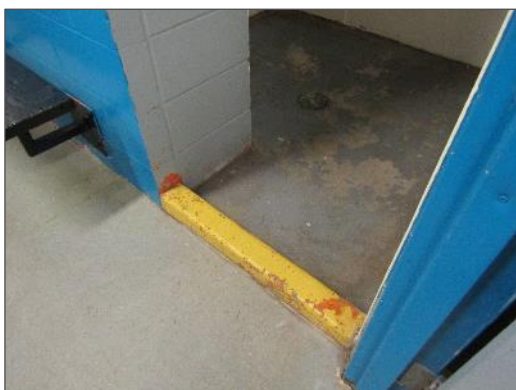
View of concrete curb at the base of the shower stall.
