FINAL **Condition Assessment of the Mechanical and Electrical Systems**

290 Durham Street West,
Walkerton, Ontario

**Corporation for the Municipality of
Brockton**

July 31, 2019

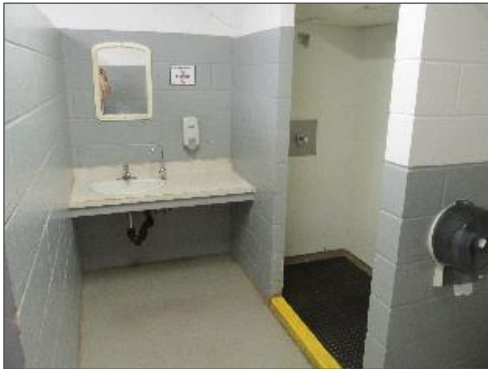
The plumbing fixtures are of various ages and in variable condition. No significant operational deficiencies were reported or observed at the time of the assessment. These styles of toilets, urinals, and lavatories typically have a Projected Useful Life (PUL) of 20 years or more.

The plumbing fixtures that are original to the building construction, in 1972, will reach the end of their PUL during the evaluation period. Based on age, partial replacement of the plumbing fixtures can be expected during the evaluation period. An allowance to selectively replace approximately 1% of the plumbing fixtures is provided in the cost table.

View of a dressing room lavatory and shower.

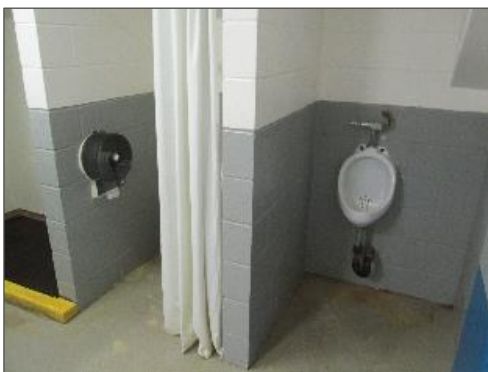
View of fixtures within a men's dressing room.

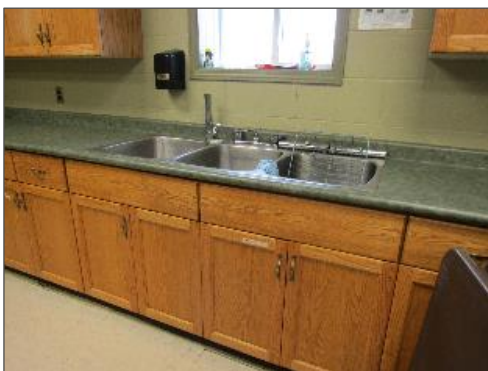
View of the second floor kitchen sink.

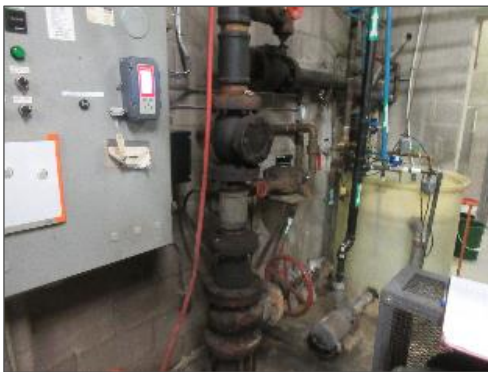
At the time of the site assessment, Pinchin did not observe a backflow prevention assembly installed at the main water supply. Pinchin recommends that a backflow prevention device be installed at the main water supply if it is required by the local by-law regulations.

View of the main water line and water meter.

Based on age and observed conditions, no significant capital expenditures other than routine maintenance are anticipated during the evaluation period. However, Pinchin recommends the water lines original to the construction of the building be evaluated (i.e., intrusive pipeline condition assessment).

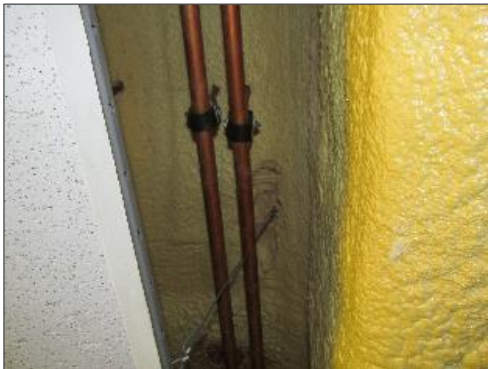
View of domestic water lines within the Site Building.

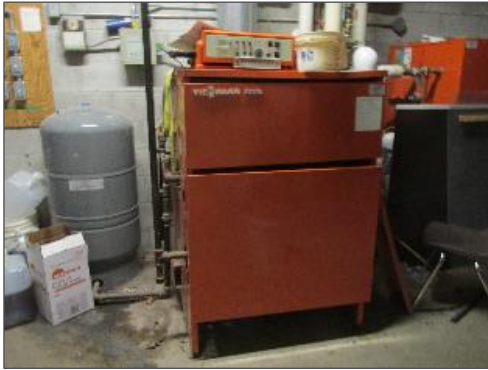
Domestic water for the Site Building is provided by one (1) gas-fired “Viessmann” domestic hot water boiler (M/N: RS-8; S/N: 8-990368) that was manufactured in 1999 and installed in 2000. The boiler has an input rate of 550 MBH. Additionally, the system features two (2) “Viessmann” tank heat exchangers (M/N: 3003502; S/N: 7219851800235) that have a storage capacity of 350 L. The domestic hot water boiler and tank heat exchanger are located in the mechanical room on the ground level. The domestic hot water and heating systems appear to perform as intended.

Similar domestic hot water boilers are known to have a PUL of approximately 25 years. Normal life cycle replacement of the boiler system and heat exchanger can be expected during the evaluation period. An allowance to replace the storage tanks has been included in the cost table.

View of the domestic hot water boiler in the main mechanical room.

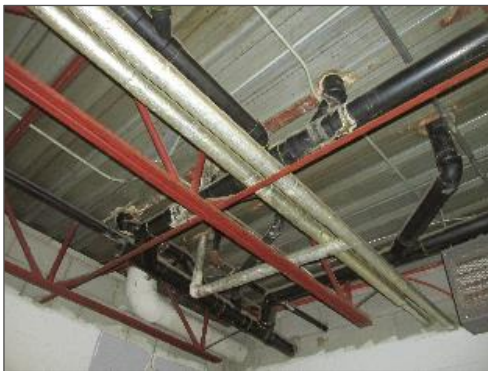
View of the sanitary waste lines from the second floor.

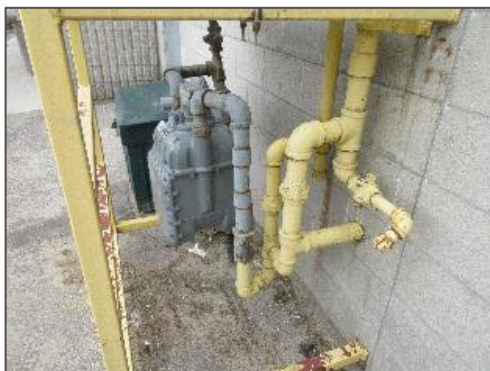
No significant deficiencies were reported or observed at the time of the assessment.

View of the Site Building's gas meter on the east elevation.

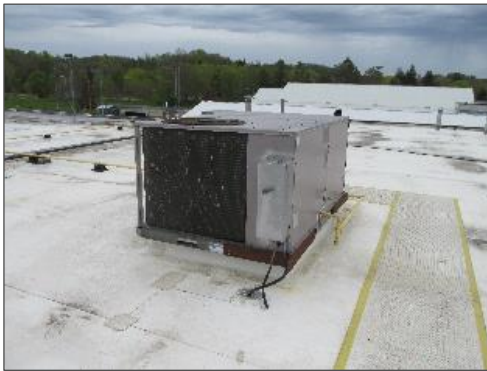
The Site Building is equipped with two (2) packaged rooftop HVAC units with natural gas-fired heating, electric powered cooling. Discharge air and return air for these units are oriented downward directly into the space below. This units appear to be running properly and no outstanding deficiencies were noted by the Site Representatives.

View of typical packaged rooftop HVAC unit atop the Site Building.

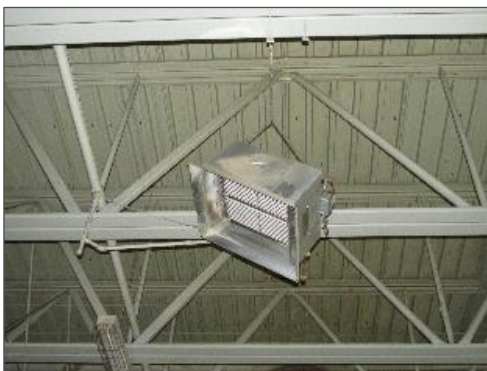
Unit heaters have an expected PUL of 15 to 20 years. Based on age and observed condition, a provision to replace the unit heaters has been included in the cost table.

View of a typical gas-fired unit heater in the grandstand of the arena.

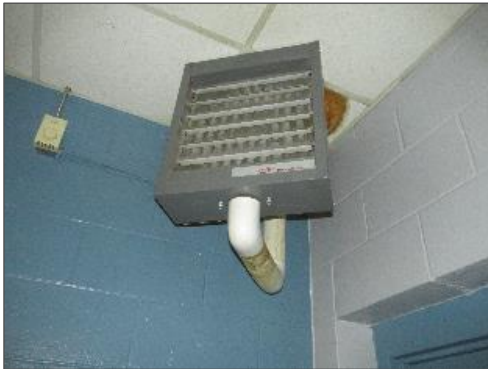
View of a typical hydronic unit heater within the Site Building.

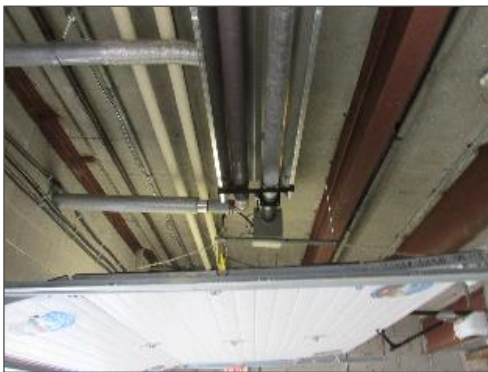
View of the infrared gas-fired tube heater located in the ice resurfacing room.

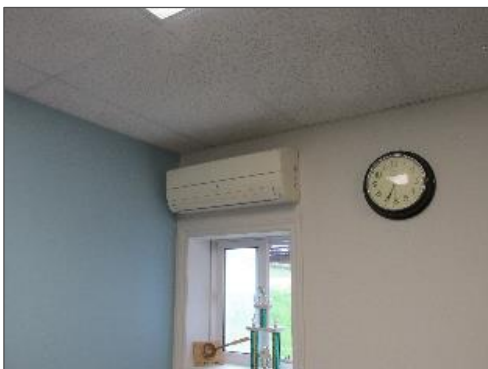
Similar condensing units are known to have a PUL of 15 years. Based on age and observed condition, a provision to replace the condensing unit has been included in the cost table.

View of the interior portion of the split A/C unit within the Parks and Recreation Administration Office.

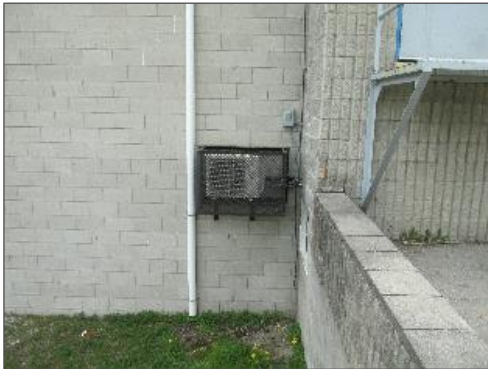
View of the exterior portion of the split A/C unit on the West elevation of the Site Building.

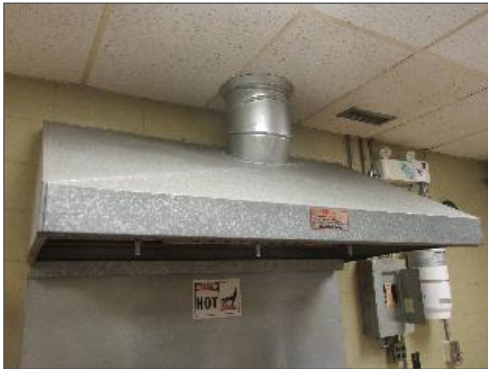
No significant deficiencies were reported or observed with any of the noted systems at the time of the assessment. However, based on age and observed conditions, a provision to replace the exhaust system has been included in the cost table.

View of the second floor kitchen exhaust system.

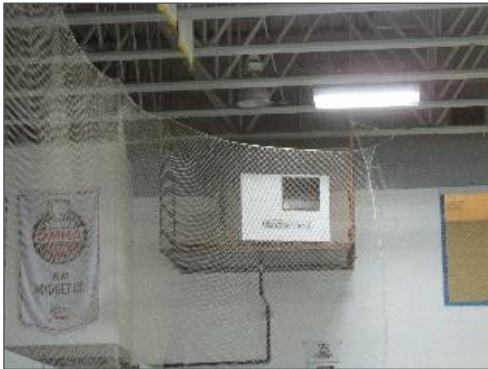
No significant deficiencies were reported or observed at the time of the assessment. Based on age and observed condition, a provision to replace the evaporator has been included in the cost table.

View of the dehumidifier unit within the rink area of the Site Building.

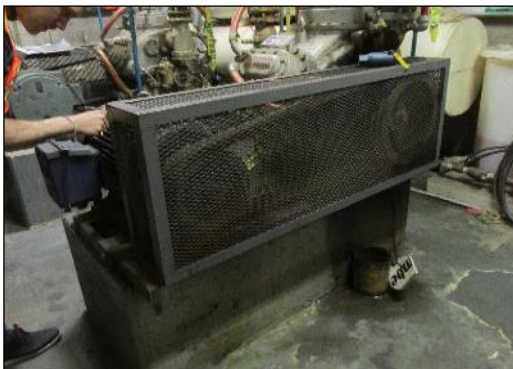
The refrigeration system utilizes two (2) reciprocating compressors located in the mechanical room. Each compressor is connected to an externally mounted electric motor via coupling connecting belt and pulley. Refrigeration piping is connected from the compressor to the outdoor air-cooled condenser. The piping is connected to chiller barrels located on the east side of the ice plant to provide cooling to the ice surface cooling floor via the circulating brine mixture before returning to the compressors. It was reported that the chiller is being replaced in the immediate term.

View of a typical compressor at the Site Building.

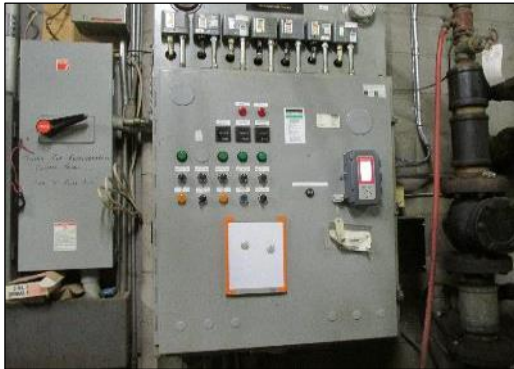
View of the ice plant refrigeration system local control within the mechanical room.

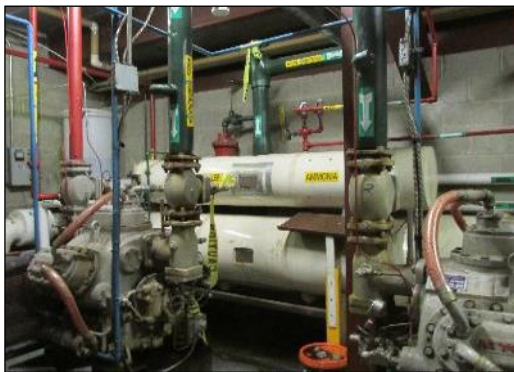
The Site Representative identified that the existing chiller is due for replacement and has been scheduled in the coming year. The replacement budget has been included in the cost table.

View of ice plant chiller barrels.

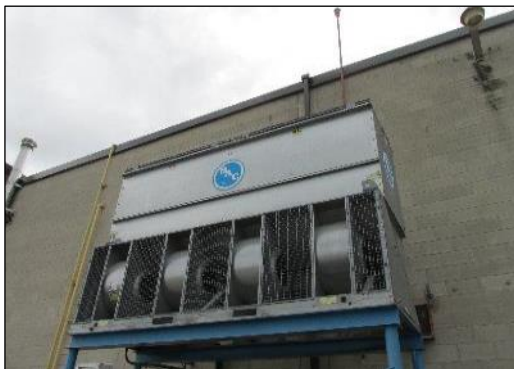
View of the exterior mounted evaporative condenser.

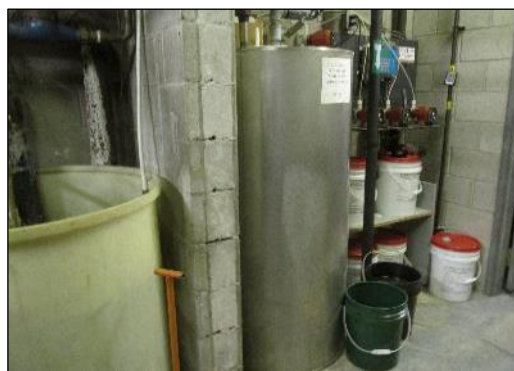
View of the return tank for the ammonia within the mechanical room.

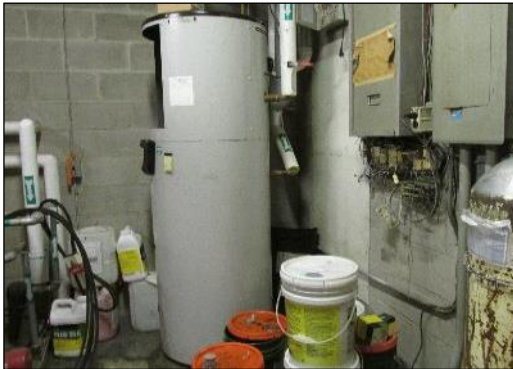
View of the decommissioned heating boiler for the water used to flood the rink.

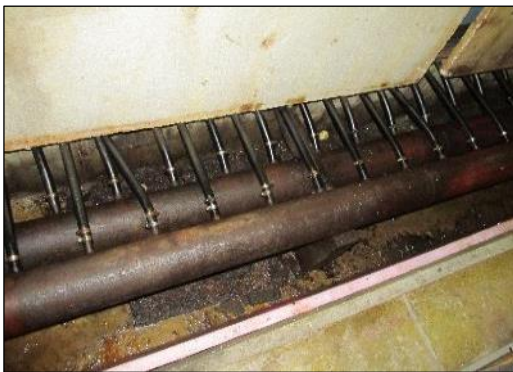
The brine lines serving the ice surface may develop leaks over time, causing the brine to leak onto the slab surface below. Pinchin recommends applying Rink Seal Pro into the brine pipes to prevent future leaks and to extend the PUL of the brine piping. It is recommended that the manufacturer be consulted prior to applying the product.

View of the refrigerant manifold for the cooling of the rink slab.

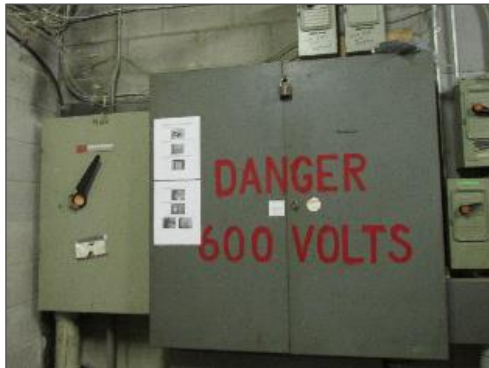
View of the main disconnect switch and the metering cabinet within the main electrical room.

Based on the age of the building and observed conditions, it is strongly recommended that the electrical distribution service be reviewed in its entirety. It is recommended that an infrared (IR) thermographic scan be completed on the electrical distribution and panels at the facility every three (3) years (or more frequent if required by insurance), as part of regular scheduled maintenance, to check for any issues related to overloading, loose connections or related issues. Preventive maintenance should continue to be carried out as well. This practice of infrared scanning should be carried out as part of routine operation and therefore the cost is not included in this report. It was reported that an IR scan of the electrical system has not been completed at the facility. Allowance to conduct an IR scan of the electrical panels

and distribution panels every 3 years (3 times during the term of analysis) has been included during the term of analysis.

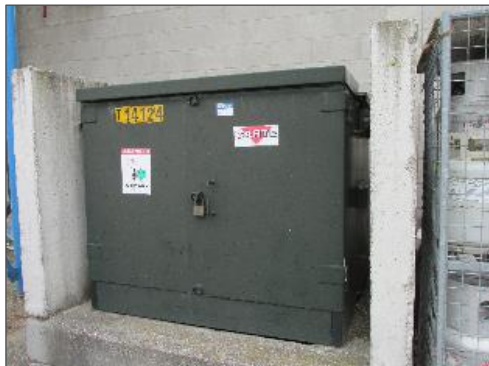
View of the transformer located at the east elevation of the Site Building.

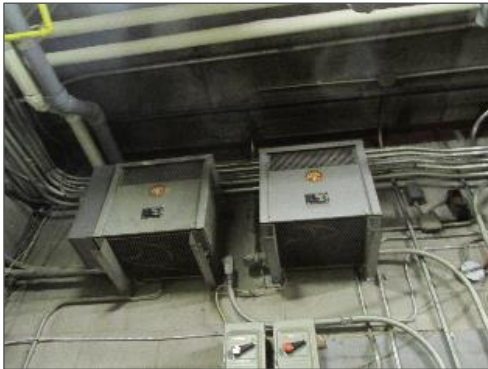
The Site Building is equipped with two (2) interior distribution transformers located in the electrical room, suspended on the east wall of the room. Additionally, there is a dry-type transformer located in the second floor electrical room that provides power to the electrical panel within the "Hawk's Nest."

Based on age and reported conditions, no significant capital expenditures other than routine maintenance are anticipated during the evaluation period.

View of suspended transformers within the main electrical room.

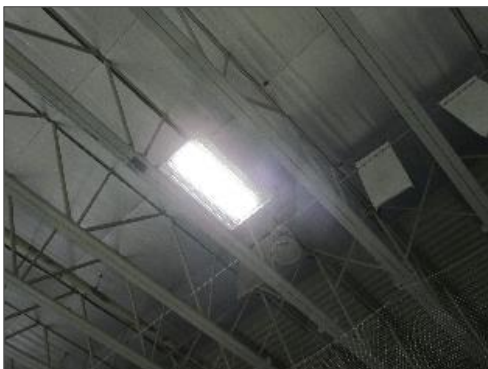
The interior lighting is predominantly provided by bi-pin T12 linear fluorescent lamps, while the arena area is lit with bi-pin T8 linear fluorescent lamps. The lamps are housed in various types of fixtures. Interior lighting is controlled manually. The original HID lamps within the rink area have been decommissioned and T8 linear fluorescent lamps were installed. No significant deficiencies were observed at the time of the assessment.

Interior lighting will reach the end of its PUL during the evaluation period. A provision to replace the interior lighting has been included in the cost table. Replacement of the T12 fluorescent lamps with more energy efficient interior lighting should be considered.

View of typical light fixture within the rink area of the Site Building.

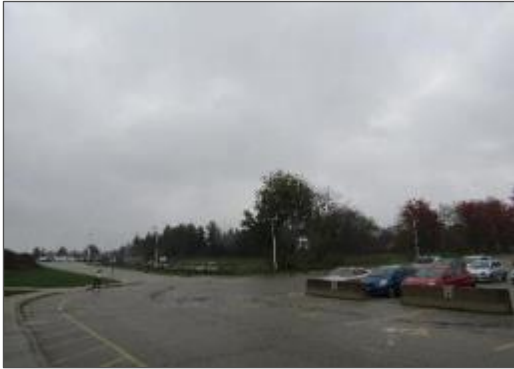
View of pole mounted parking lot lighting fixture.

Based on observed and reported conditions, it is not anticipated that major expenditures are required, other than routine maintenance and repairs during the term of analysis of this report.
