## **Hazardous Building Materials Assessment**

Walkerton Community Centre  
290 Durham Street West,  
Walkerton, Ontario

June 24, 2019

Pinchin File: 238555

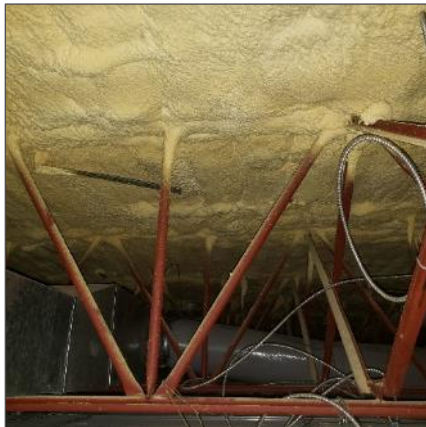
The yellow foam spray-applied insulation present on the structure throughout the second floor ceiling space was sampled and determined to not contain asbestos (samples 0009A-G).

Non-asbestos yellow foam spray-applied insulation present on the structure, Location 2.

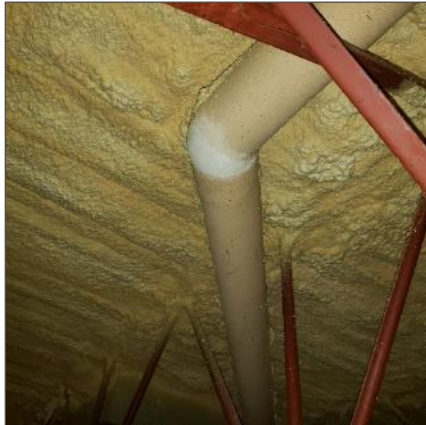
Parging cement, containing chrysotile asbestos, is present on pipe fittings (elbows and tees) on hot water and rain water leader pipe systems in locations 1, 2, 4-6, 10, 21-24, 26 (samples 0005A-C). Parging cement is a friable insulation, jacketed with canvas and were observed in poor to good condition. There are approximately 60 pipe fittings insulated with parging cement.

Asbestos-containing paring cement present on a rain water leader pipe fitting, location 2.

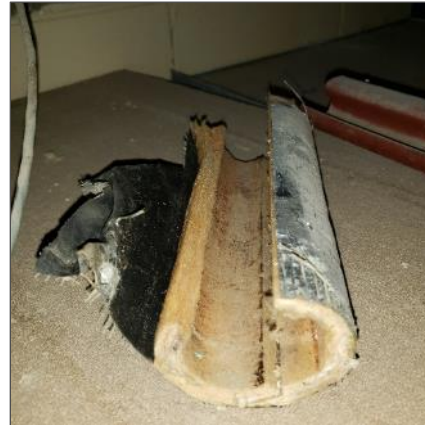
Non-asbestos black tar paper present underneath foil wrap on fiberglass pipe insulation, location 1.

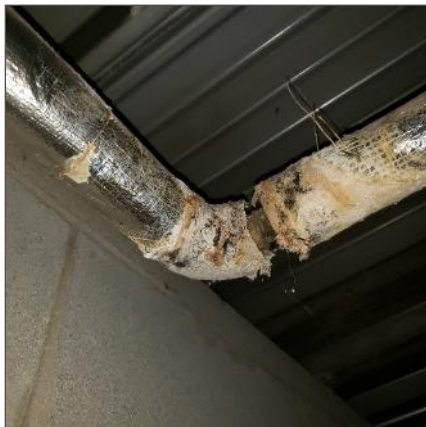
Asbestos-containing paring cement present on a hot water pipe fitting in poor condition, location 1.

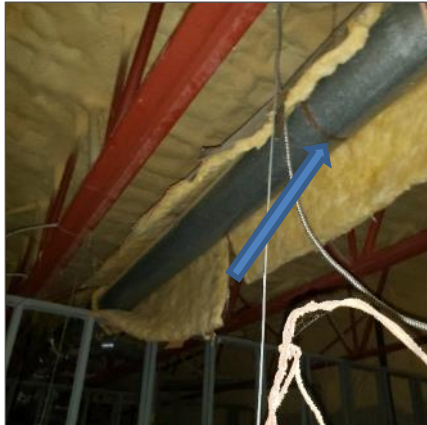
Brown duct mastic, presumed to contain asbestos, is present on ducting in Location 3, the material maybe present in other locations throughout the building. Mastic is a non-friable material and is in good condition.

Presumed asbestos-containing brown duct mastic present on fiberglass insulated duct, location 3.

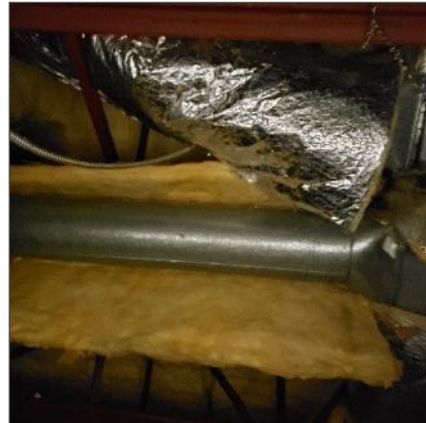
Ducting insulated with foil-faced fiberglass, location 2.

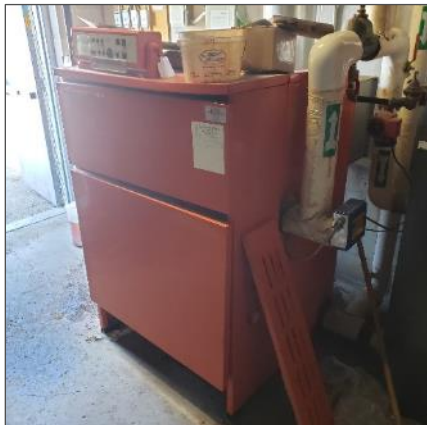
Boiler insulated with non-asbestos fiberglass, location 27.

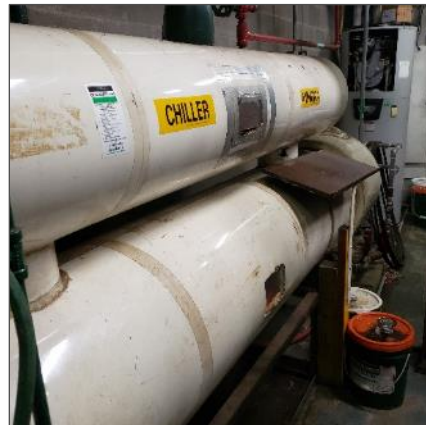
Chiller insulated with non-asbestos fiberglass, location 27.

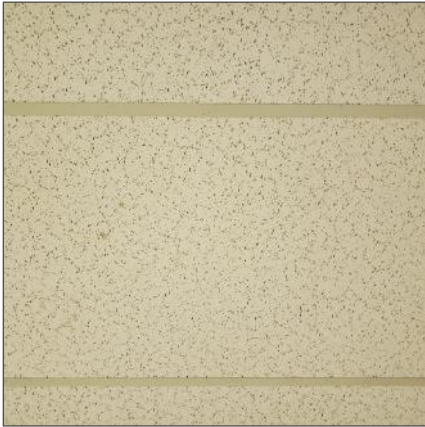
Non-asbestos 24"x48", lay-in, pinhole and fleck ceiling tiles, location 1.

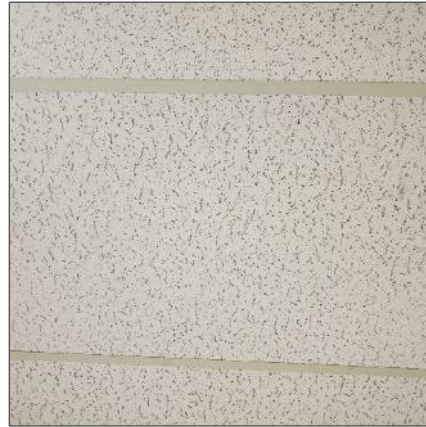
Non-asbestos, 24"x48", lay-in, pinhole and fissure ceiling tiles, location 1.

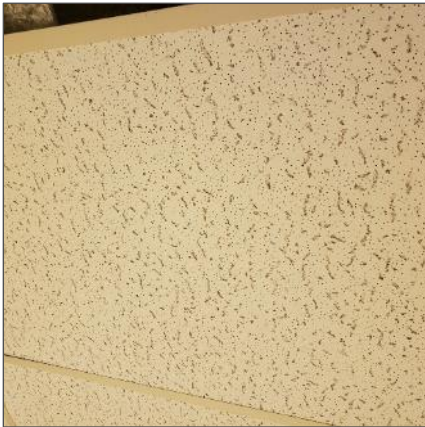
Non-asbestos 24"x48", lay-in, pinhole and width-wise fissure ceiling tiles, location 2.

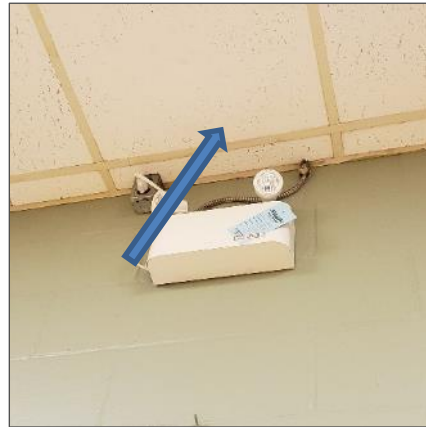
The asbestos-containing ceiling tiles are considered to be non-friable and are in good condition.

Asbestos-containing 24"x48", lay-in, pinhole and lengthwise fissure, location 2.

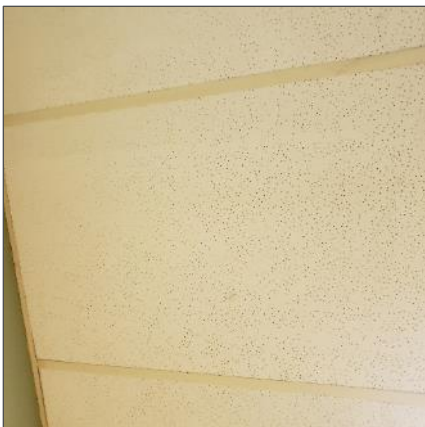
Asbestos-containing 24"x48", lay-in, small and medium perforation ceiling tiles, location 3.

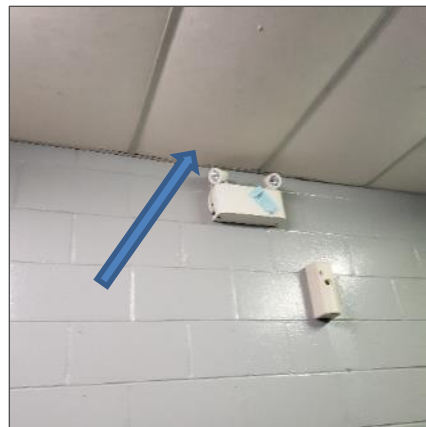
Non-asbestos 24"x48" white wood fibre ceiling tiles, location 24.

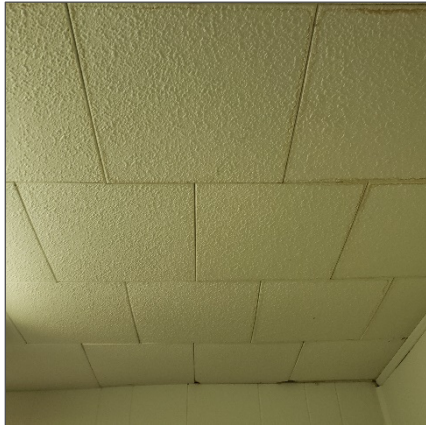
Non-asbestos 12"x12" white textured wood fibre ceiling tiles, location 25.

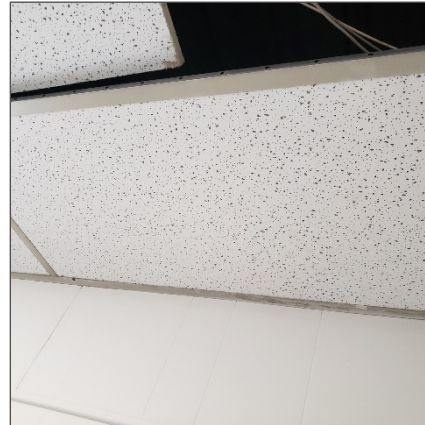
Non-asbestos 24"x48", lay-in, small and medium pinhole ceiling tiles, location 25.

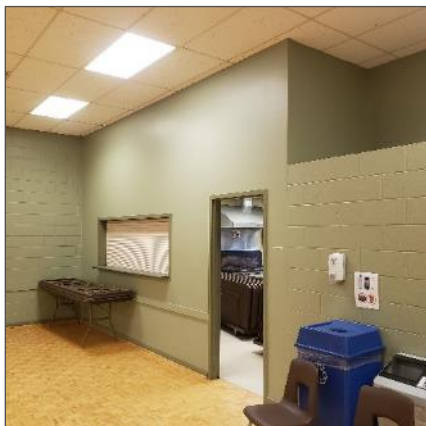
Drywall (gypsum board) and drywall joint compound is present as a wall and bulkhead finish in locations 2-10, 25 and 30 and was found to contain chrysotile asbestos (samples 0007A-E). The asbestos-positive results indicate that at minimum, the original drywall joint compound application contains asbestos and all drywall joint compound should be presumed to contain asbestos. Further sampling may be considered in an attempt to delineate asbestos-containing drywall compound from newer, non-asbestos drywall compound. Drywall joint compound is a non-friable material. There is approximately 2,700 square feet of drywall ranging from poor to good condition.

Asbestos-containing drywall joint compound wall, location 2.

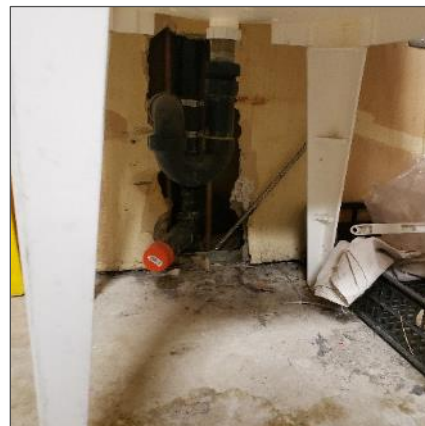
Asbestos-containing drywall joint compound on wall in poor condition with debris, location 9.

Material, Quantity & Condition	Location	Recommended Procedure
Dark blue paint with elevated levels of lead, twenty square feet flaking	Location 13	Remove in accordance with low risk abatement procedures
Ceiling tile, non-asbestos with four square feet of visible mould growth	Location 1	Remove in accordance with EACO Level 1 mould procedures
Asbestos-containing parging cement on two pipe elbows in poor condition	Location 1	Remove in accordance with Glove Bag asbestos procedures in conjunction with EACO Level 1 mould procedures
Asbestos-containing drywall joint compound on wall finishes, twelve square feet in poor condition and debris	Location 9	Remove debris and damaged drywall and seal remaining edges following Type 2 asbestos procedures.

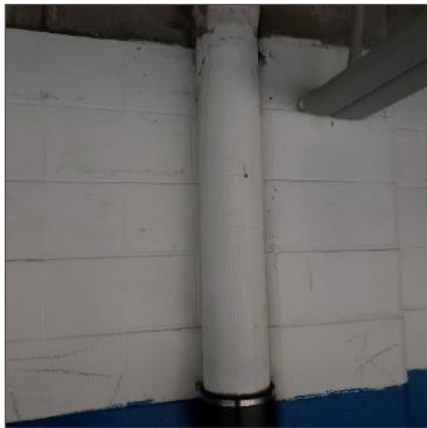
Transite pipe, presumed to contain asbestos based on visual observation, is present as rain water leaders in locations 1, 2, 21, 23, 26, 28 and 29A. Transite is non-friable material and was observed in good condition. There is approximately 560 linear feet of Transite piping. Transit is presumed to be present below the slab/grade.

Asbestos-containing Transite rain water leader, location 26.

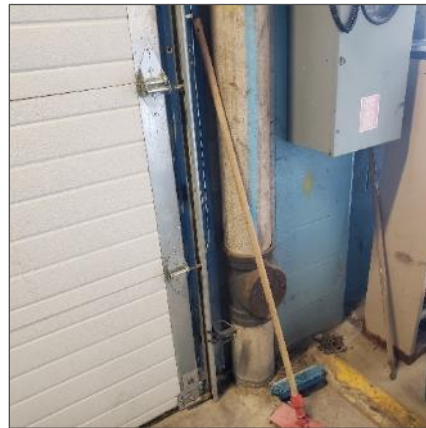
Asbestos-containing Transite rain water leader presumed present below grade, location 27.

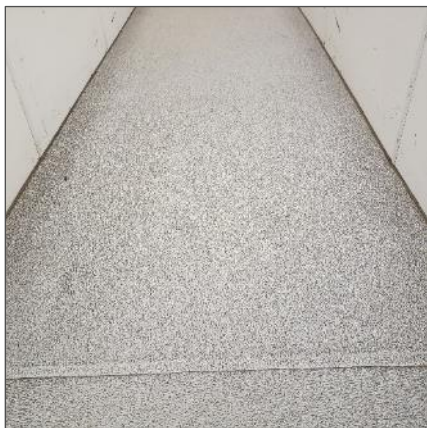
Non-asbestos white and grey pebbled vinyl sheet flooring, Location 31.

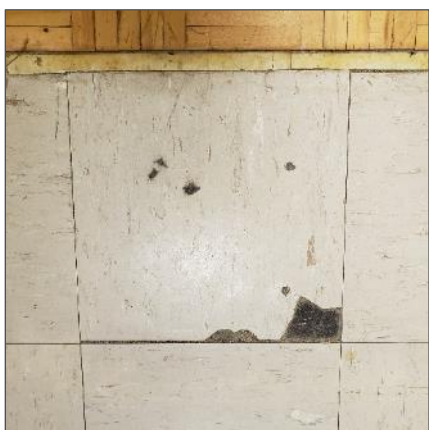
The asbestos-containing vinyl floor tiles and mastic are non-friable and were observed in good condition.

Asbestos-containing 12"x12" light grey with red and white fleck vinyl floor tiles and associated mastic, location 3.

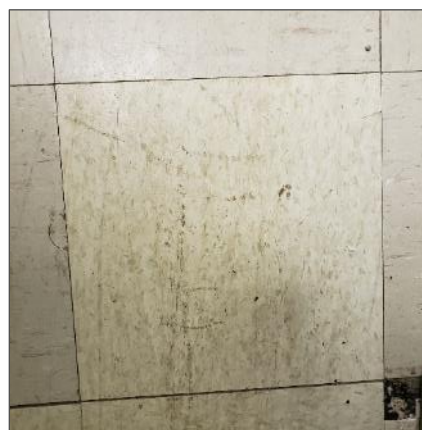
Non-asbestos 12"x12" white, beige and olive fleck vinyl floor tiles with asbestos-containing mastic, location 3.

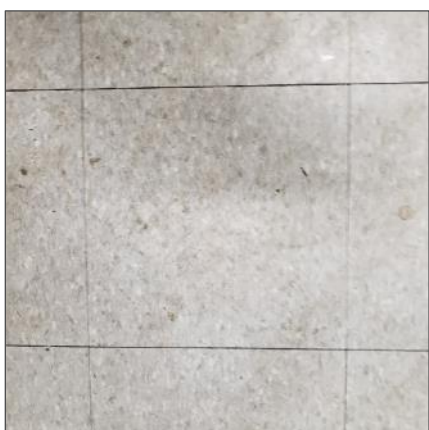
Non-asbestos 12"x12" grey and white fleck vinyl floor tiles, location 16.

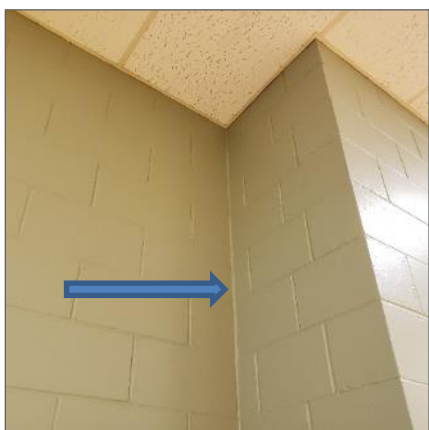
Asbestos-containing caulking is a non-friable material and was observed in good condition.

Asbestos-containing white caulking present at interior concrete block expansion joints, location 2.

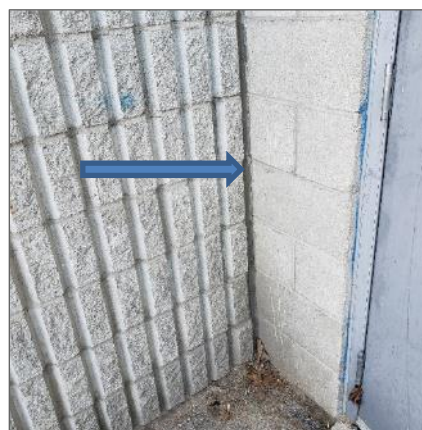
Asbestos-containing grey expansion joint caulking present at the exterior, location 32.

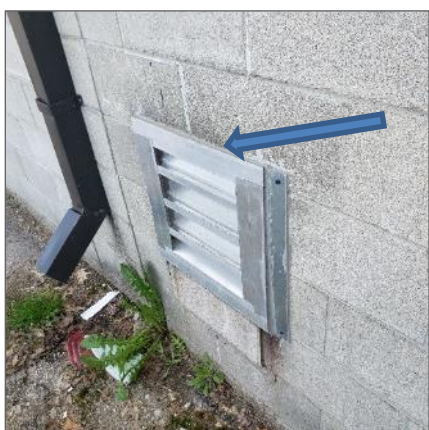
Non-asbestos light grey caulking at exterior vent penetration, location 32.

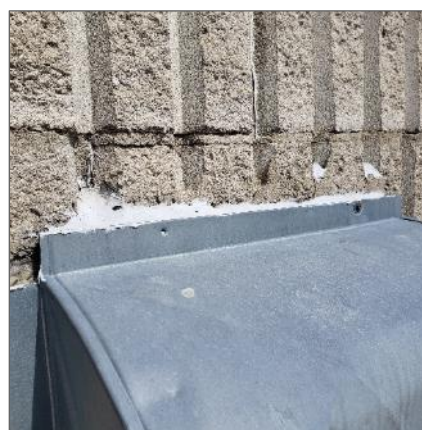
Non-asbestos grey and yellow caulking underneath present at exterior vent penetration, location 32.

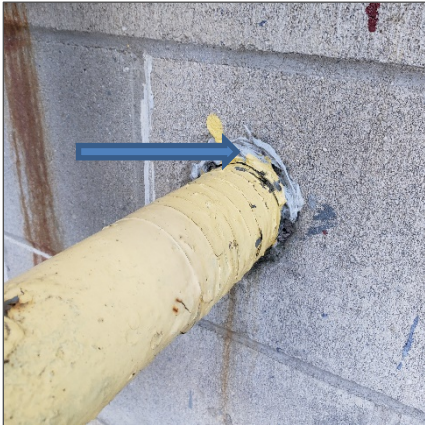
Asbestos-containing grey firestopping present at gas line penetration at the exterior, location 32.

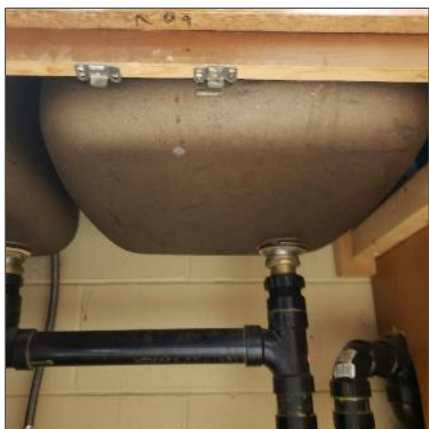
Gold antisweat mastic, containing chrysotile asbestos, is present underneath sinks in locations 8, 10 and 16 (samples 0016A-C). Antisweat mastic is a non-friable material and was observed in good condition. There are approximately 8 sinks with gold antisweat mastic.

Asbestos-containing gold antisweat mastic present underneath a sink, location 8.

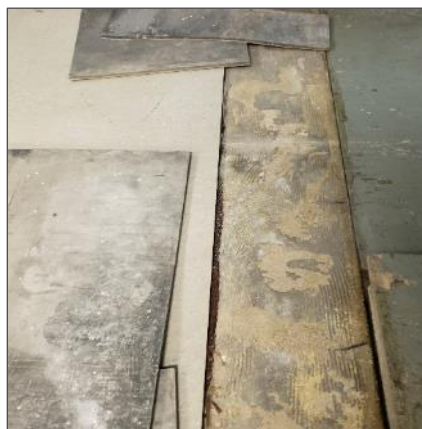
Non-asbestos beige mastic present under grey rubber floor tiles, location 1.

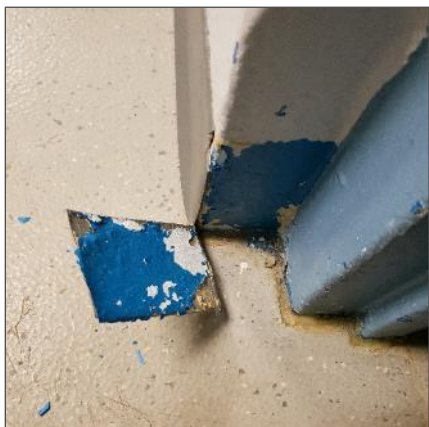
Non-asbestos beige mastic present under grey baseboards, location 1.

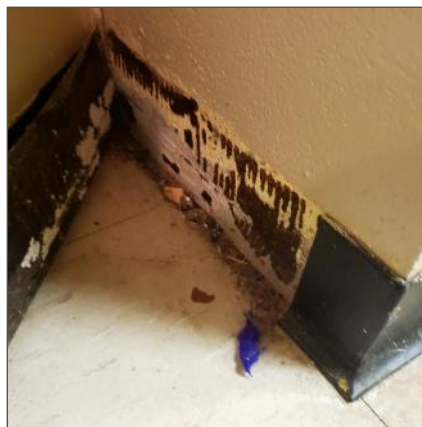
Non-asbestos dark brown baseboard mastic present under brown baseboards, location 7.

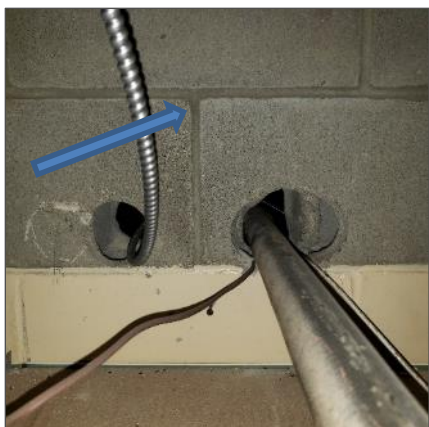
Non-asbestos mortar present in concrete block wall, location 1.

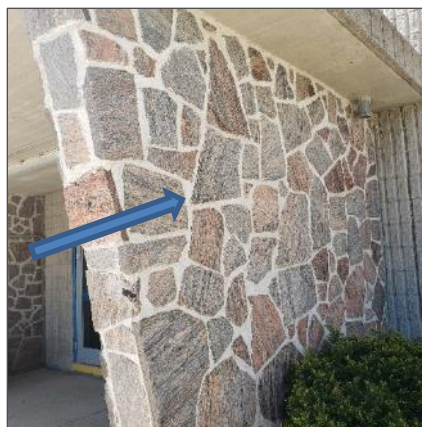
The mortar present in the exterior decorative stone in location 32 was sampled and determined to not contain asbestos (samples 0020A-C).

Non-asbestos mortar present in exterior decorative stone wall, location 32.

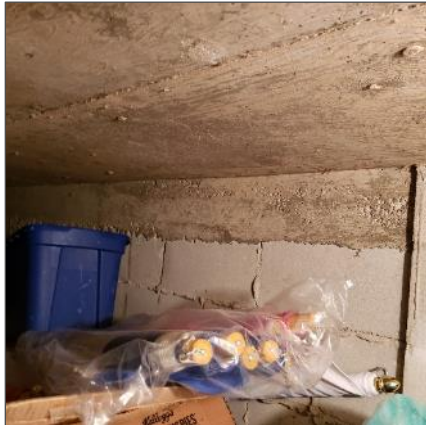
The concrete parging, present on walls and ceilings within location 20 was sampled and determined to not contain asbestos (samples 0018A-C).

Non-asbestos parge present on concrete walls and ceilings,  
location 20.

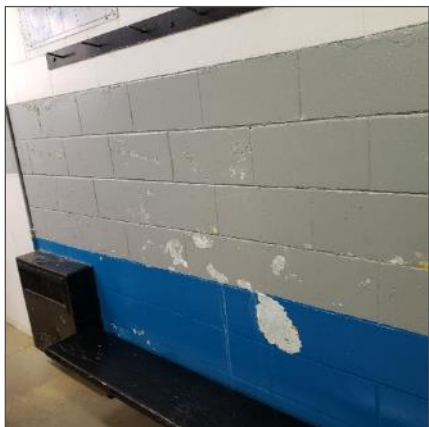
Results above 0.1% are considered elevated (i.e., greater than the EACO guideline of 0.1% for lead-containing paints). Paints with elevated levels of lead was flaking/peeling in the following areas on the following items:

- Dark blue paint on concrete block walls in Location 13.

Dark blue paint with elevated levels of lead flaking from concrete block wall, location 13.

Items painted with paints containing elevated levels of lead may be a hazardous waste. Test lead-painted materials for leachable lead prior to disposal.

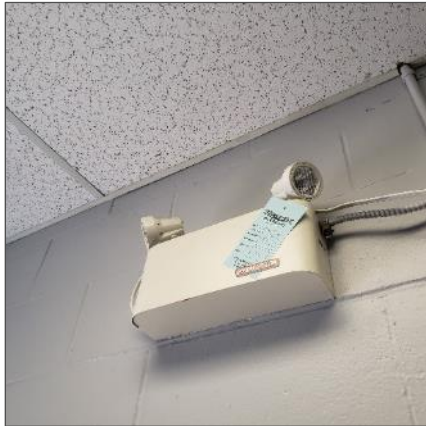
Lead-containing batteries are presumed present in emergency lighting and fire alarm control panels.

Lead-containing batteries presumed present in emergency lighting, location 1.

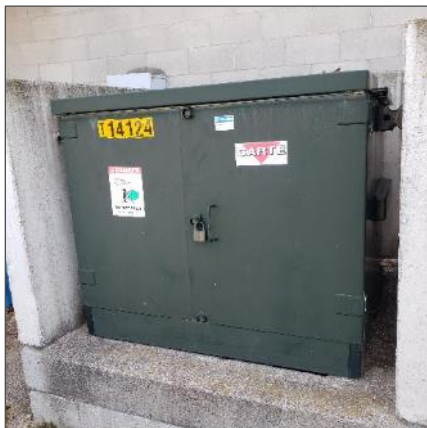
The dielectric fluid within the transformer located at the exterior is presumed to contain PCBs until further sampling proves otherwise.

Transformer with presumed PCB containing dielectric fluid present at the exterior, location 32.

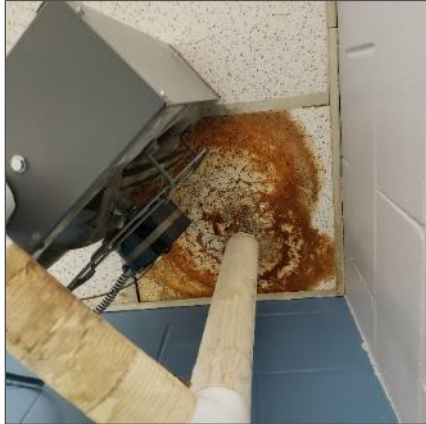
Visible mould growth and water staining is present on one non-asbestos ceiling tile and two asbestos-containing parging cement pipe fittings in location 1. There is approximately 4 sq. ft of visible mould growth.

Mould growth and staining present on ceiling tile, location 1.

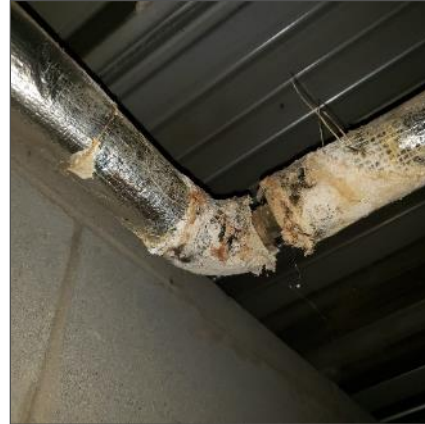
Mould growth present on a pipe fitting with asbestos-containing parging cement, location 1.
