Municipality of Brockton

2018 – Greenock Structure No. 0013 OSIM

BRIDGE REVIEW REPORT

Structure No.: 0013
MTO Site No.: N/A
Location: Lot 23A, Concession 8, Greenock Survey
Date of Review: May 31, 2019
Inspector: Jesse Borges, B. Eng., EIT
Estimated Safe Loading: No posting required.

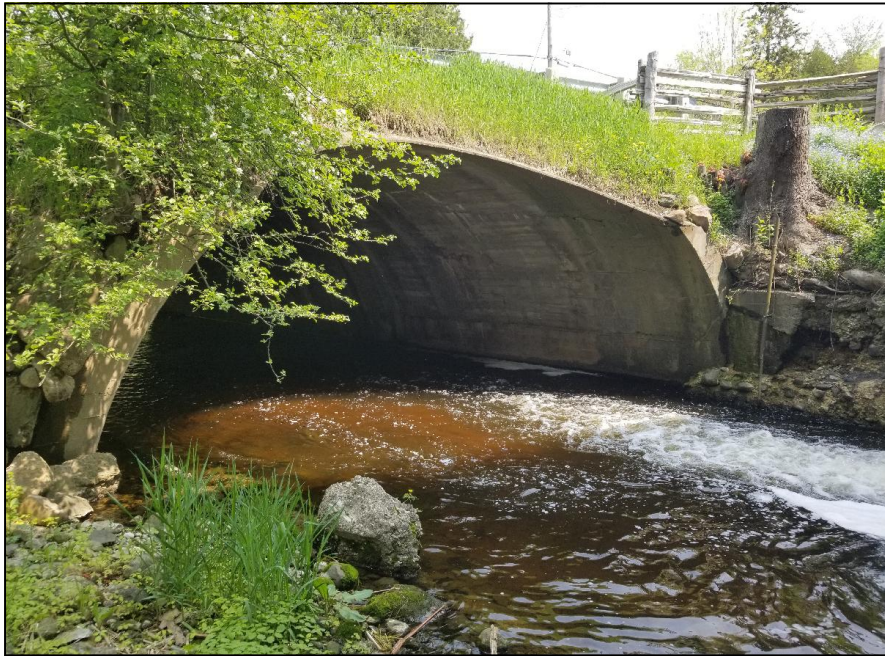
Photo 1 - View of south elevation.

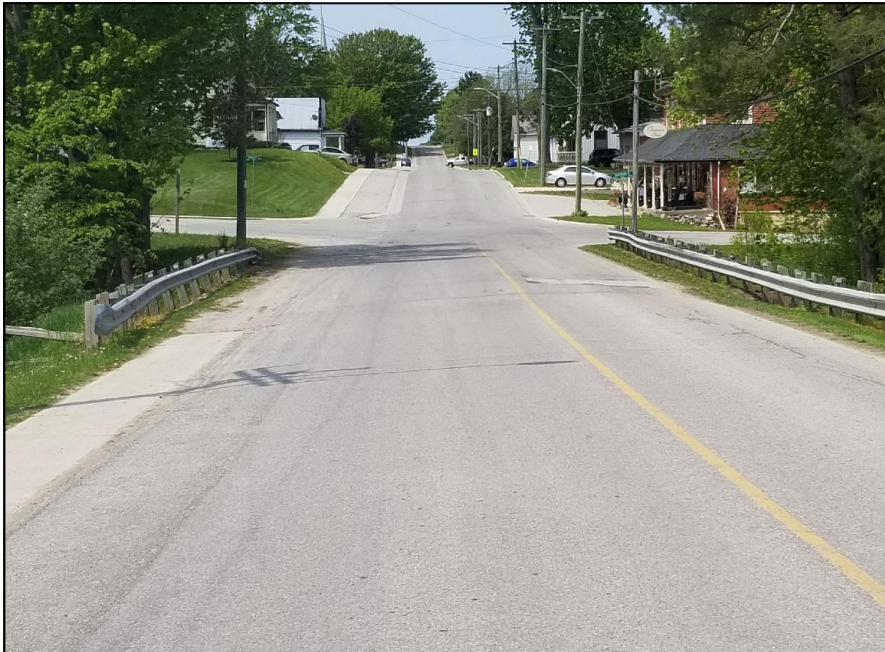
Photo 2 - View of roadway looking west.

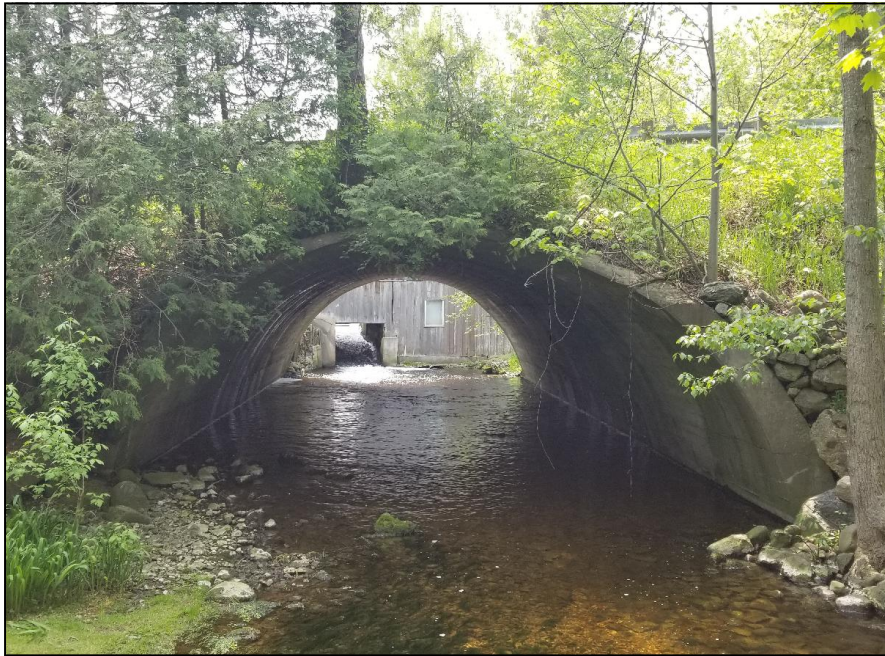
Photo 3 - View of north elevation.

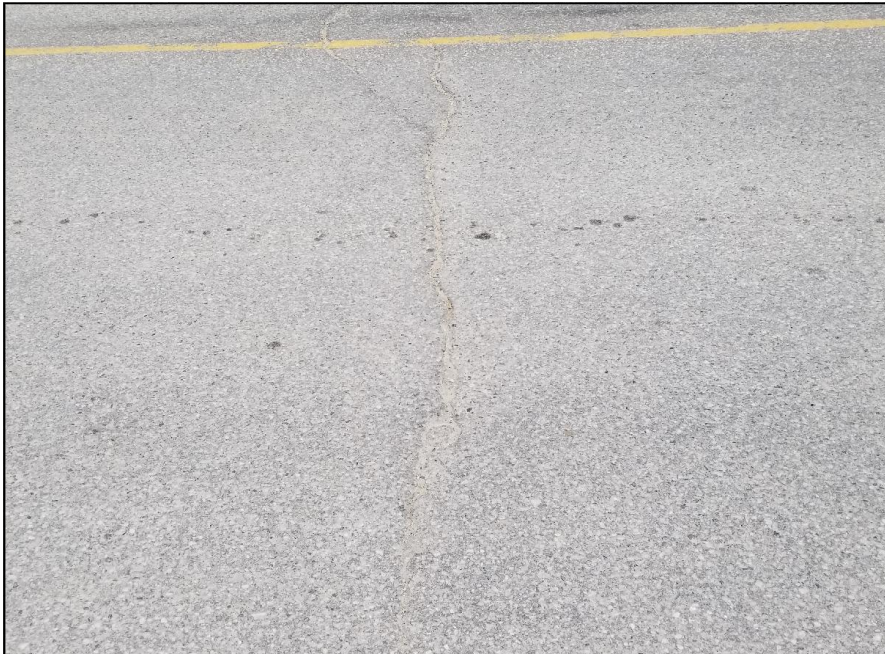
- Asphalt wearing surface is in fair to poor condition with longitudinal and transverse cracks. Asphalt at north has been patched.
- There is a steel beam guiderail on the structure and off the approaches.

Photo 4 - Typical transverse crack in asphalt.

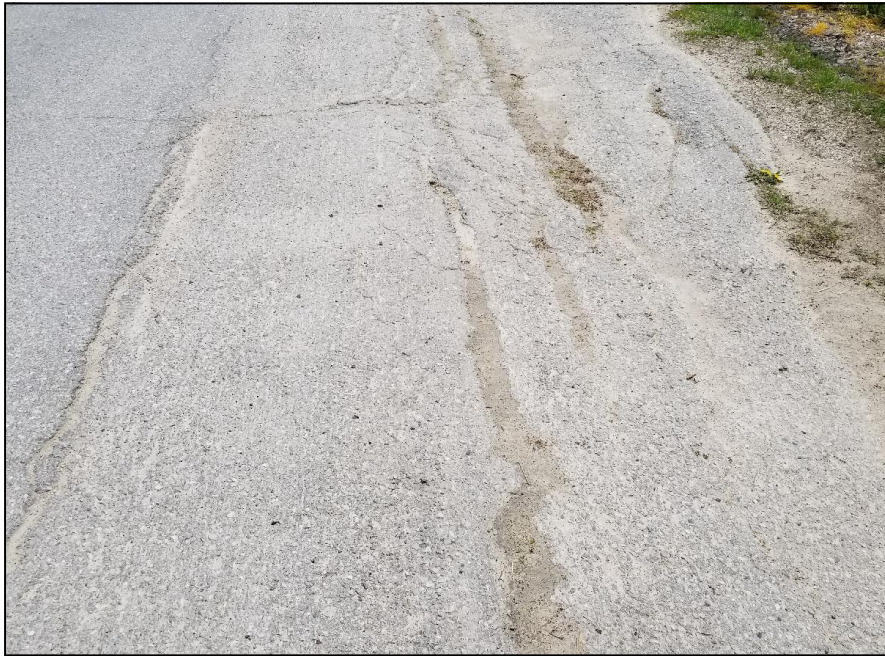
Photo 5 - Settlement and cracking of asphalt along southern edge of wearing surface.

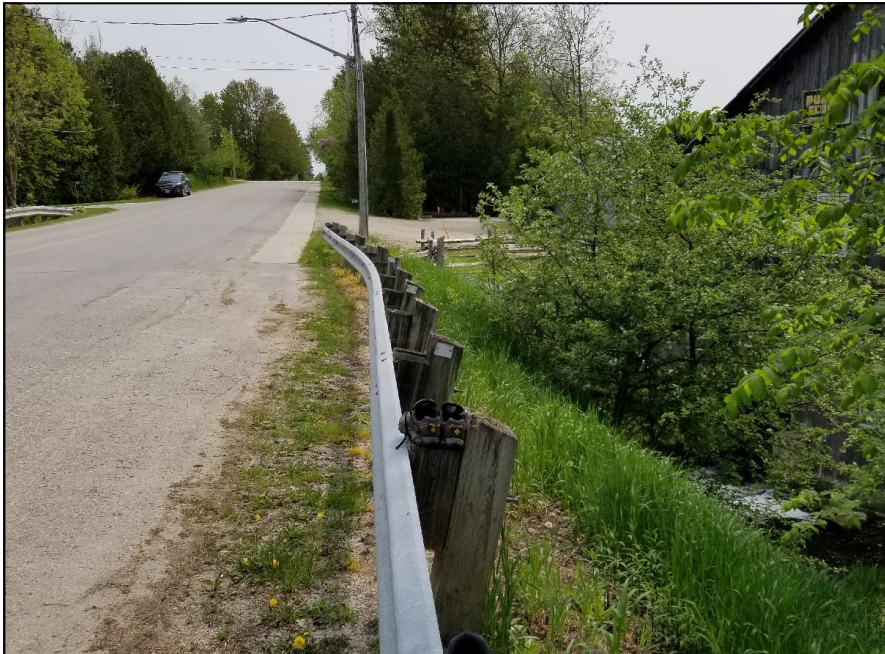
- There is some spalling at the south soffit and the northwest wall exposing reinforcing steel.
- South embankment is failing, causing the guiderail to be pulled down and away from the roadway.

Photo 6 - Outward rotation of south steel beam guiderail.

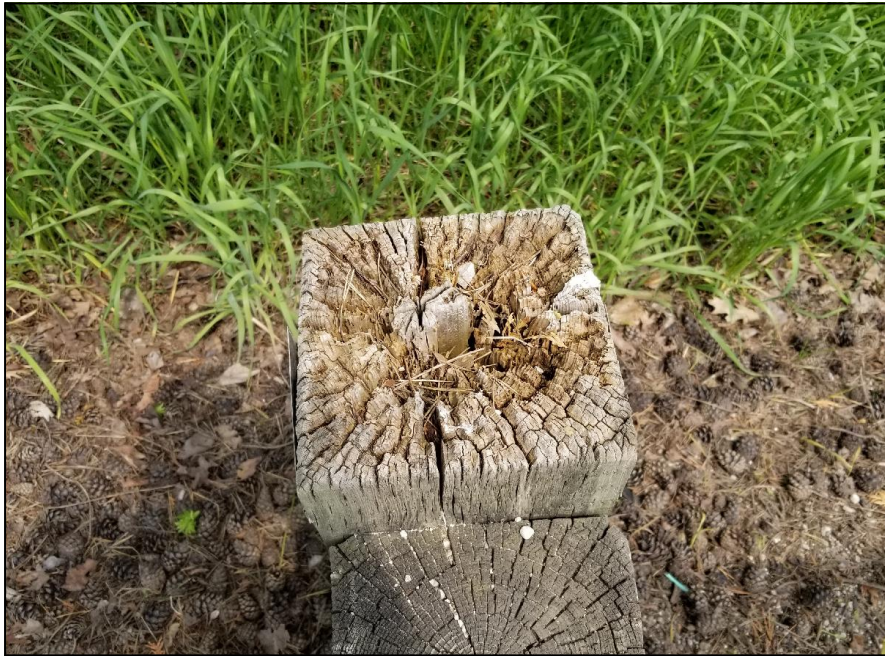
- Several guiderail posts and bearing blocks are damaged in the southwest and northeast approaches.
- The southeast retaining wall is not part of the structure but does have severe deterioration and water leaking. Failure of the following wall could cause problems for the culvert.

Photo 7 - View of typical rotted post.

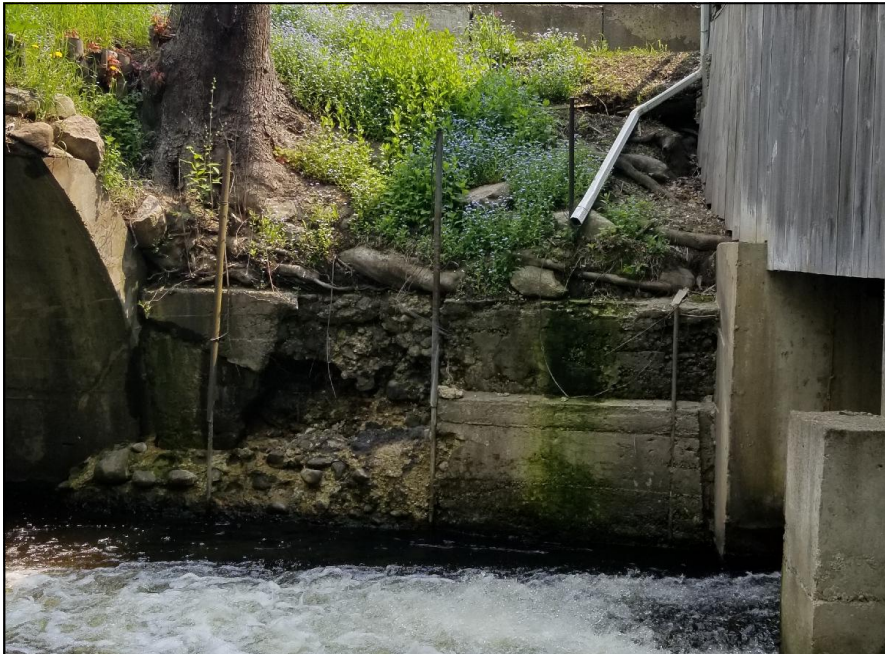
Photo 8 - Deteriorated retaining wall at southeast.

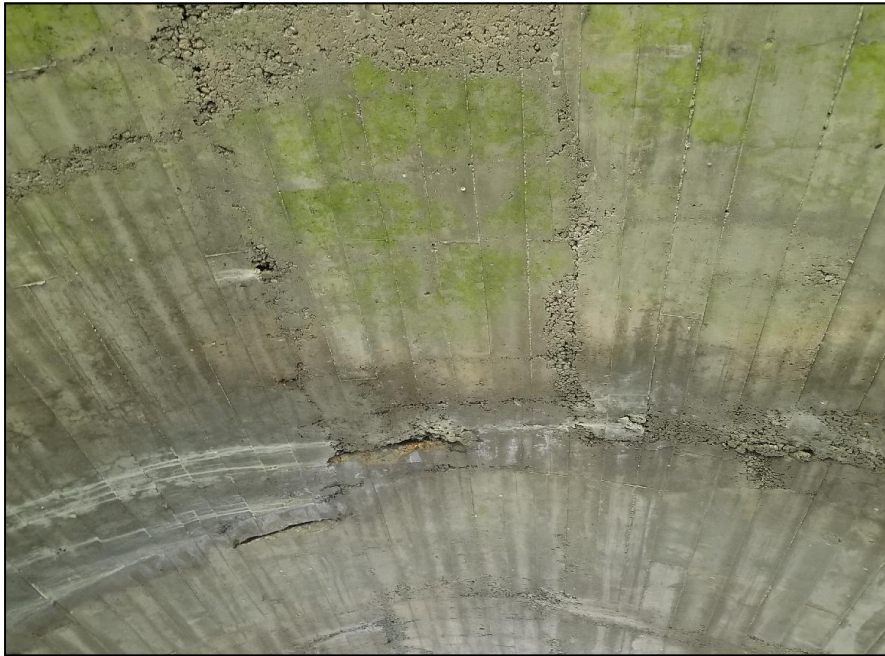
Photo 9 - View of typical soffit condition.

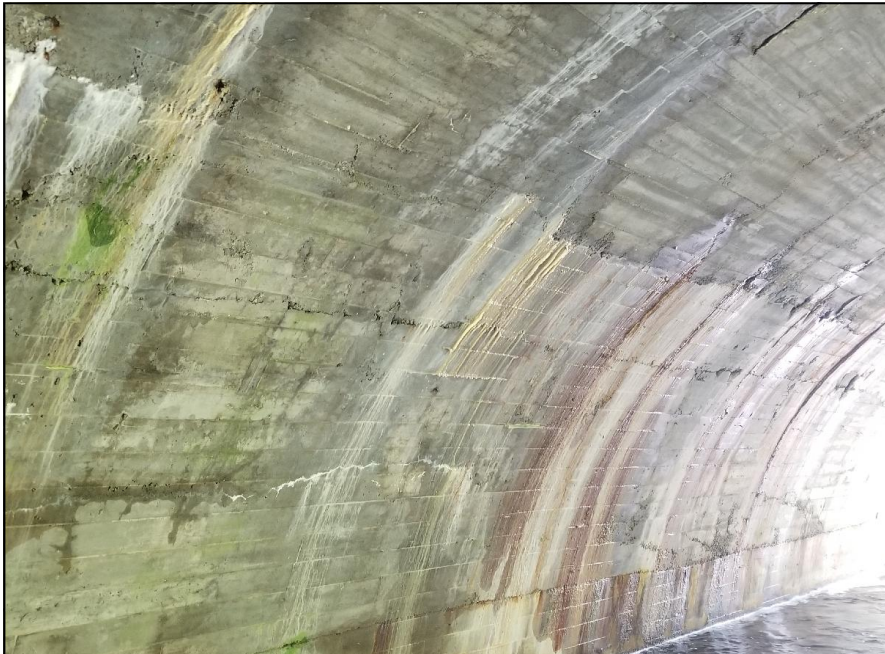
- There is a large stone wingwall in the southwest corner. There is no mortar between the stones.
- There is no drip edge cast into the soffit.
- There is a medium horizontal crack along the width of the structure at each construction joint. There is also light honeycombing along the length of the construction joints.

Photo 10 - Evidence of water seepage through original construction joints.

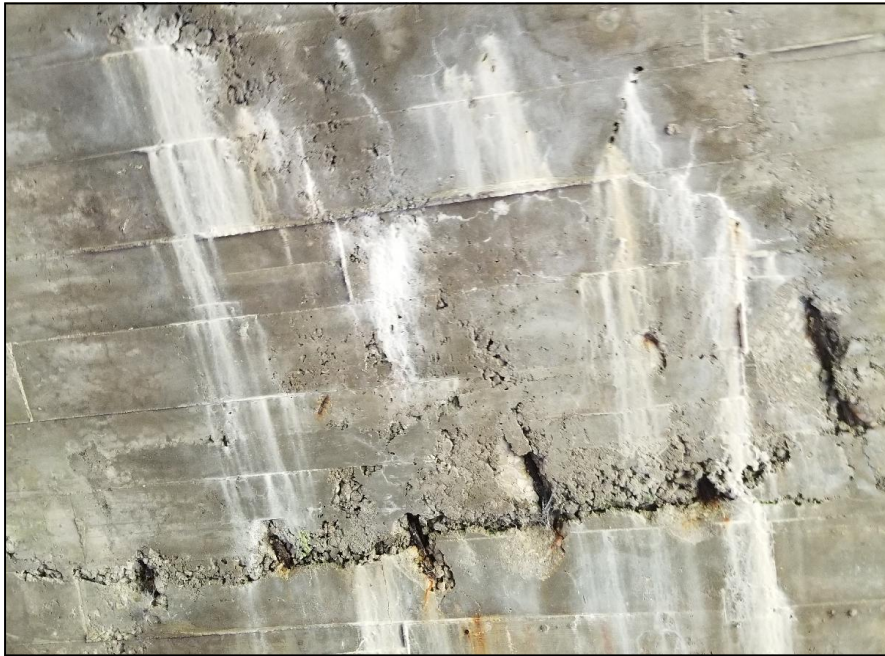
Photo 11 - Barrel wall with exposed reinforcing.

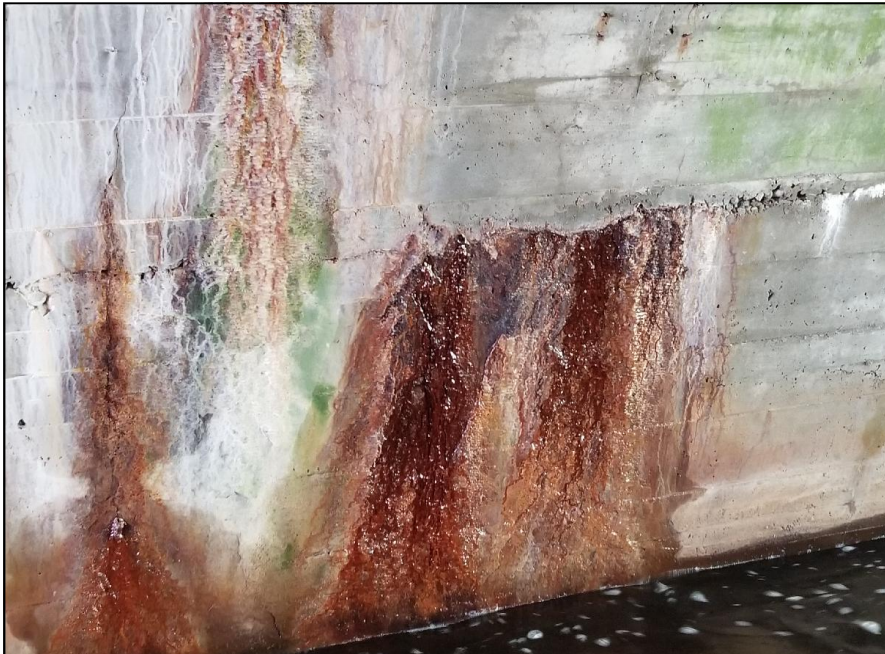
- There are numerous hairline to medium longitudinal and transverse cracks throughout the structure with efflorescence indicating water is leaking through the entire structure.

Photo 12 - Active water seepage through barrel wall.

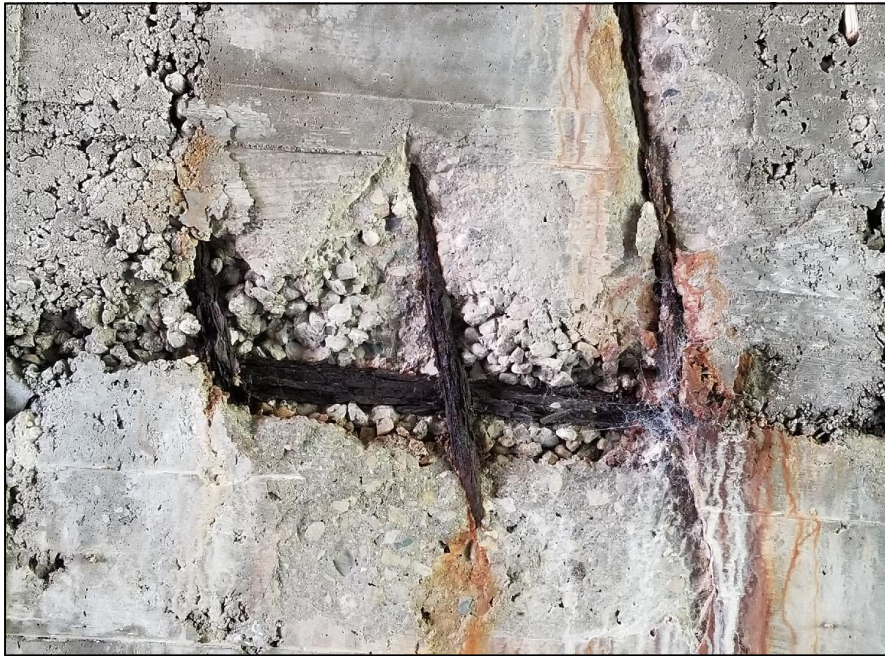
Photo 13 - Exposed reinforcing with severe section loss.

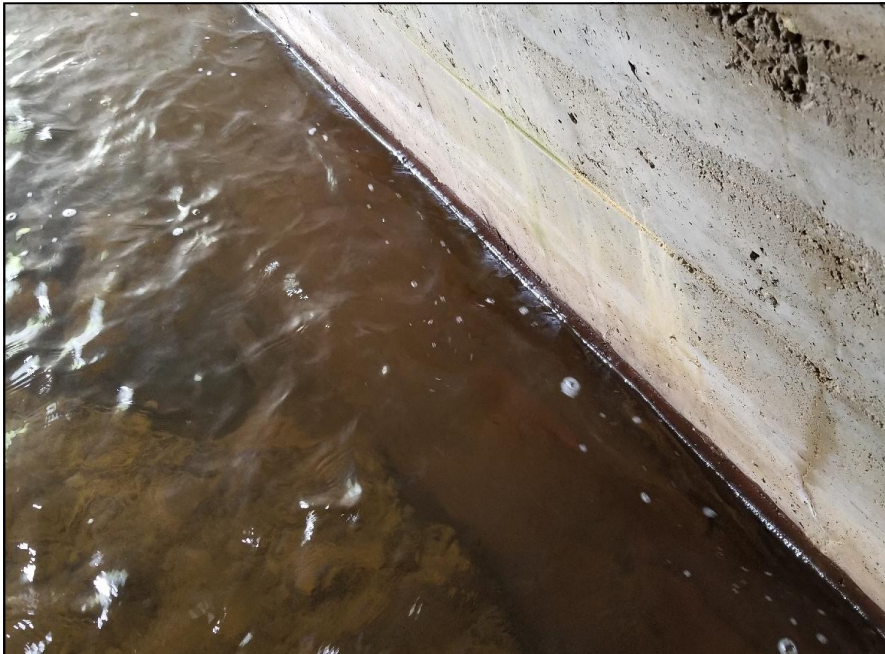
Photo 14 - Top of foundation exposed at southwest.

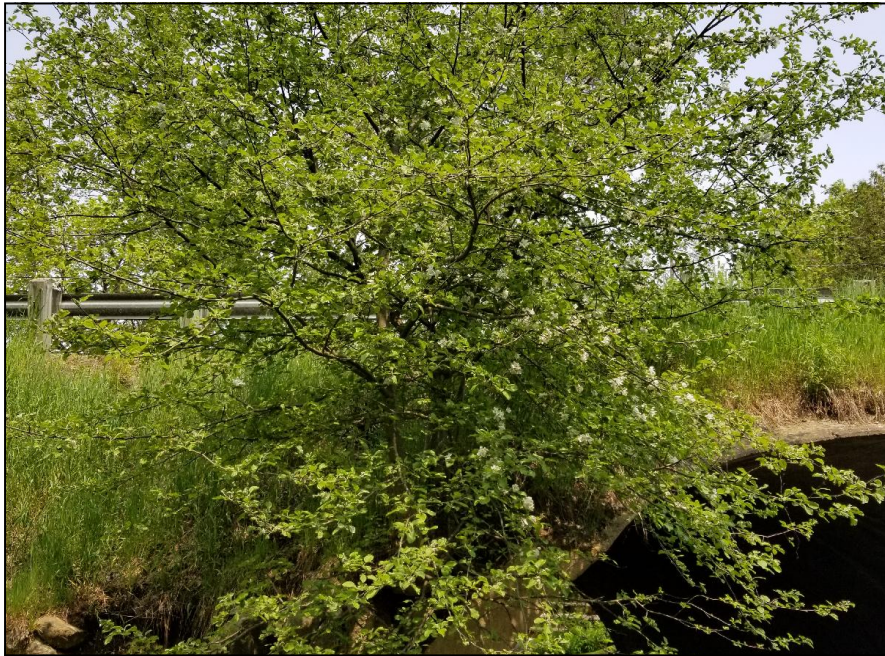
- The large vegetation growing beside and on top of the barrel will allow roots to damage the structure.

Photo 15 - Large vegetation (tree) growing on top of culvert.

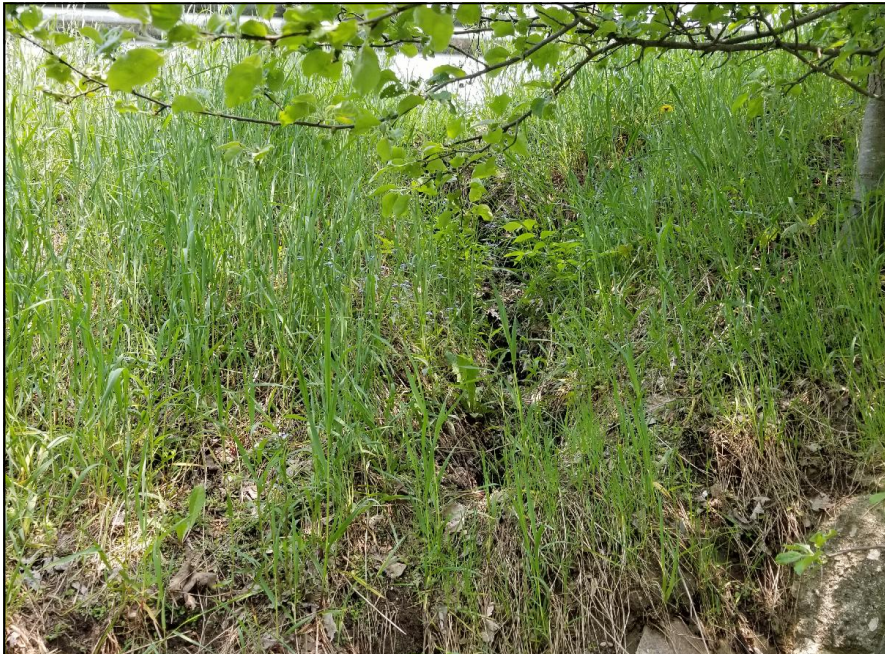
- There is no headwall on either side of the culvert. It appears that part of the ground behind the southwest corner has slumped in and the grade is eroding due to water runoff on the steep slope.

Photo 16 - Voids at southwest embankment due to erosion.

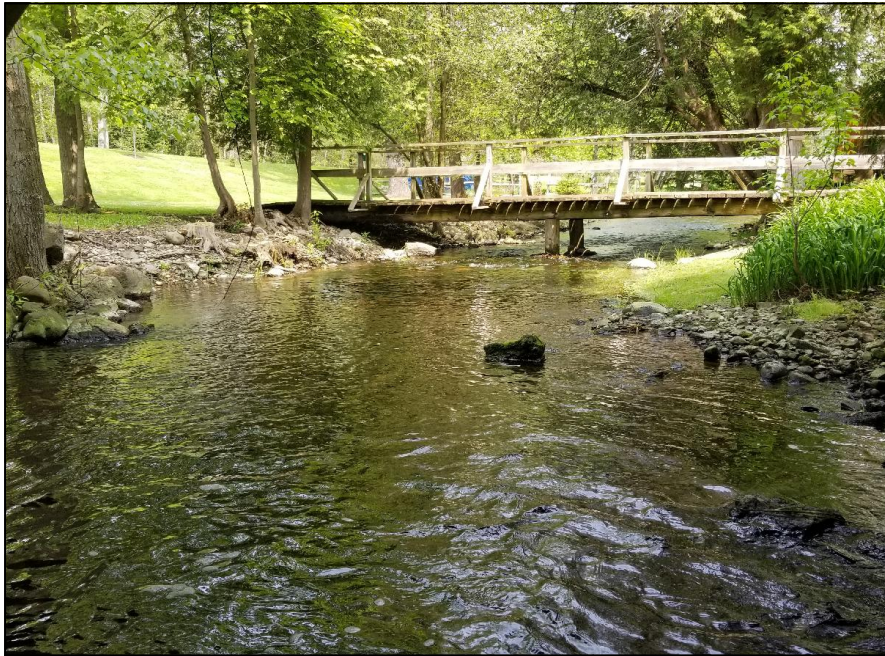
Photo 17 - View of watercourse looking north.

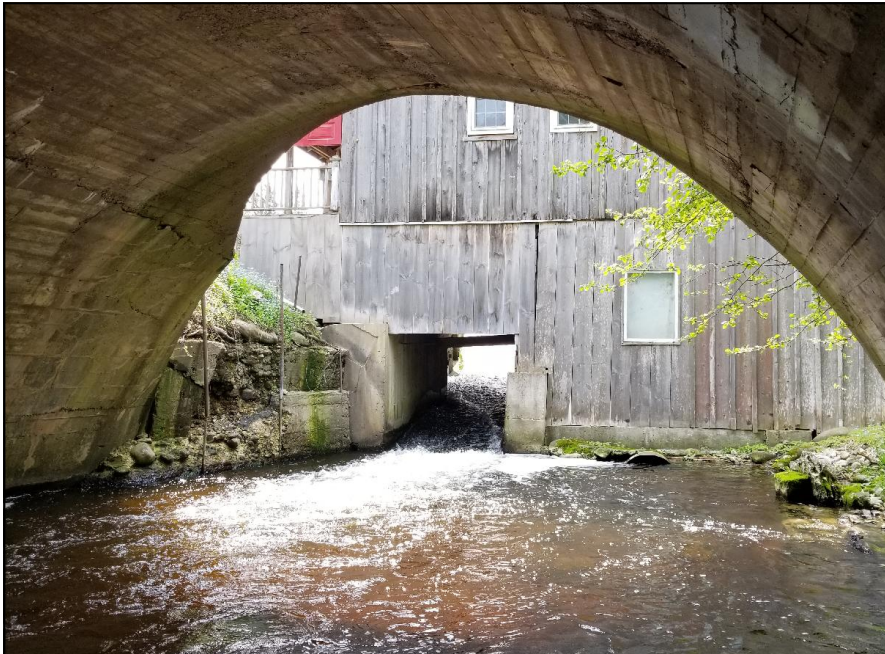
Photo 18 - View of watercourse looking south.
