Municipality Of Brockton

## Load Posting Evaluation Greenock Structure No. 006

**GMBP File: 216137-1**

**October 2020**

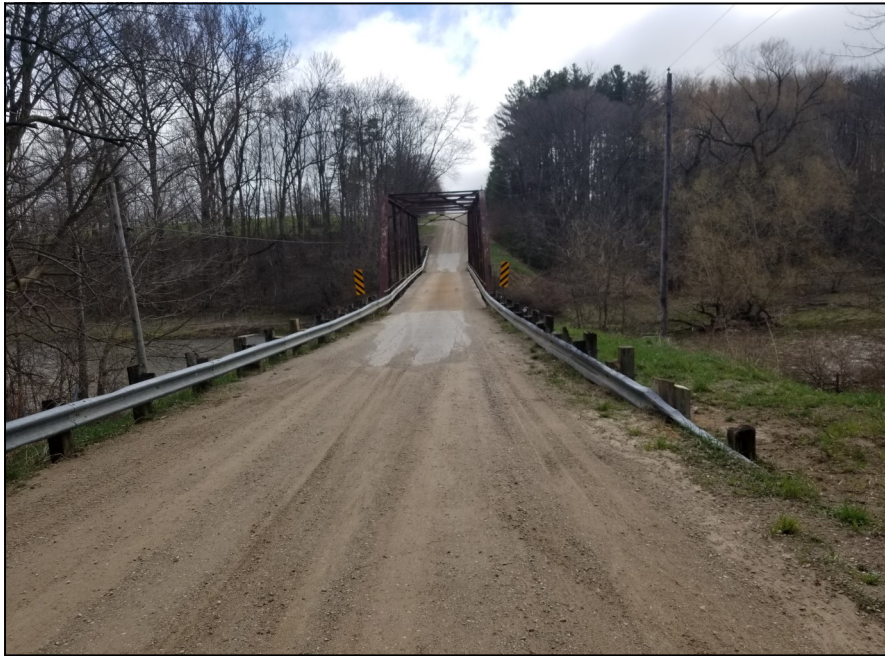
**Photo 1** - View of structure from west (May 1, 2020).

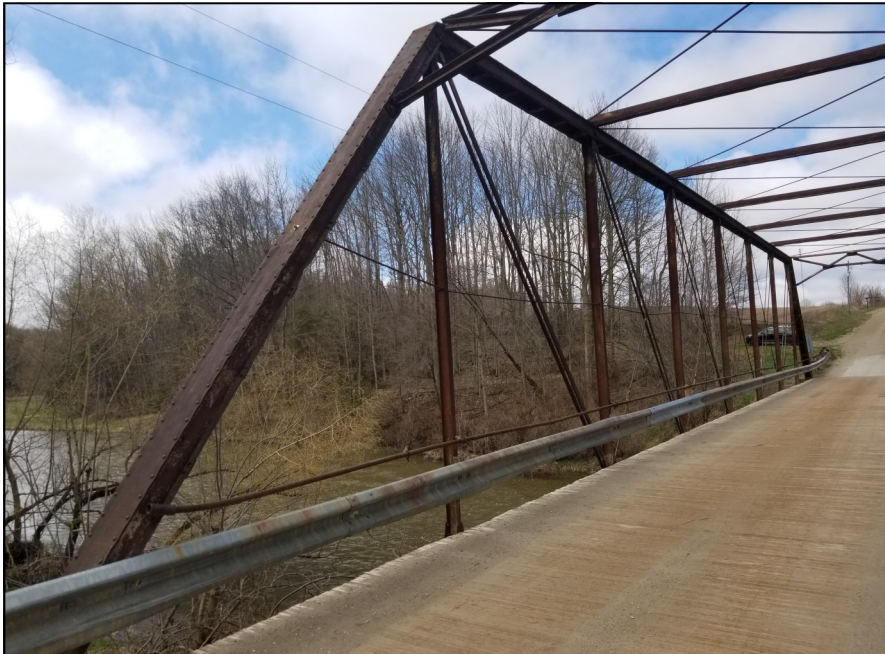
**Photo 2** - View of south truss (May 1, 2020)

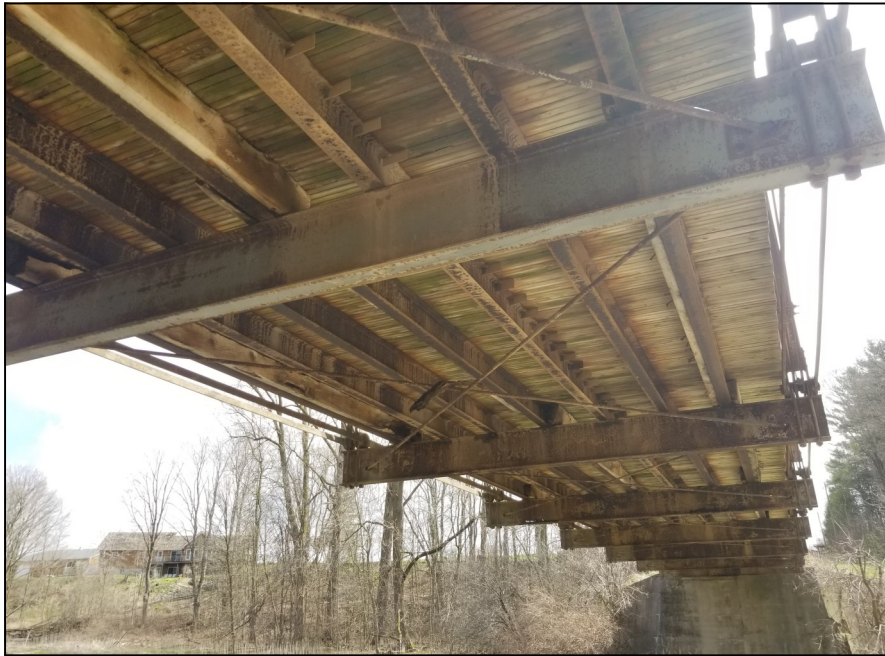
**Photo 3 -** View of soffit looking east (May 1, 2020).

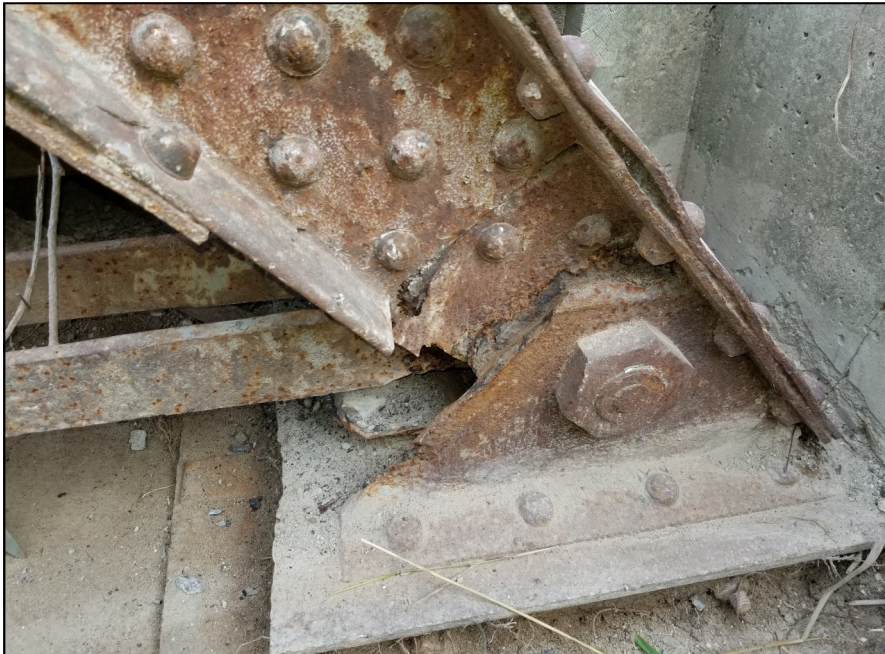
The northeast, southeast and southwest bearing connections are in poor condition with severe corrosion and section loss. Perforations can be noted in connection plates and gussets which connect the top and bottom chord to the bearing plate. The northwest bearing connection is in good condition having been recently replaced in 2012. It has been recommended in previous bridge review reports that the tops of the abutments should be cleaned due to the large amounts of gravel and vegetation covering the bearing seat and truss connections. It is expected that the constant accumulation of gravel and vegetation growth on the bearing seats has allowed for moisture to be trapped against the concrete surface and truss connections, thus accelerating the deterioration of these components.

The rivets at the northeast and southeast bearing connections are in poor condition with severe corrosion and section loss. While trying to clean the loose corrosion off of the steel members over the bearing plates, the interior end of several rivets fell off.

**Photo 4 -** View of southeast bearing connection (September 22, 2020).

- Replacement of the NE, SE and SW bearing connections.
- Replacement of the NE and SE bottom chords.
- Replacement of 3 to 4 cross beams.
- Concrete repairs to the east bearing seat.

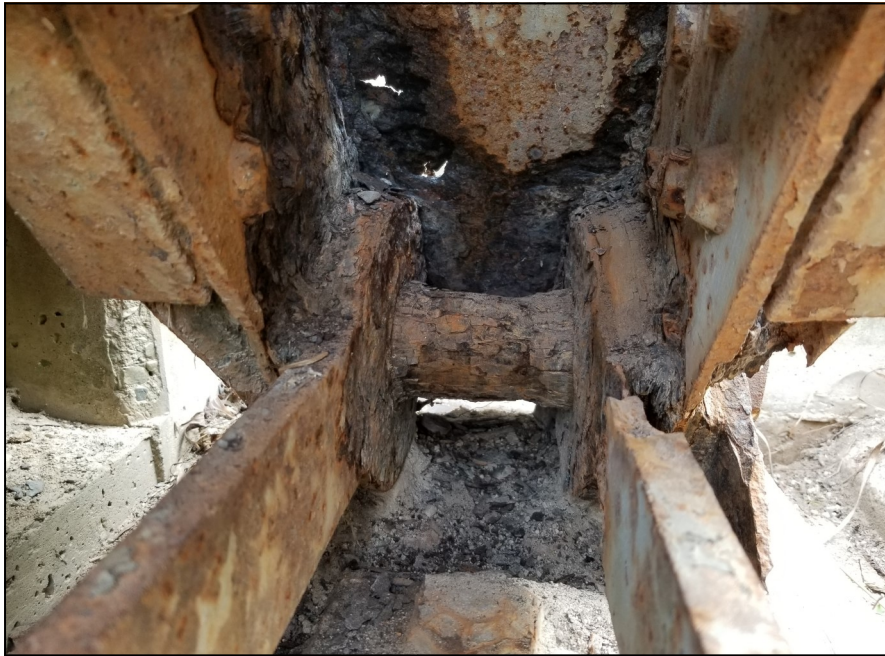
**Photo 5 -** Severe corrosion and section loss at southeast bearing connection (September 22, 2020).

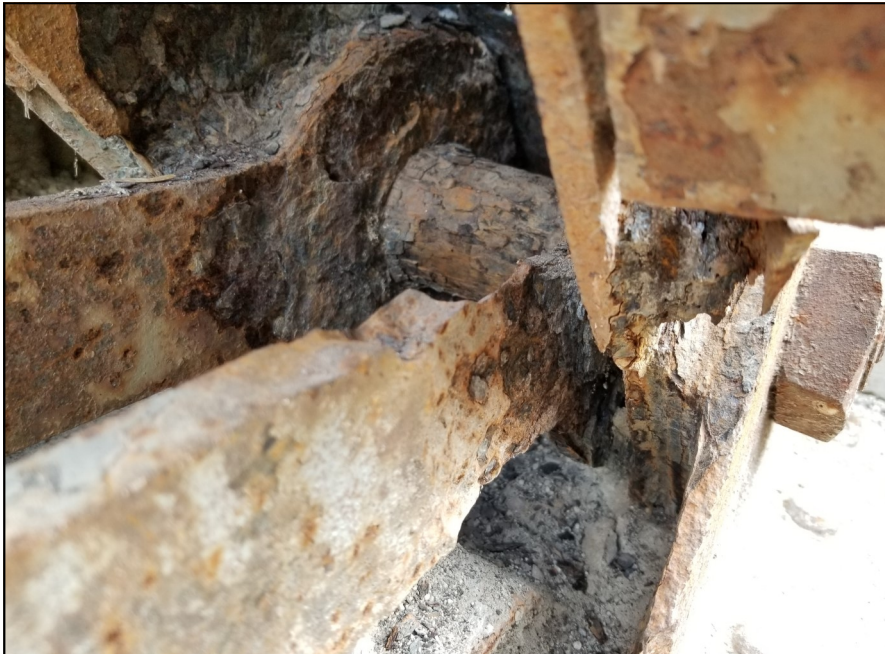
The bottom and top chord are exhibiting significant corrosion and section loss (30% to 75%) at the northeast and southeast bearing connections. The remaining portions of the bottom and top chord, as well as all webs, are showing signs of minor deterioration and section loss (10% to 15%). Several of the vertical webs within the truss and portions of the bottom chord are permanently deformed. It should be noted that connections at the top of the truss were visually reviewed from the deck surface only.

| Structural Element | CL1-625-ONT | CL2-625-ONT | CL3-625-ONT | CHBDC Recommendation |
|---|---|---|---|---|
| Bottom Chord | 0.116 | 0.125 | 0.149 | Close Structure |

**Photo 6 -** Approximately 75% section loss at east end of south bottom chord (September 22, 2020).

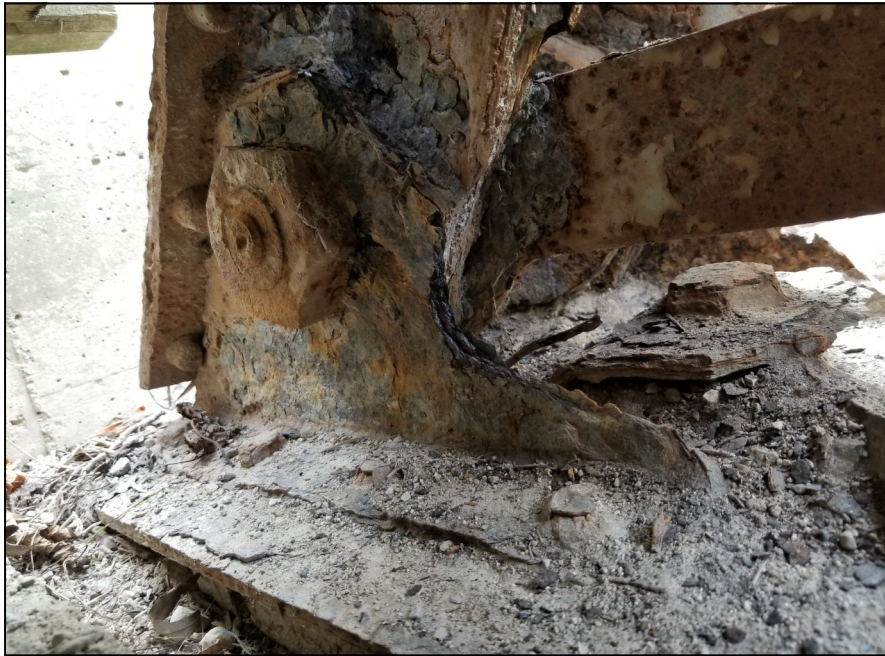
| Structural Element | CL1-625-ONT | CL2-625-ONT | CL3-625-ONT | CHBDC Recommendation |
|---|---|---|---|---|
| Gusset Plate at Bearing | 0.149 | 0.168 | 0.216 | Close Structure |

**Photo 7–** Severe corrosion and section loss of gusset plate at southeast bearing connection (September 22, 2020).

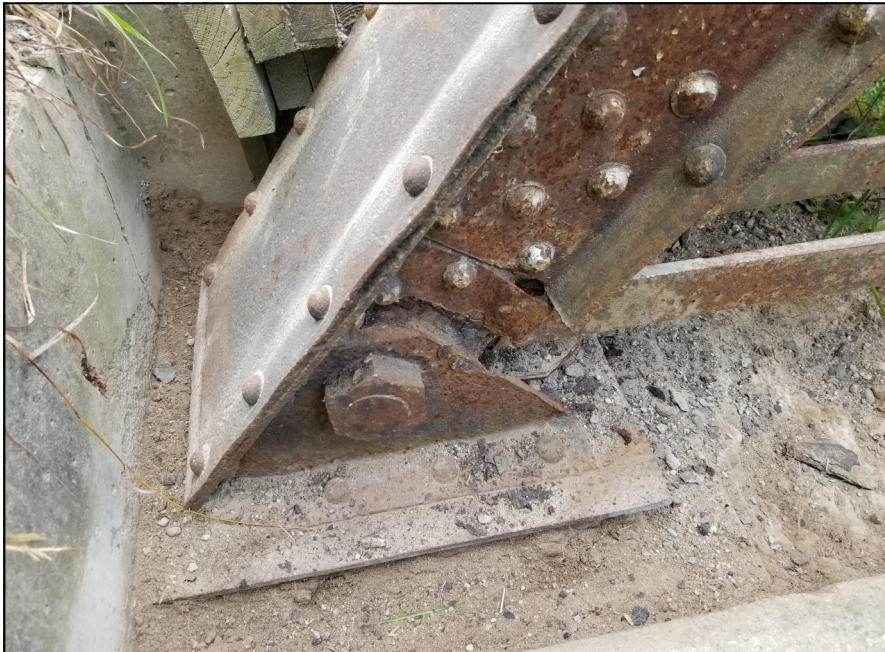
**Photo 8 -** View of northeast bearing connection (September 22, 2020).

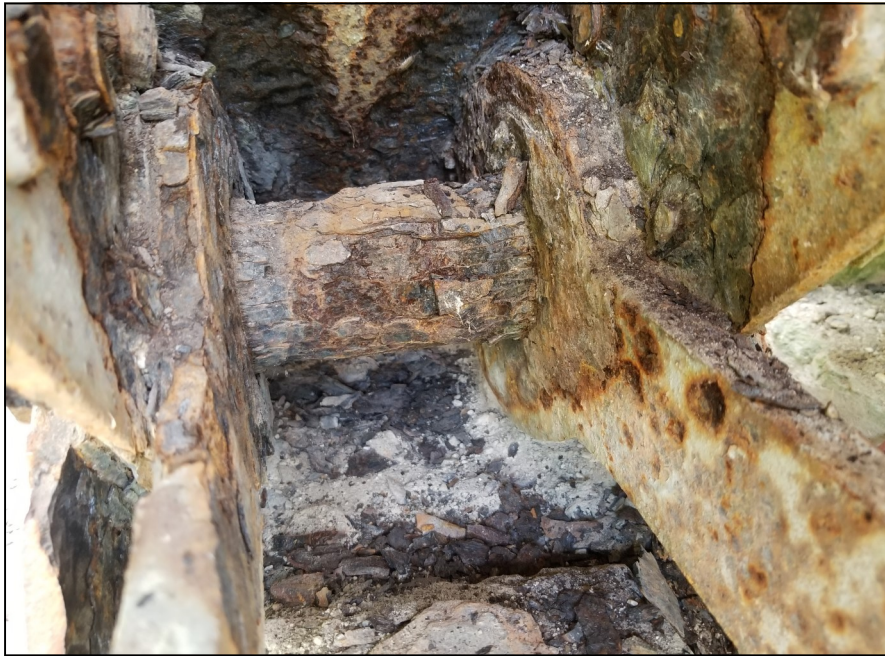
**Photo 9-** Severe corrosion and section loss at northeast bearing connection (September 22, 2020).

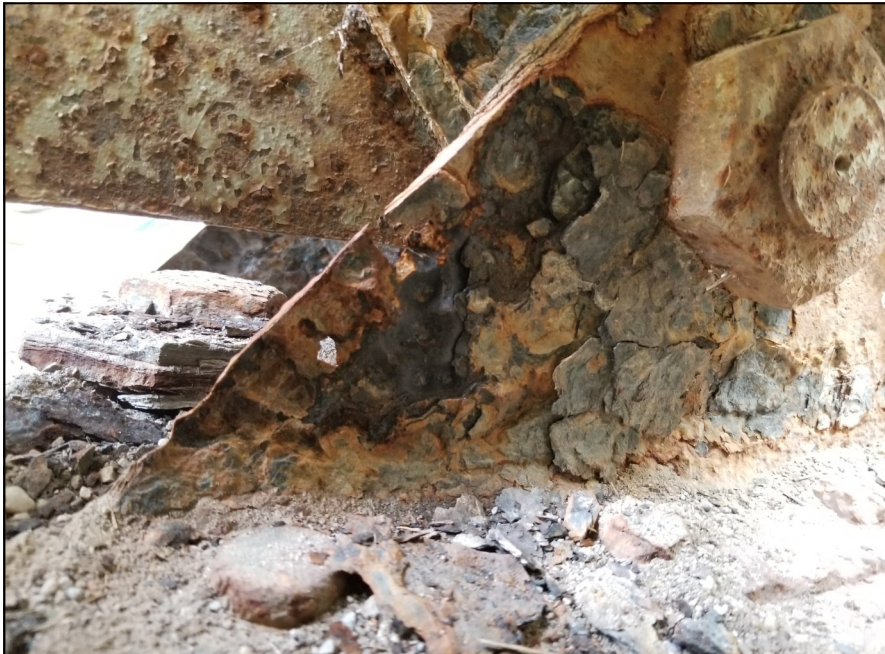
**Photo 10 -** Severe corrosion and section loss of gusset plate at northeast bearing connection (September 22, 2020).

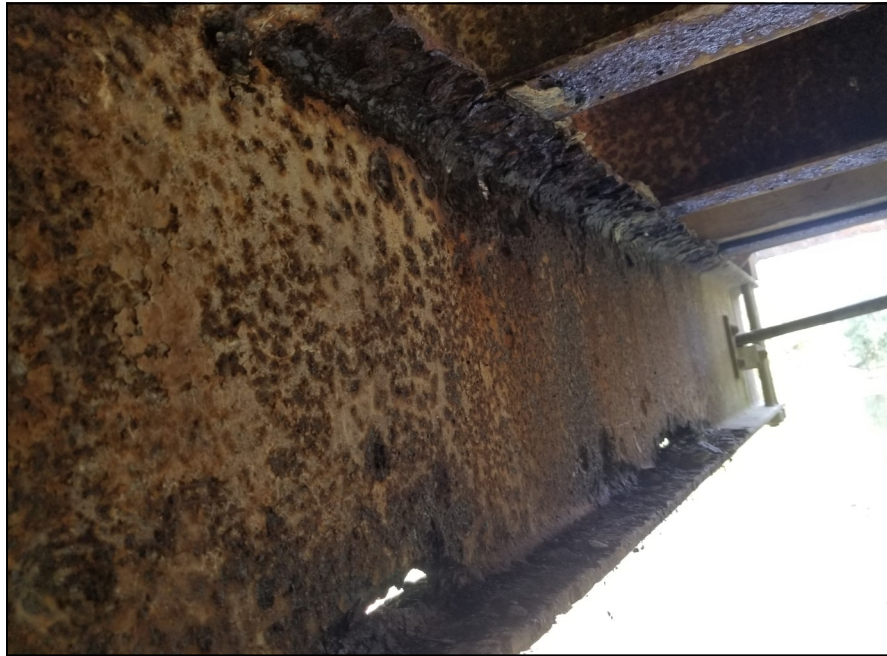
The cross beams are in fair to poor condition exhibiting severe corrosion and section loss in localized areas. In extreme cases, the top flange and bottom flange have approximately 80% and 50% section loss respectively, significantly more than observed in 2016. The vertical web of the cross beams has approximately 15% to 30% section loss with localized perforations near the bottom flange. Although the interior cross beams were not able to be closely inspected during the subject review, it appears that all the cross beams have experienced similar section loss with the exception of the western most cross beam, which was recently replaced in 2008.

| Structural Element | CL1-625-ONT | CL2-625-ONT | CL3-625-ONT | CHBDC Recommendation |
|---|---|---|---|---|
| Cross Beams | 0.254 | 0.254 | 0.254 | Close Structure |

**Photo 11** - Severe corrosion, section loss and perforations at east cross beam (September 22, 2020).

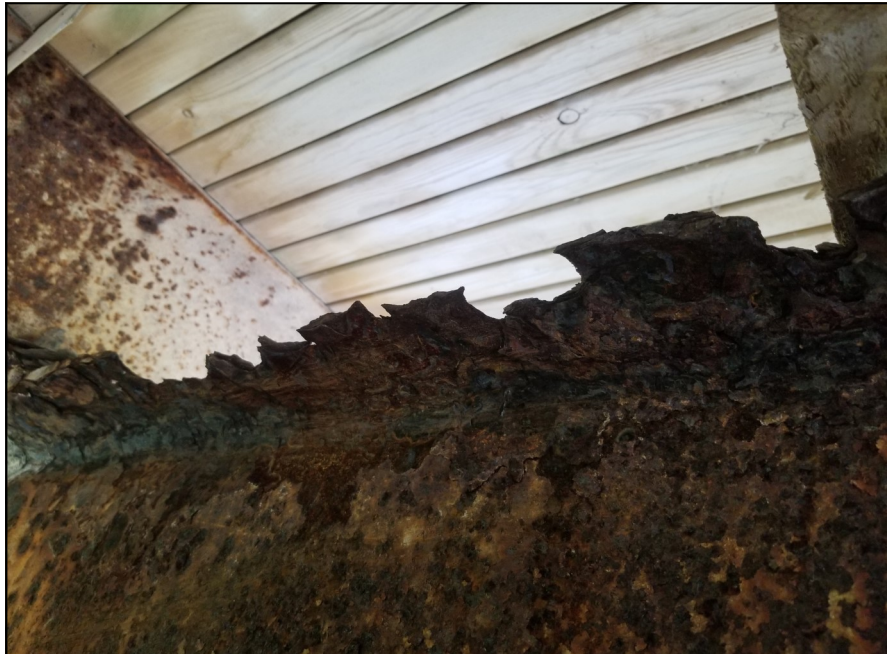
**Photo 12** - Approximately 80% section loss at top flange of cross beam (September 22, 2020).

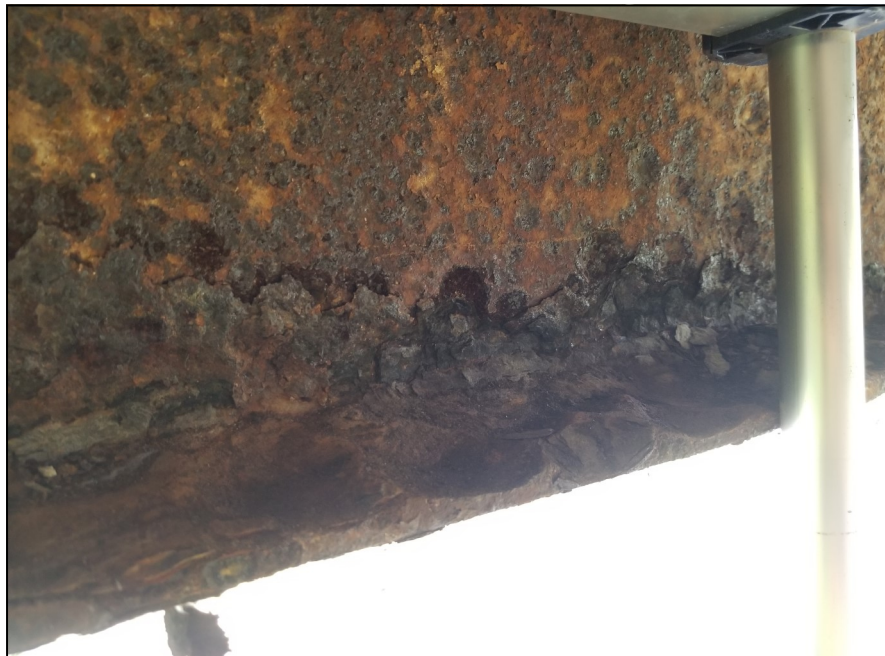
**Photo 13** - Approximately 50% section loss at bottom flange of cross beam (September 22, 2020).

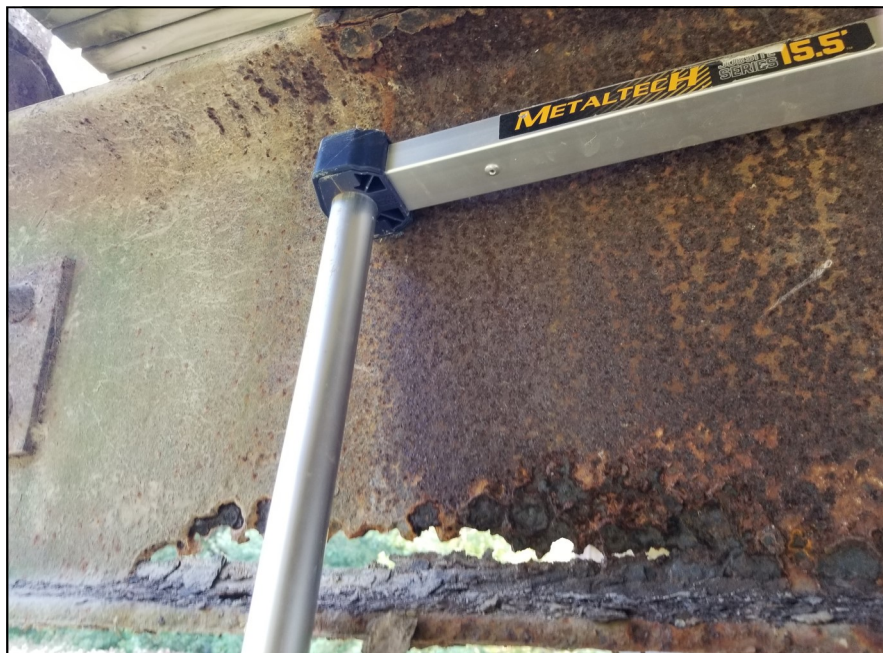
**Photo 14** - Large perforation (350mm x 50mm) at north end of cross beam near mid span (September 22, 2020).

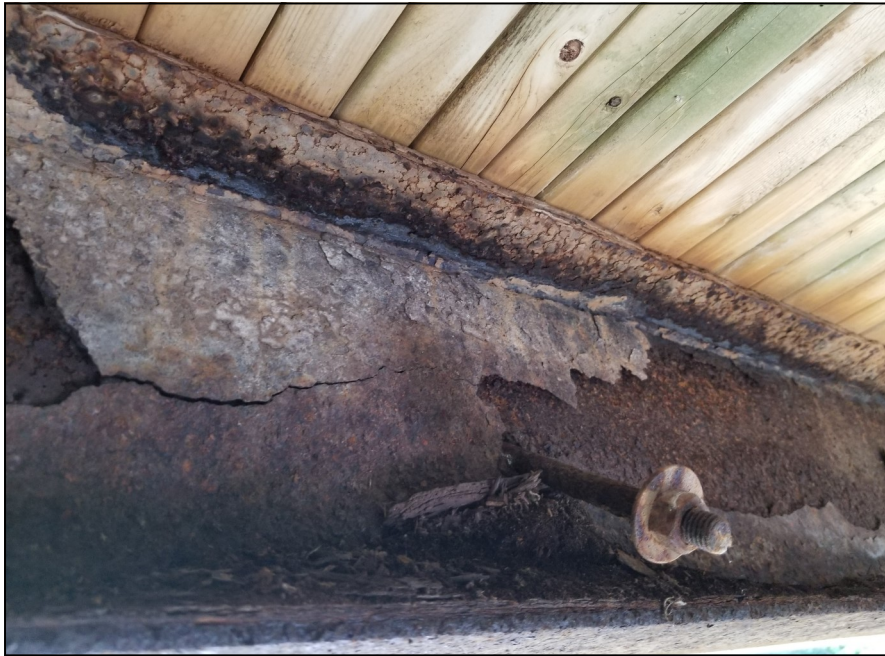
The stringers are showing medium to severe corrosion throughout with more significant corrosion where the stringers are bearing on the abutments. In some cases, the corrosion has resulted in significant section loss and perforations through the webs of some of the stringers. Full height layers of corrosion have begun to flake off of the webs of the stringers. This was not observed during our 2016 review. The previous timber reinforcing installed between the flanges of the stringers is in poor condition and no longer providing support. The presence of the timber may have been detrimental, as it may have trapped water against the steel, accelerating the corrosion process.

**Photo 15** - Approximately 30% section loss throughout stringer supports (September 22, 2020).

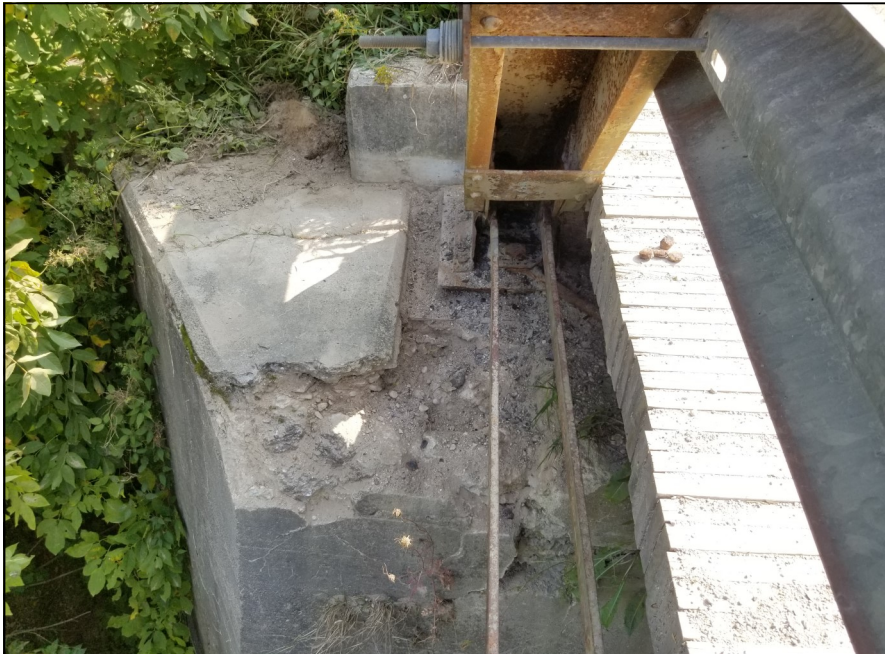
Our review of the abutment bearing seats is limited due to the amount of vegetation and gravel covering the concrete. Medium to wide cracking was noted at each truss connection which could indicate the substructure is being overstressed by the truss connections. The northeast corner of the bearing seat is in poor condition with severe spalling and deterioration.

**Photo 16** - Significant concrete deterioration and spalling noted adjacent to northeast bearing connection (September 22, 2020).
