Re: Bridge Closure Recommendation  
Greenock Bridge Structure. No. 6  
Municipality of Brockton

**LOAD POSTING EVALUATION – 2020  
GREENOCK BRIDGE STRUCTURE NO. 006  
MUNICIPALITY OF BROCKTON**

Structure No. 0006

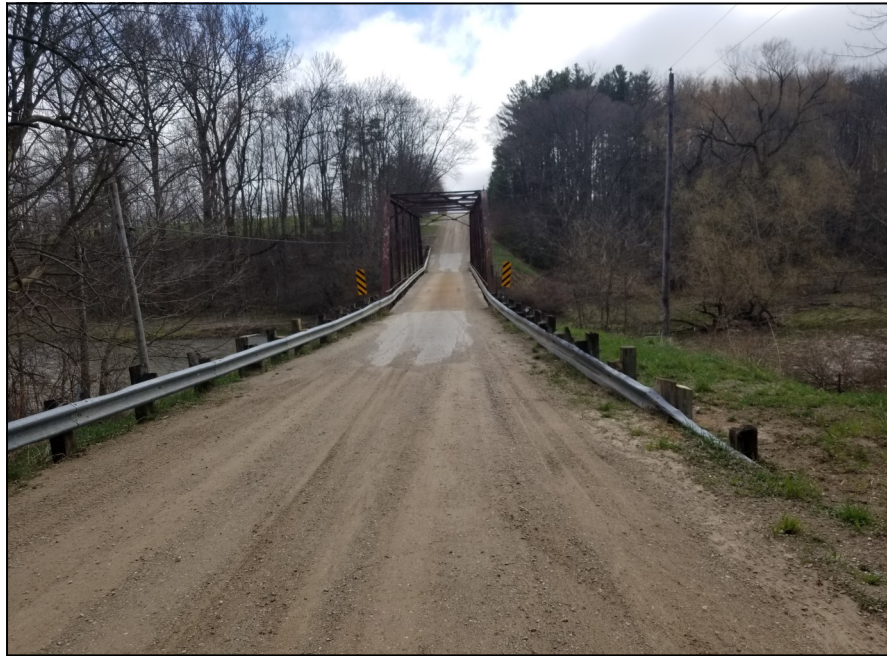
**Photo 1** - View of structure from west (May 1, 2020).

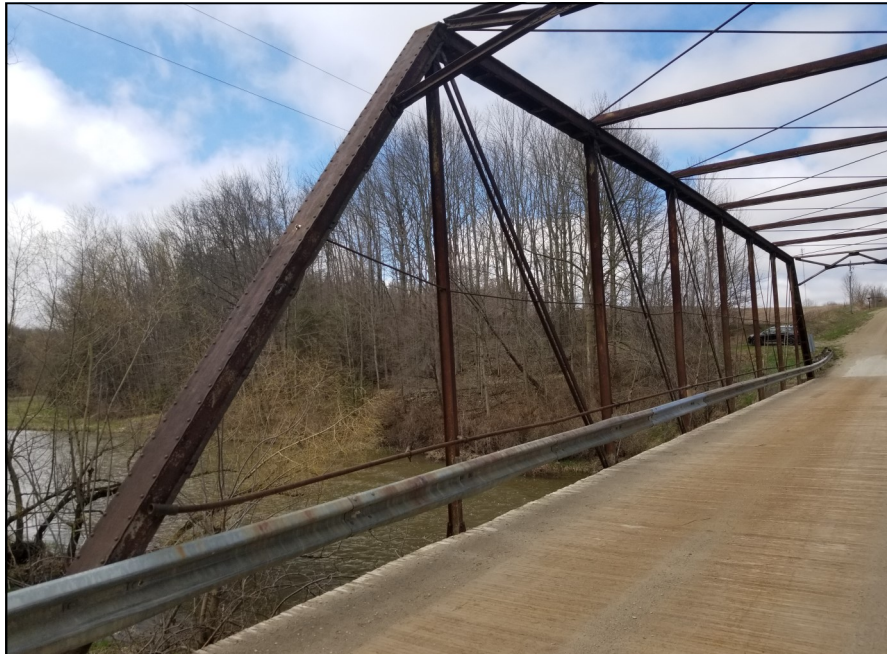
**Photo 2** - View of south truss (May 1, 2020)

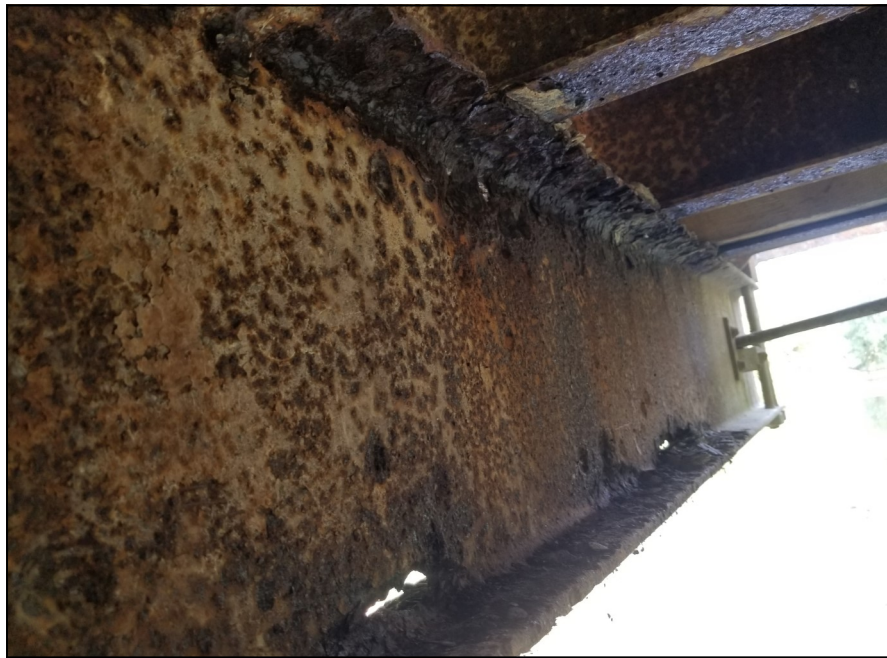
**Photo 11** - Severe corrosion, section loss and perforations at east cross beam (September 22, 2020).

- Replacement of the NE, SE and SW bearing connections.
- Replacement of the NE and SE bottom chords.
- Replacement of 3 to 4 cross beams.
- Concrete repairs to the east bearing seat and abutment wall.

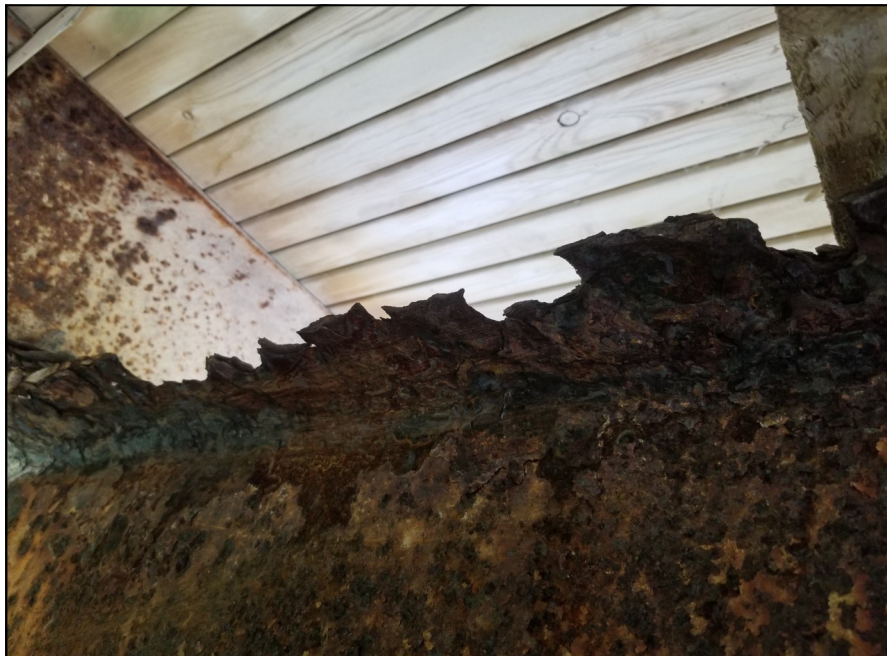
**Photo 12** - Approximately 80% section loss at top flange of cross beam (September 22, 2020).

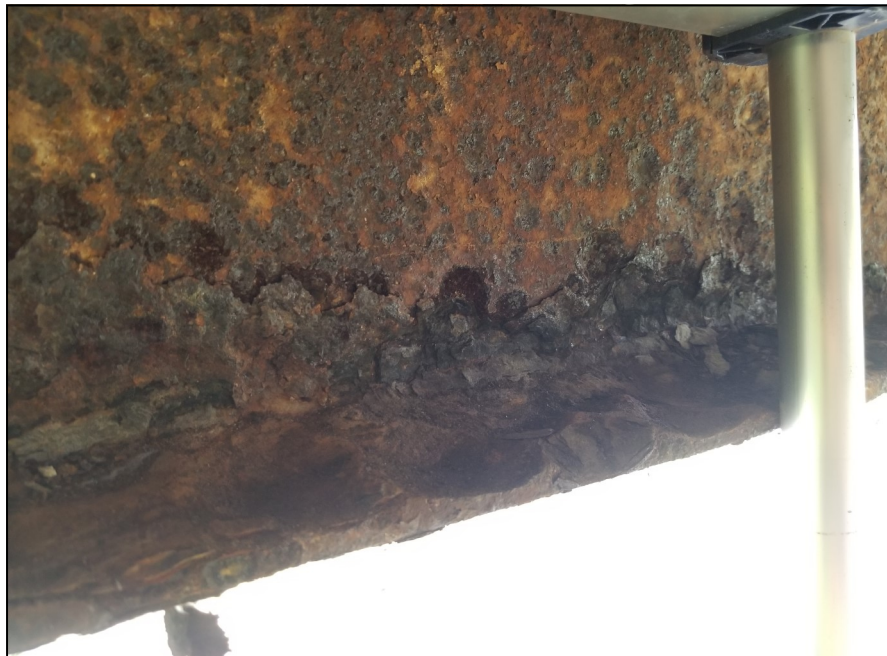
**Photo 13** - Approximately 50% section loss at bottom flange of cross beam (September 22, 2020).

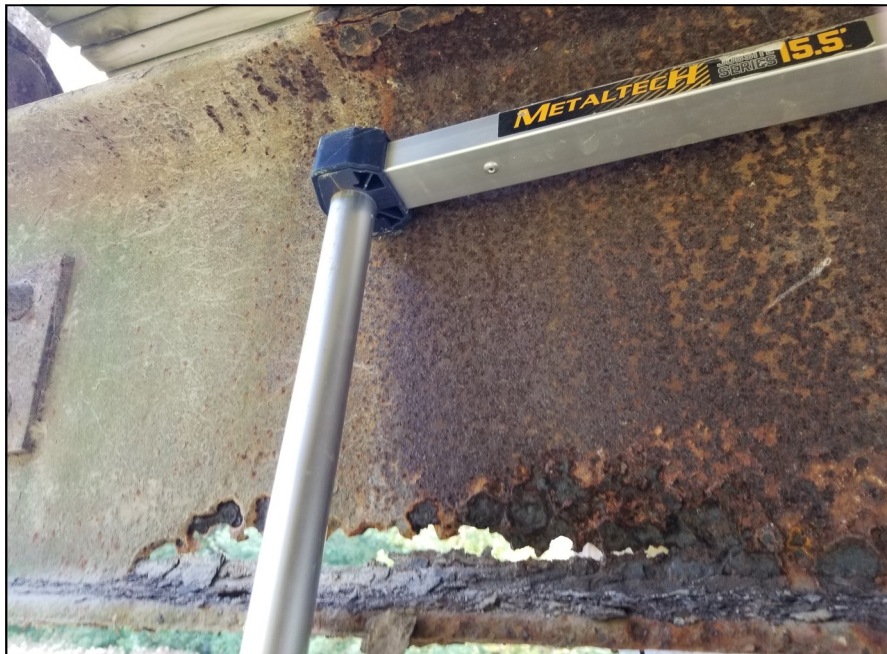
**Photo 14** - Large perforation (350mm x 50mm) at north end of cross beam near mid span (September 22, 2020).

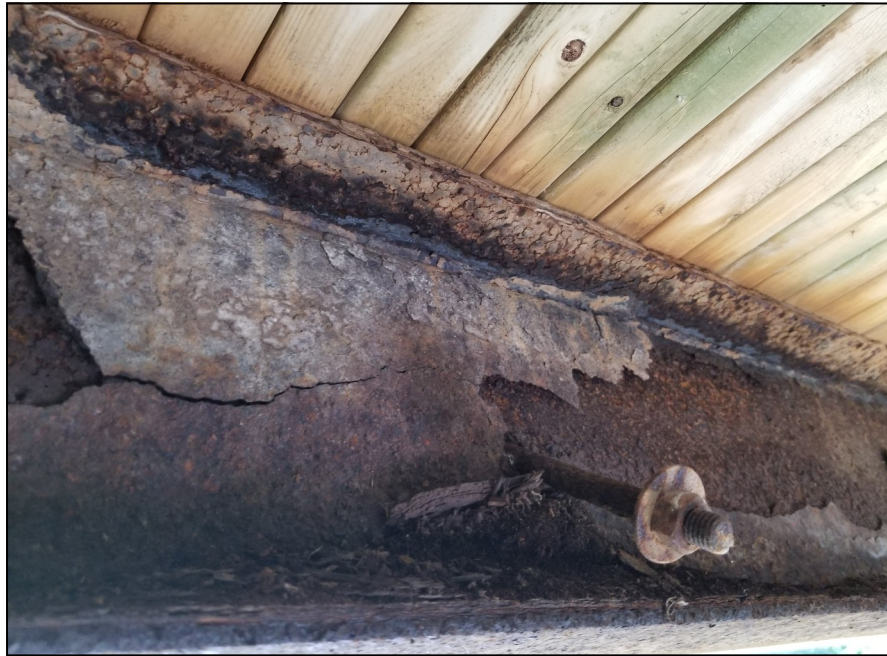
**Photo 15** - Approximately 30% section loss throughout stringer supports (September 22, 2020).

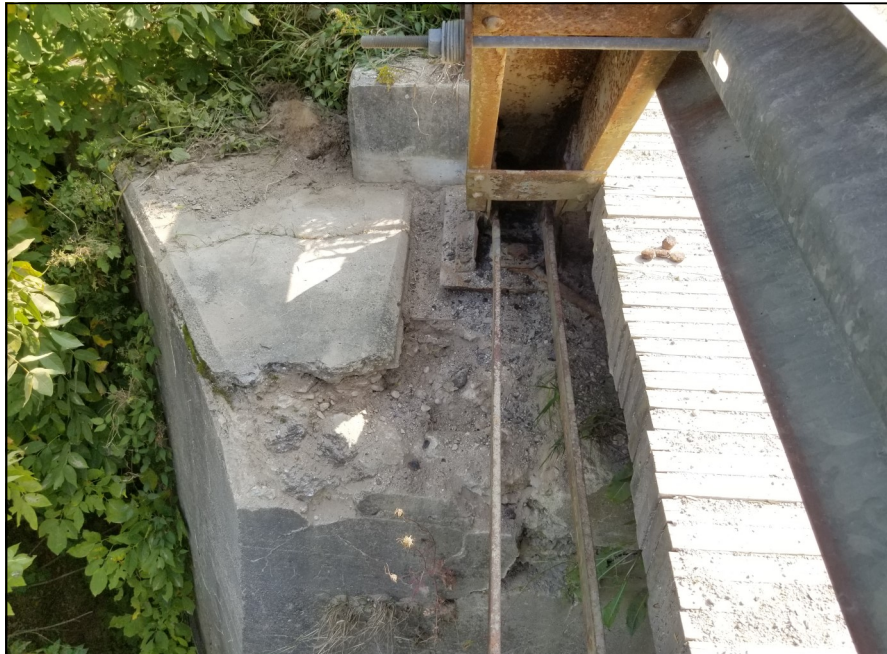
The bridge substructure is in fair to poor condition with significant spalling, wide vertical cracks and evidence of water penetration through the back of the abutment. Cracking on the bearing seat adjacent to the truss connections could indicate that the substructure is being over stressed by the truss. The bearing plates at each truss connection appear to be touching the front face of the ballast wall. A vertical crack on the ballast wall has also been noted at each truss connection which could indicate that the truss is applying pressure to the ballast wall. Please refer to the 2020 Load Evaluation Report for full details regarding the condition of the structure.

**Photo 16** - Significant concrete deterioration and spalling noted adjacent to northeast bearing connection (September 22, 2020).
