Municipality of Brockton Class EA for Saugeen River Bank Erosion - Walkerton

Council Meeting
January 10, 2023

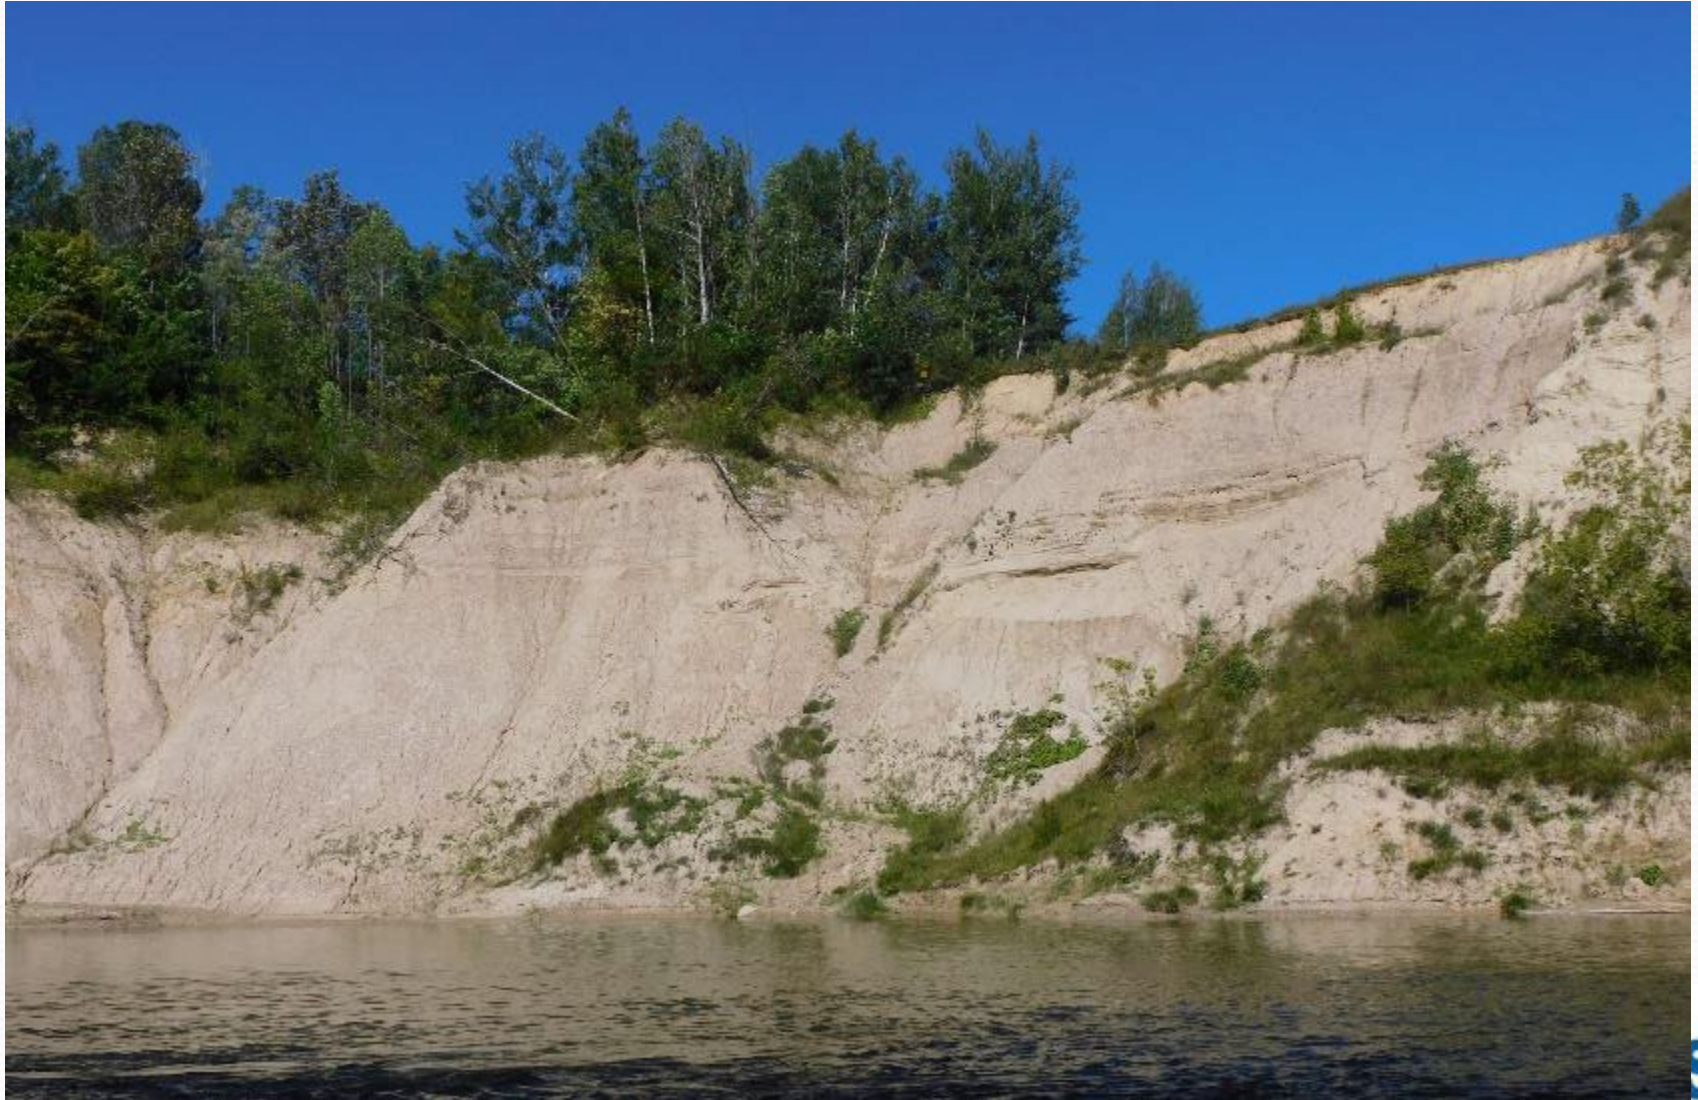
Site photos (Sept. 2021)

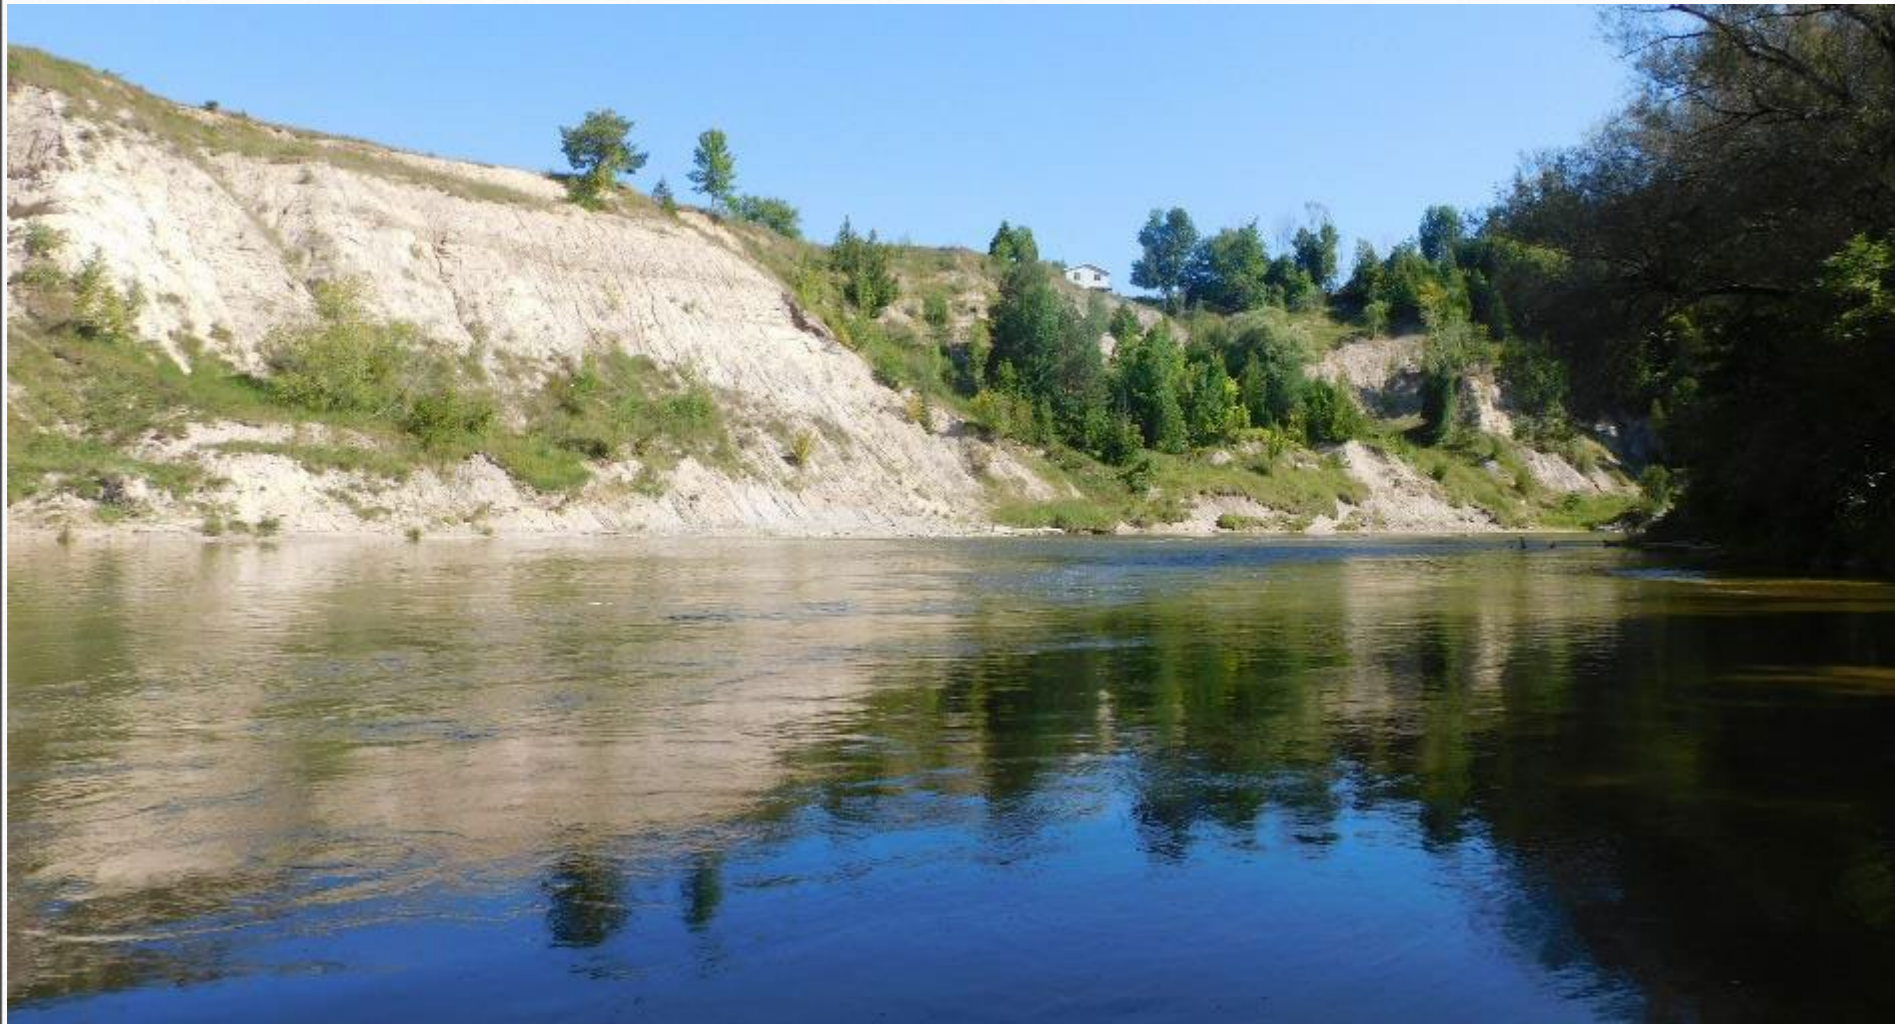
Site photos (Sept. 2021)

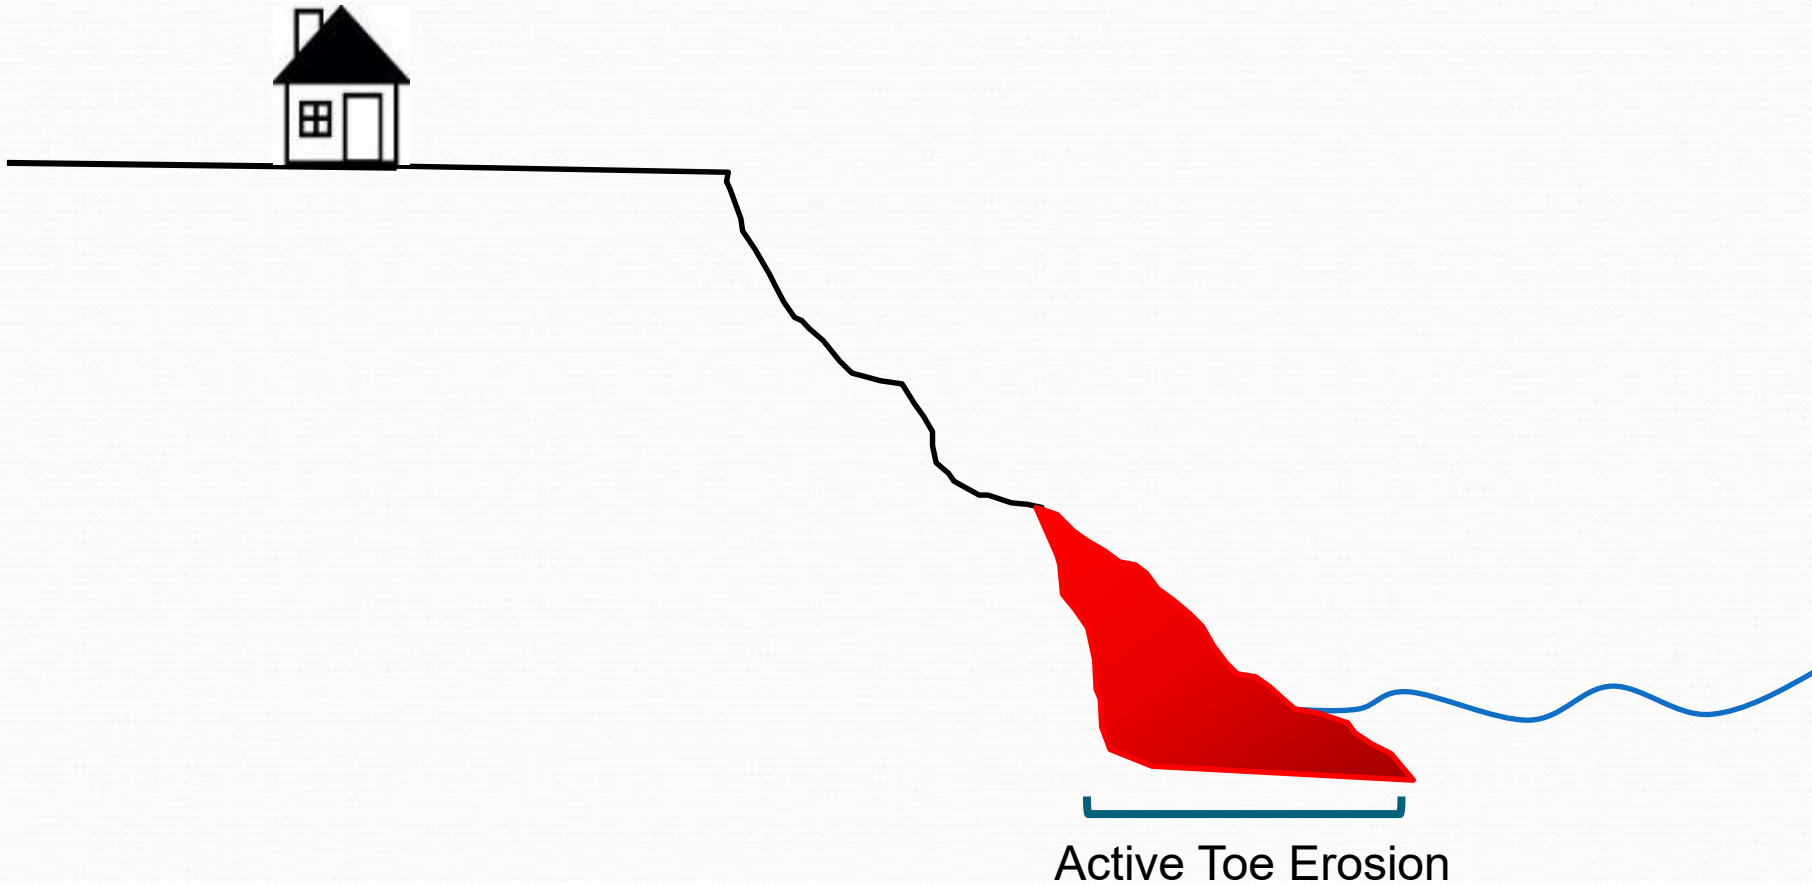
Erosion progression

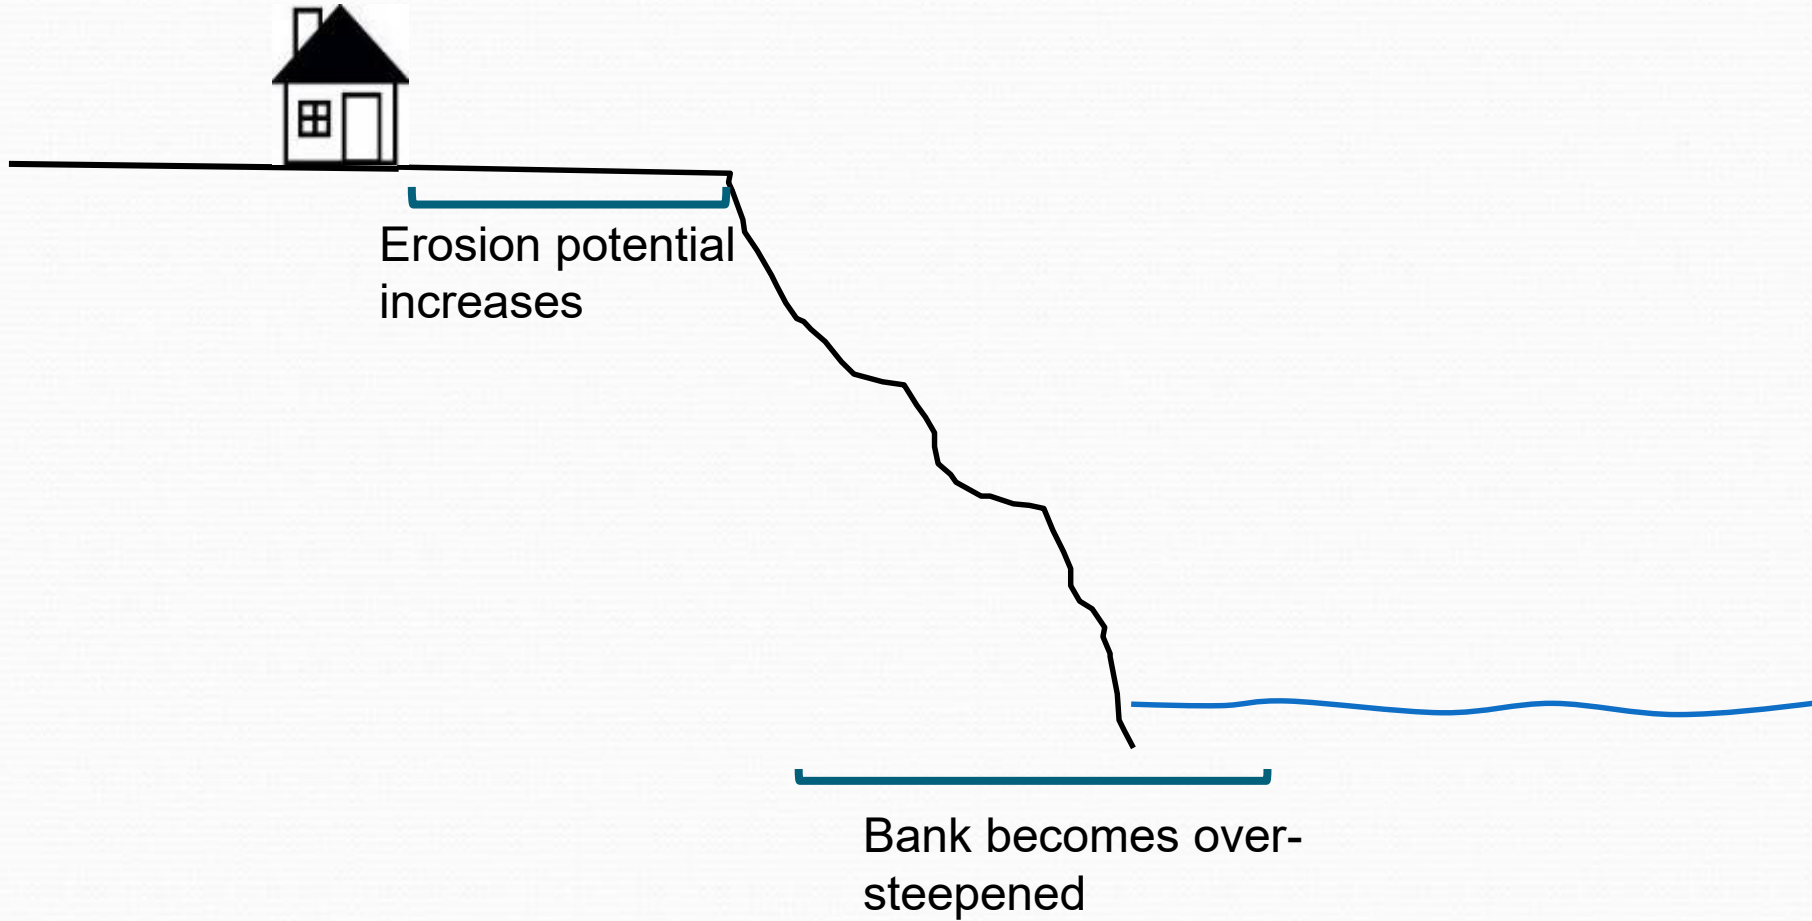
Bank is over-steepened

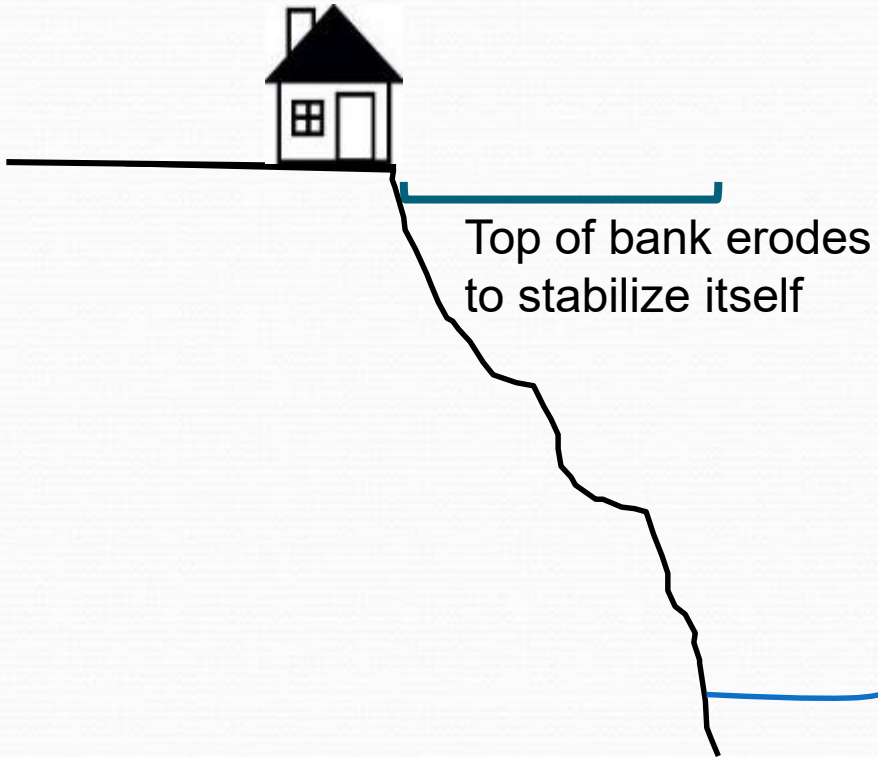
Top of bank fails

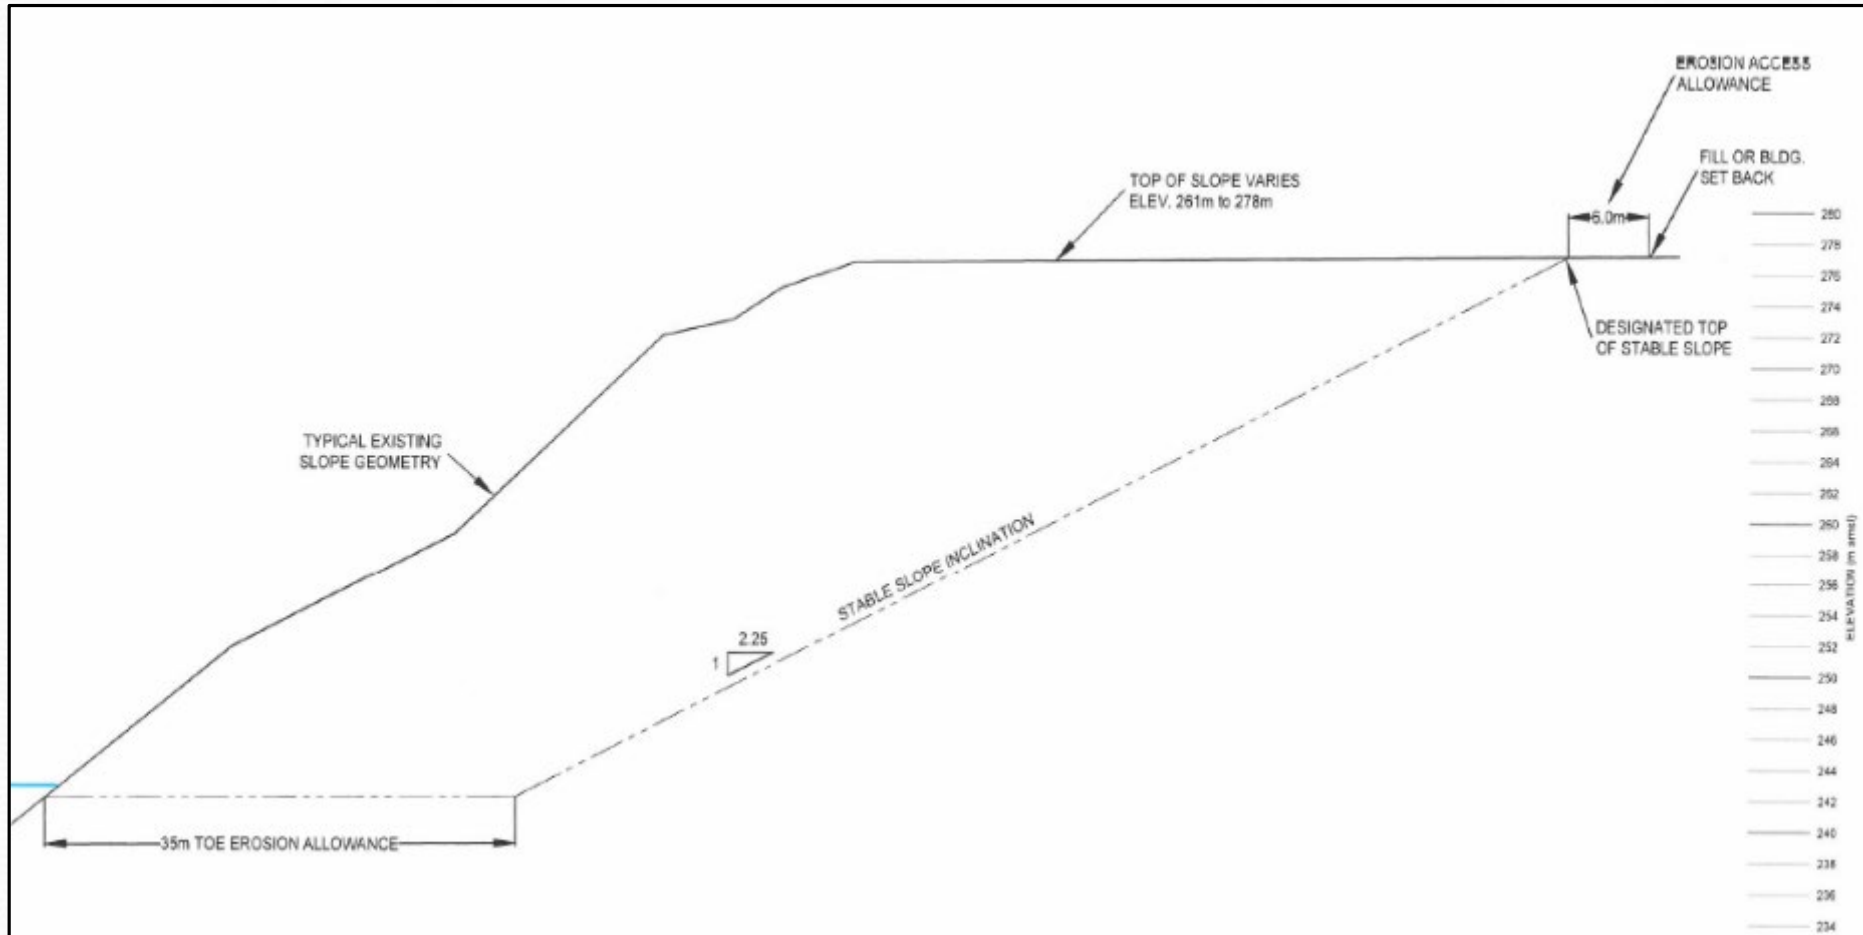
Long term erosion hazard limit

- Using the MNR slope stability guidelines – toe erosion allowance + stable slope + erosion access allowance

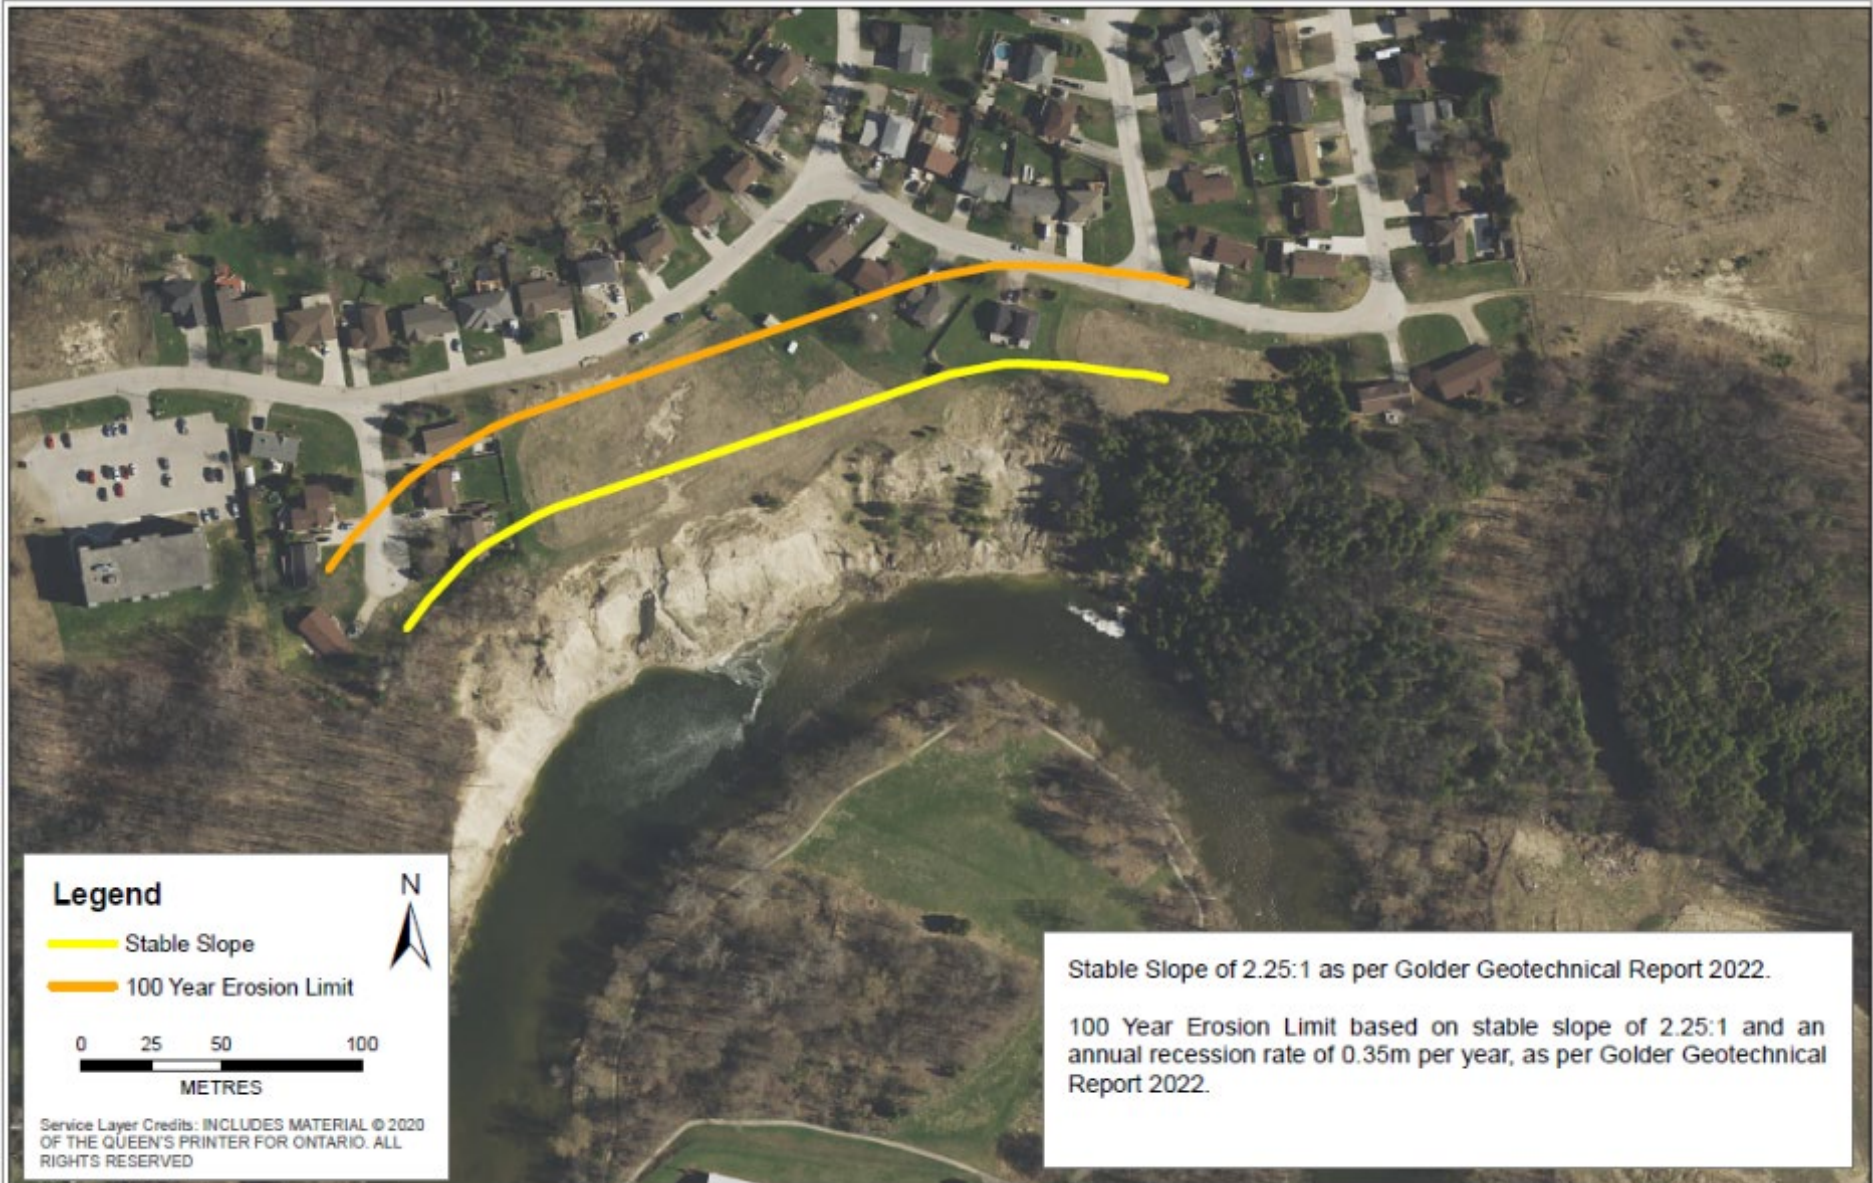
100 year recession limit

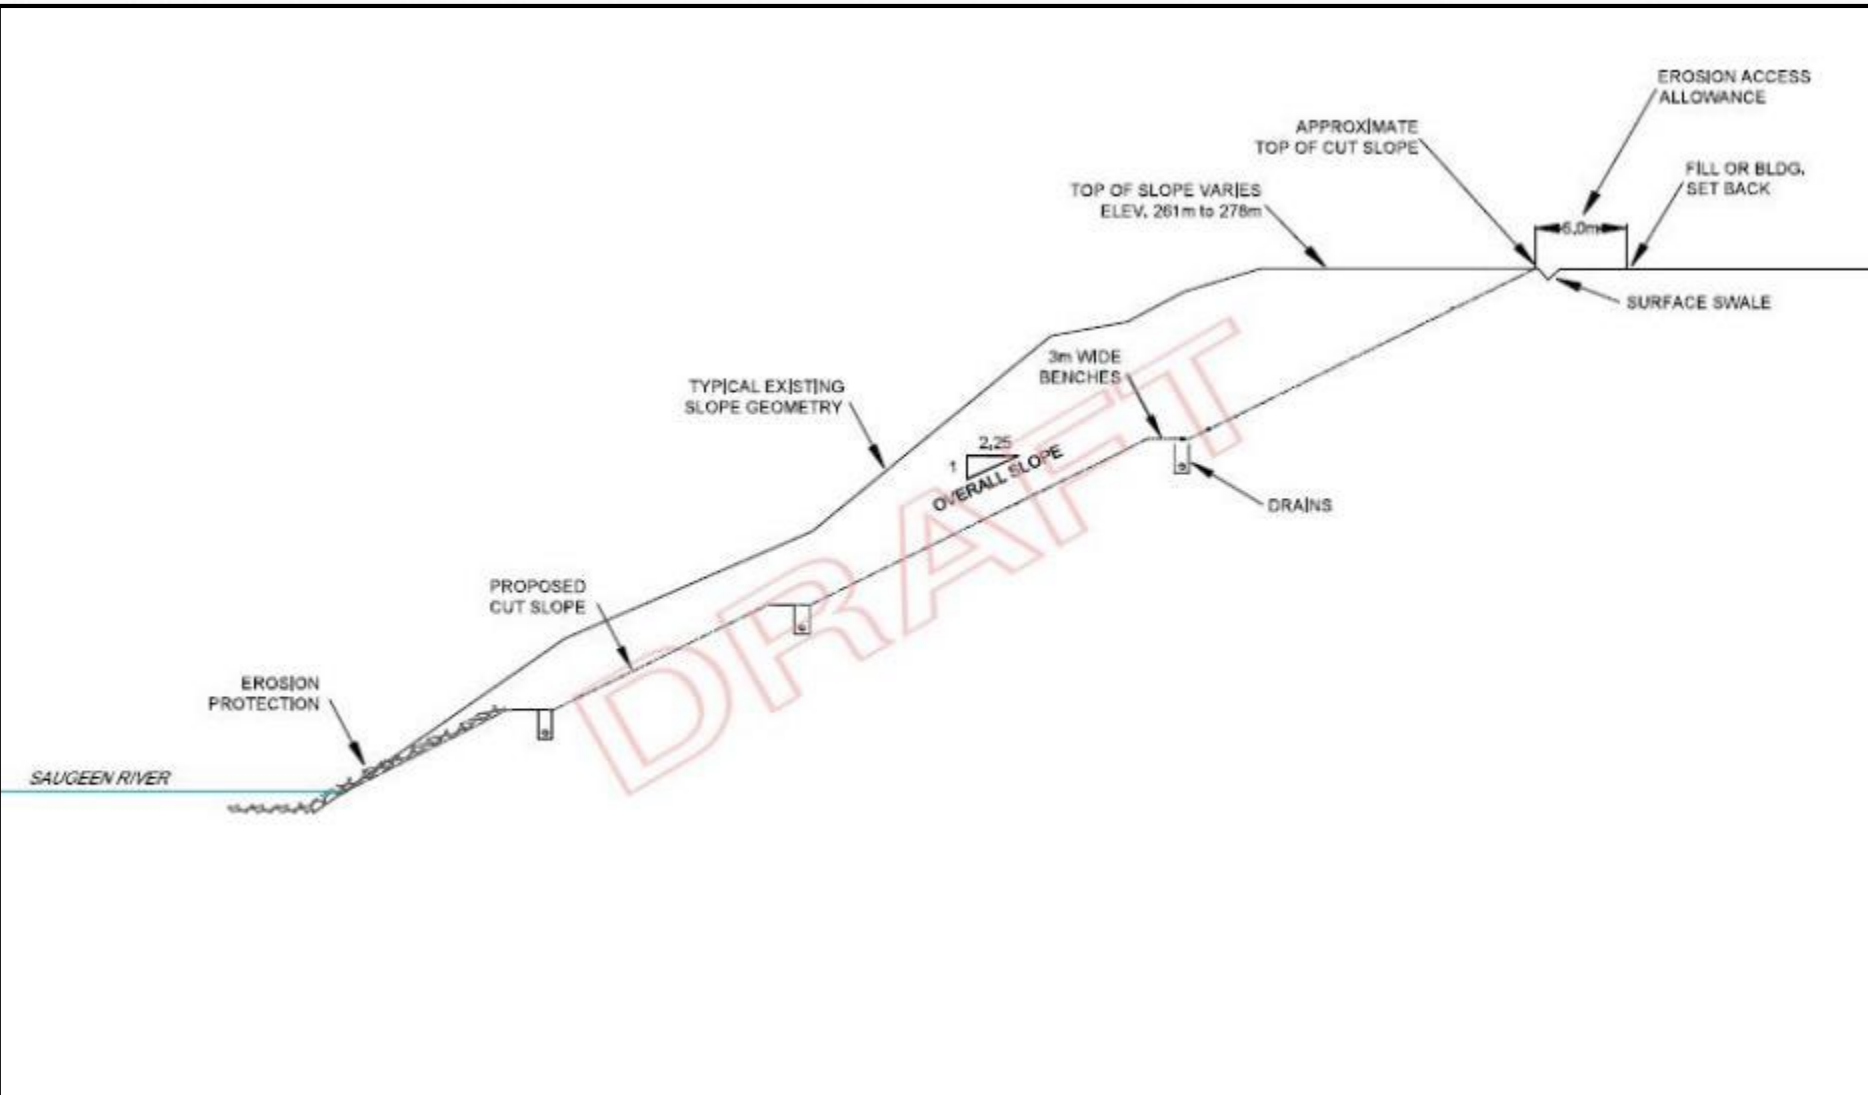
Erosion protection & regrade slope by cutting

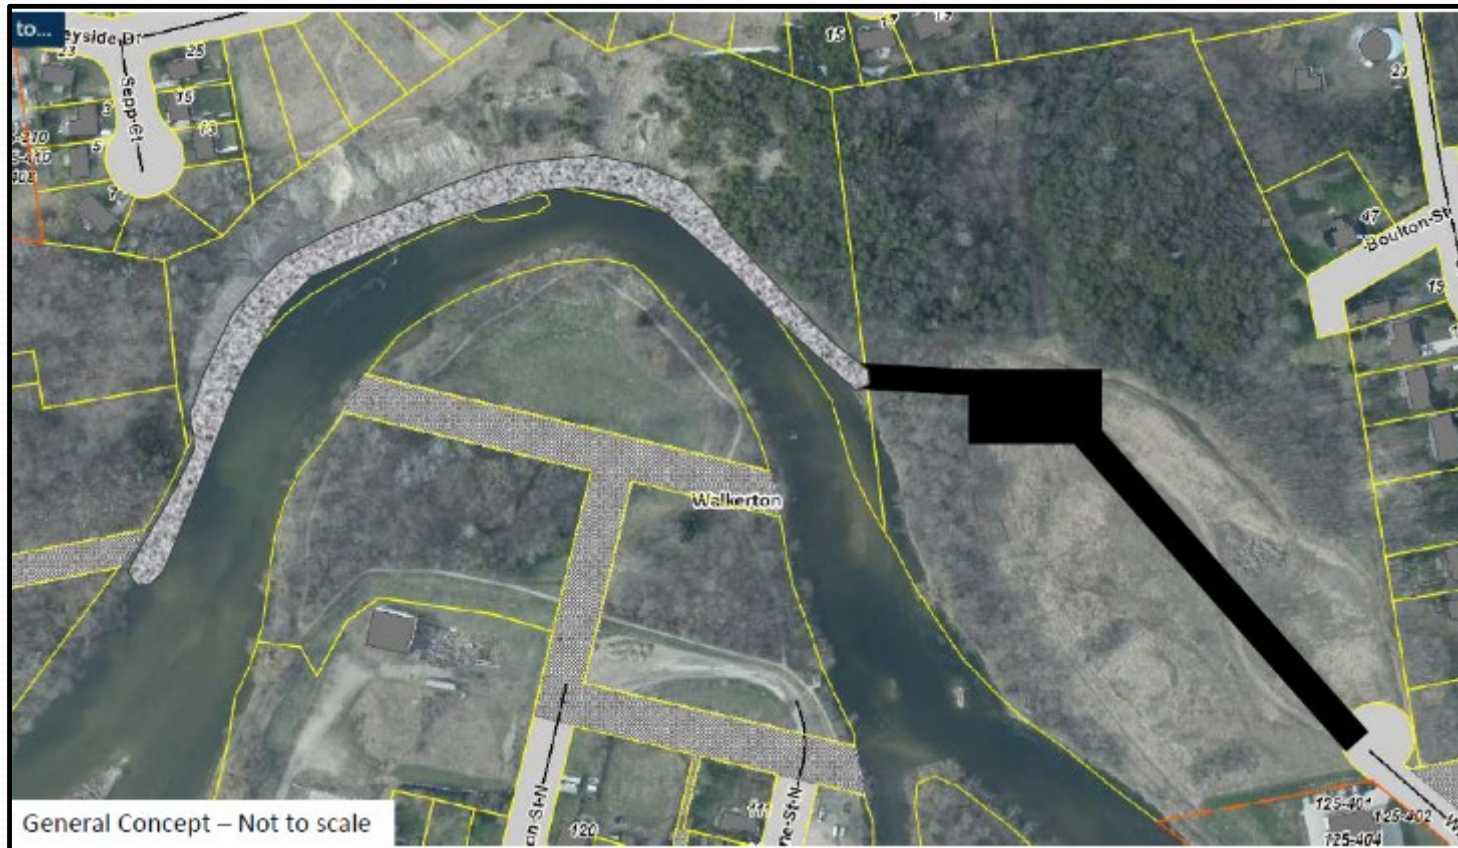
Site Access

- Construction access is difficult due to steep bank and river
- Access from top is very expensive and from west would result in tree removal – route from east is preferred

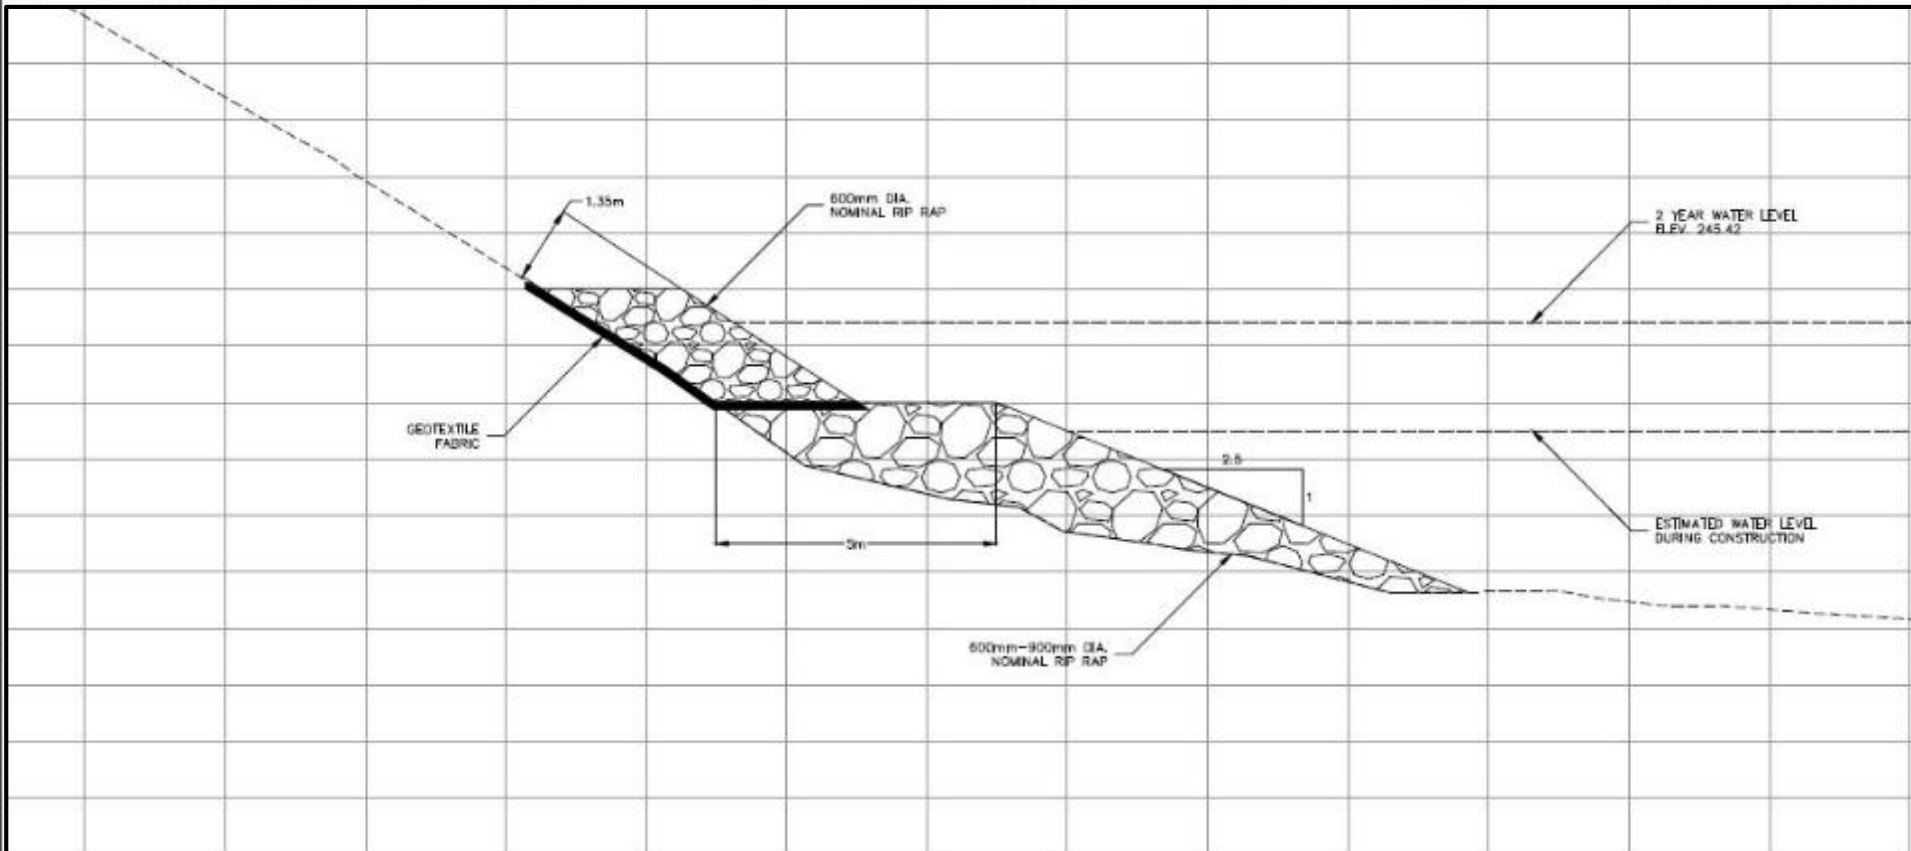
Cross-section of toe protection

SCALE - 1:75

Alternative 4 – Protect Toe and Leave Slope As Is

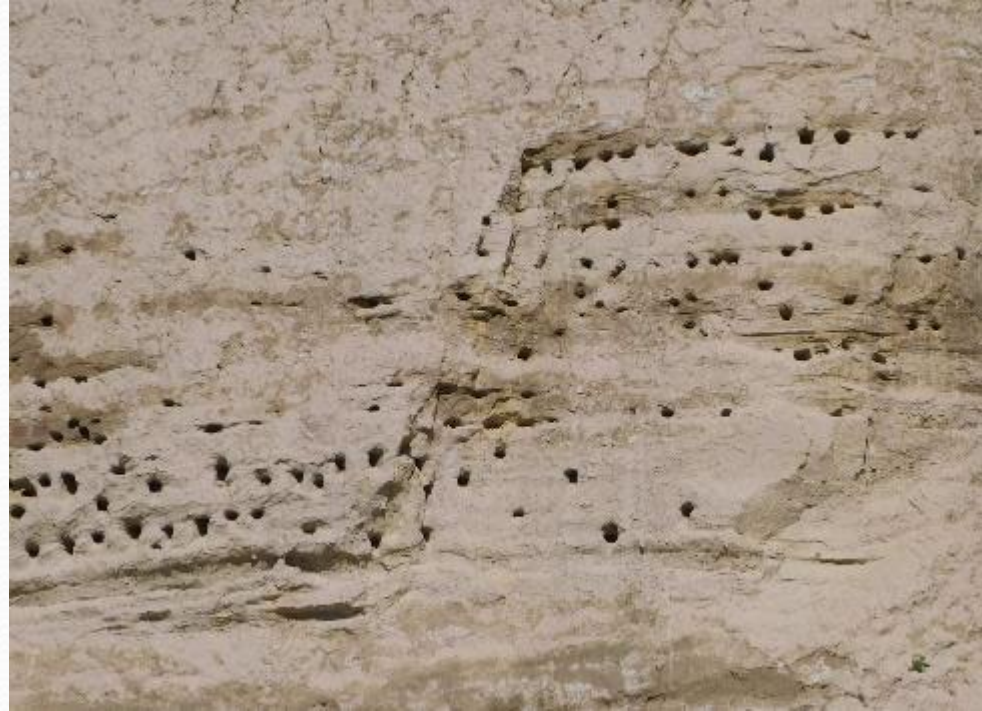
Bank Swallow nesting habitat
