COUNTY OF BRUCE

CLASS ENVIRONMENTAL ASSESSMENT DURHAM STREET BRIDGE REPLACEMENT

**PUBLIC INFORMATION MEETING
OCTOBER 4, 2022**

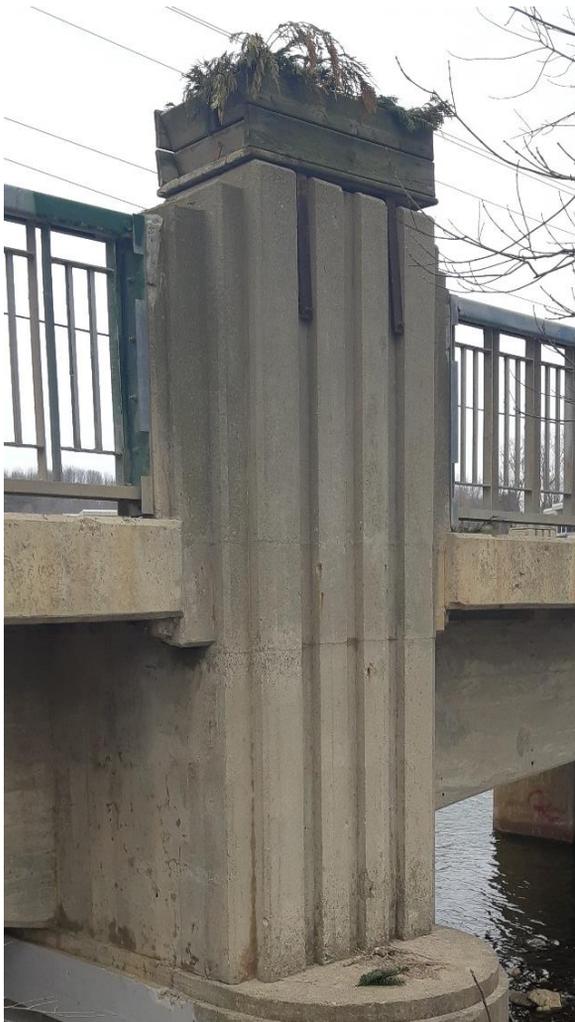
Exterior view of stanchion/pillar with embossed detailing

➤ CONCRETE RIGID FRAME T-BEAM DESIGN

“The bridge is a rare example of what was once a common concrete rigid frame T-beam bridge design with embossed stanchions/pillars and cantilevered end spans associated with late 1930’s provincial bridge construction”

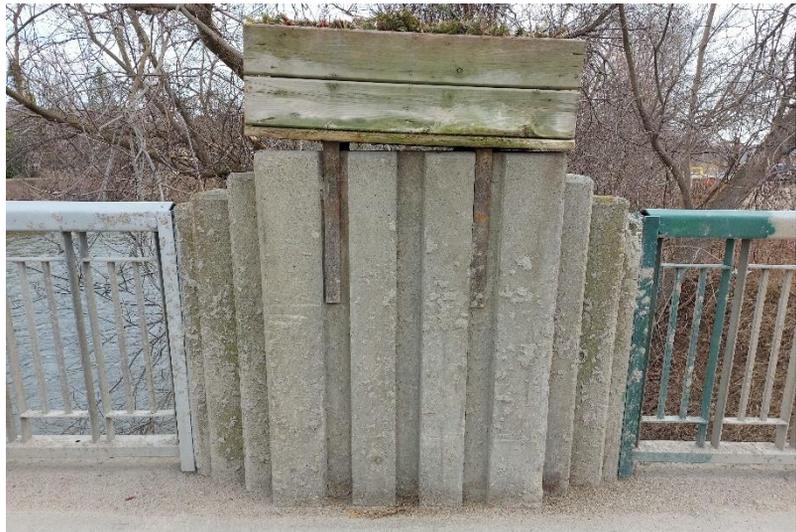
Interior view of stanchion/pillar with embossed detailing

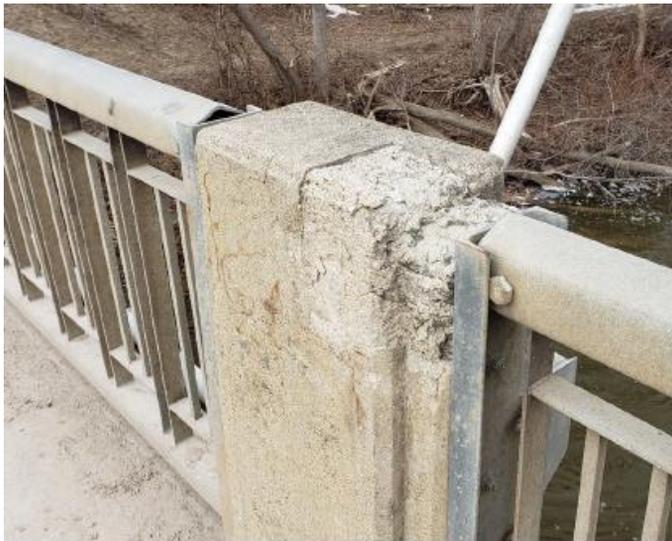
POST DETERIORATION

- AGE; CONSTRUCTED IN 1937 – 85 YEARS
- RECOMMENDED FOR REPLACEMENT BY PROVINCE DUE TO CONCERNS WITH DROP-IN SPAN HALF JOINTS
- CONCRETE DETERIORATION

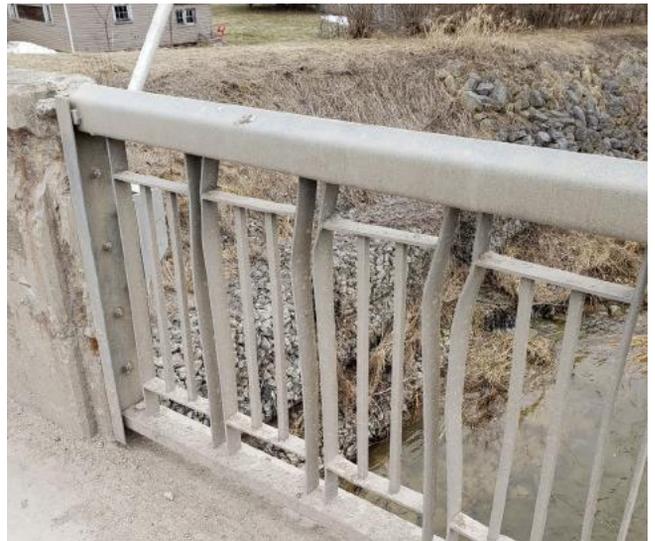
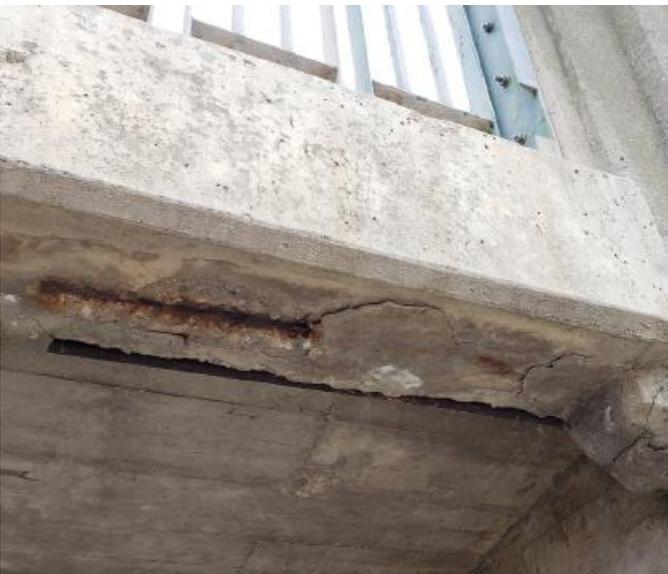
RAILING DAMAGE

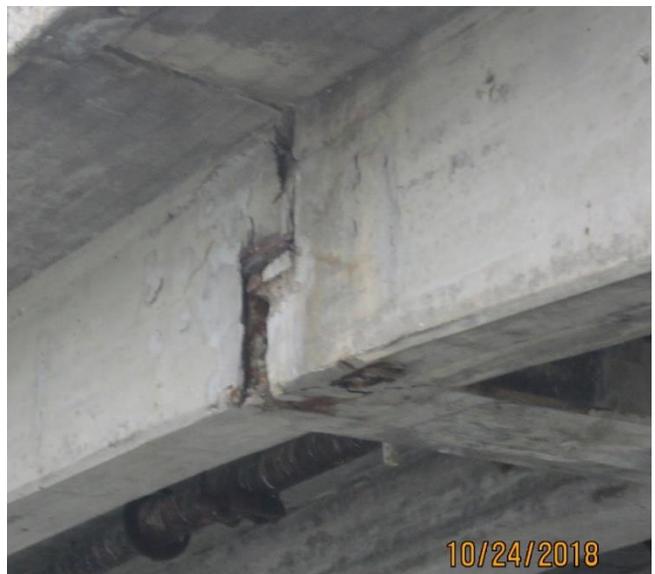
SOFFIT DETERIORATION

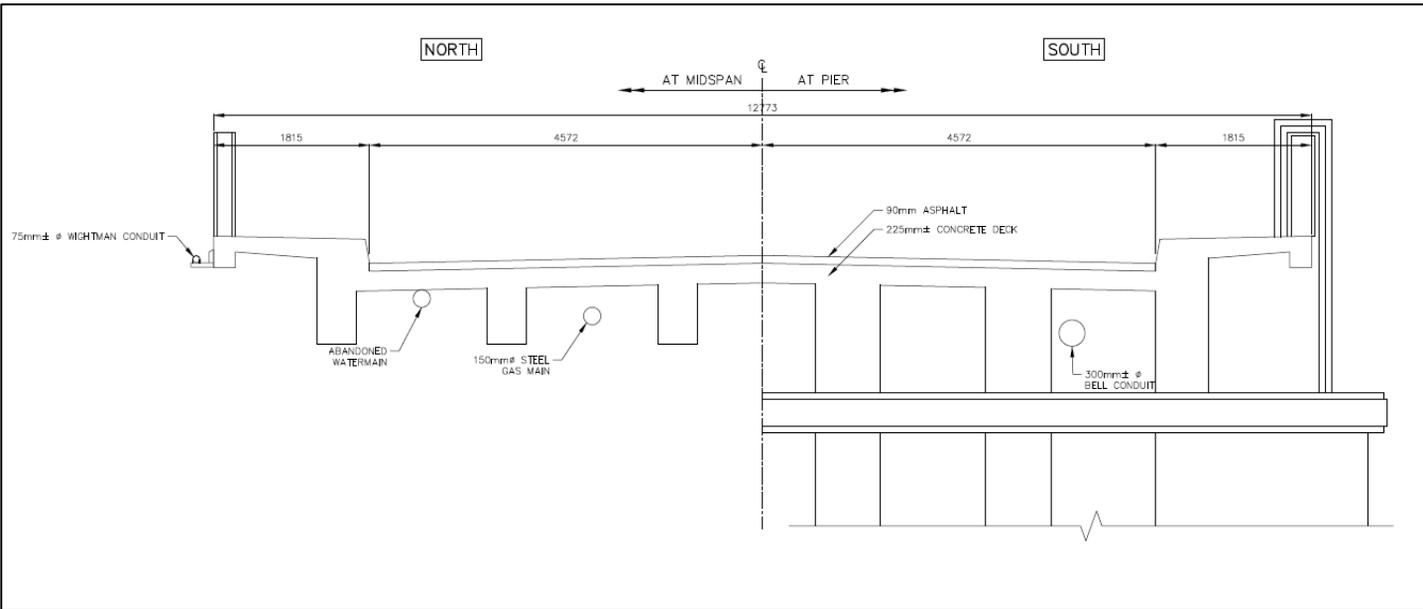
Existing Deck Section

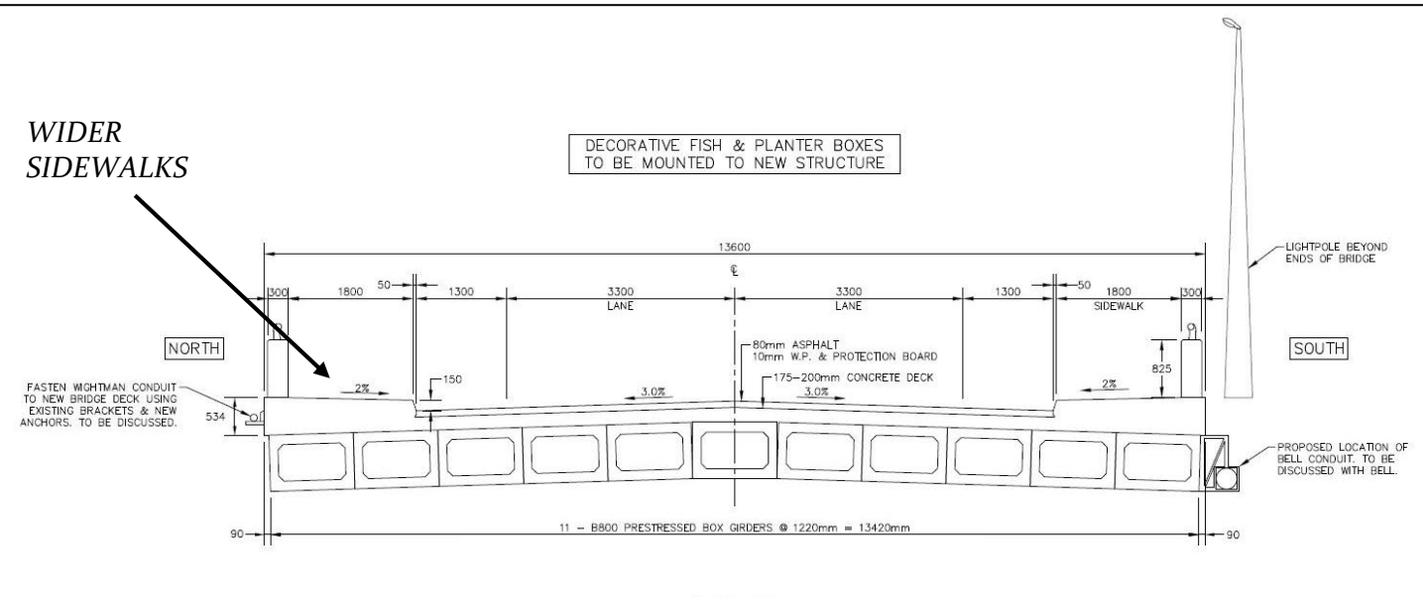
Proposed Deck Section

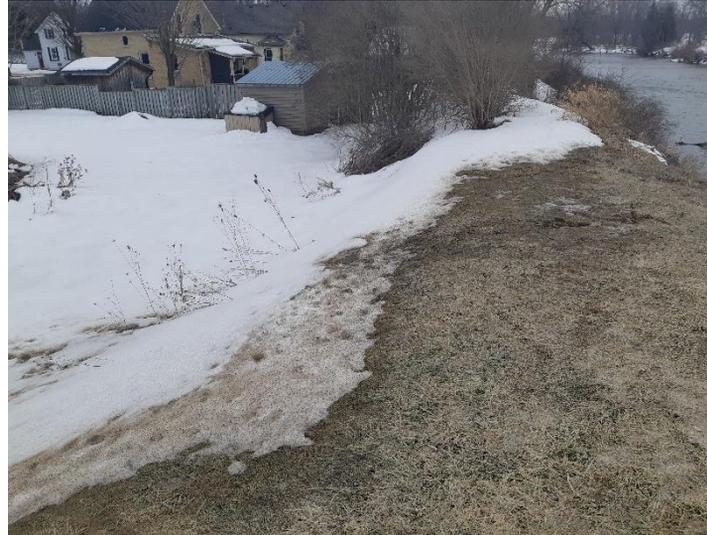
Flood control dyke adjacent to east bank

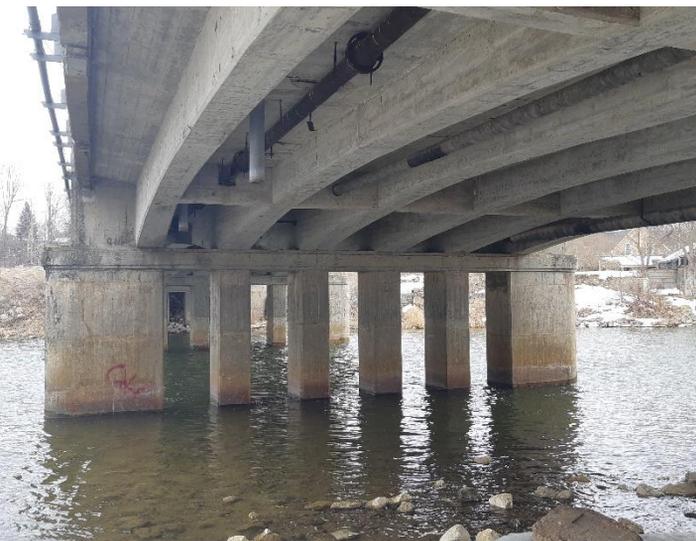
Bridge underside showing utilities

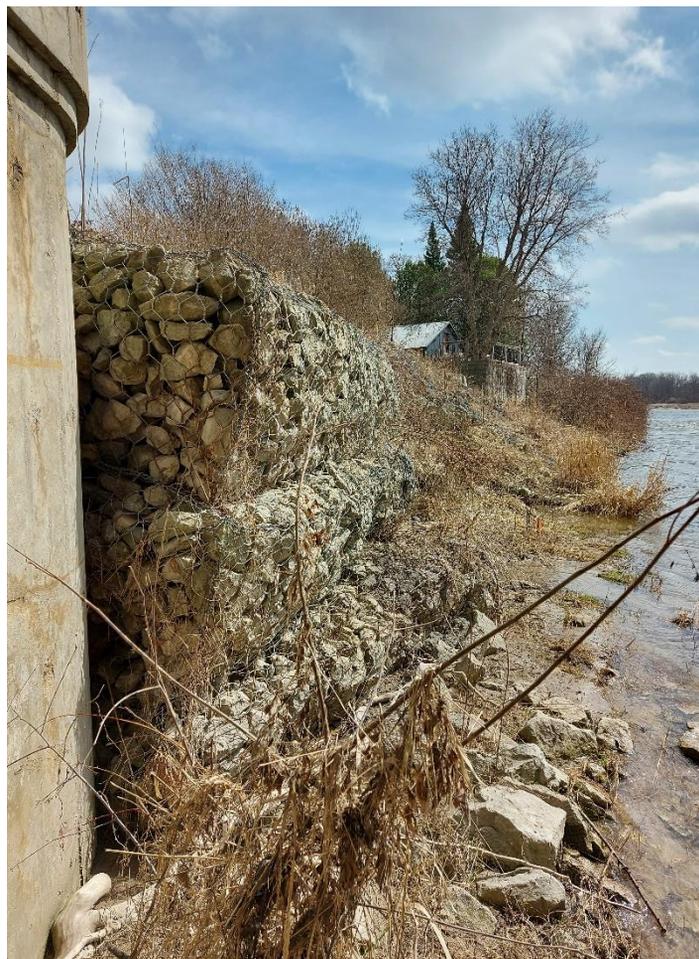
Gabion basket erosion protection
