# Brockton Multi-Use Recreation / Municipal Office Complex Project

## Report to the Project Management Committee Walkerton Community Centre Assessment

PRISM Partners Inc.

6/18/2014

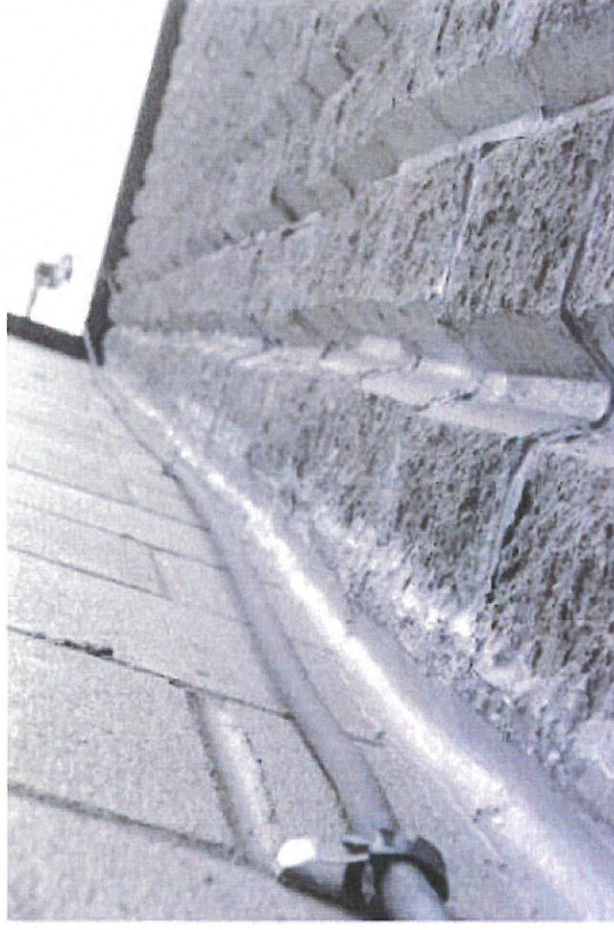
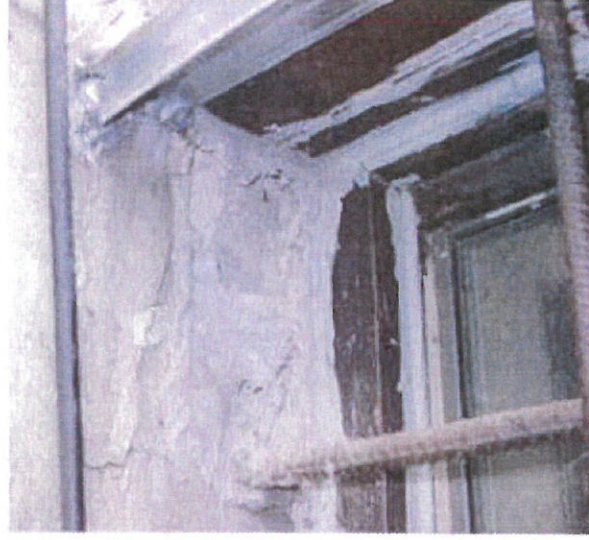
- The improper drainage created premature corrosion of the block wall, and windows resulting in irreversible water damage to the offices and interior of the building

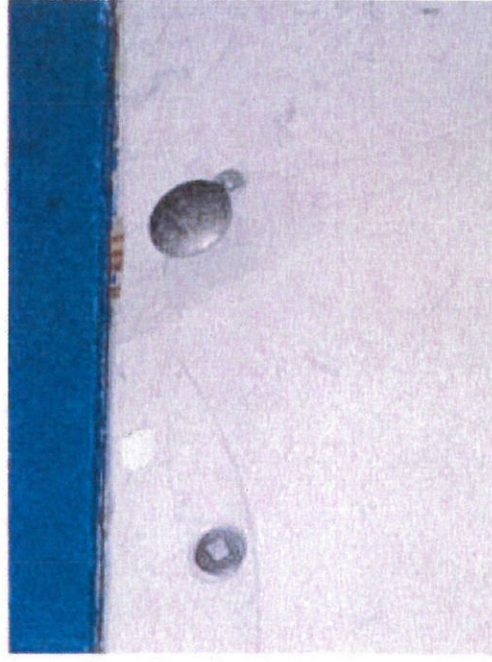
- Arena Dasher Boards and Gates, Player Benches
- The original board and gate system was installed in 1972, and later renovated by covering the existing plywood with 1/4" poly puck board
- The plywood backing had deteriorated and sandwiched together with carriage bolts to the wooden supports
- the original gates latches were worn and insecure resulting in gates opening during play
- Visiting teams expressed concerns for player safety

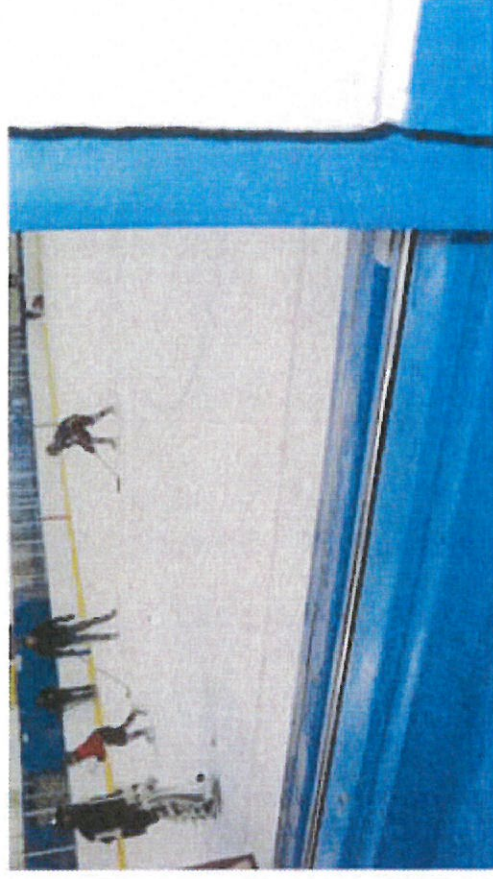
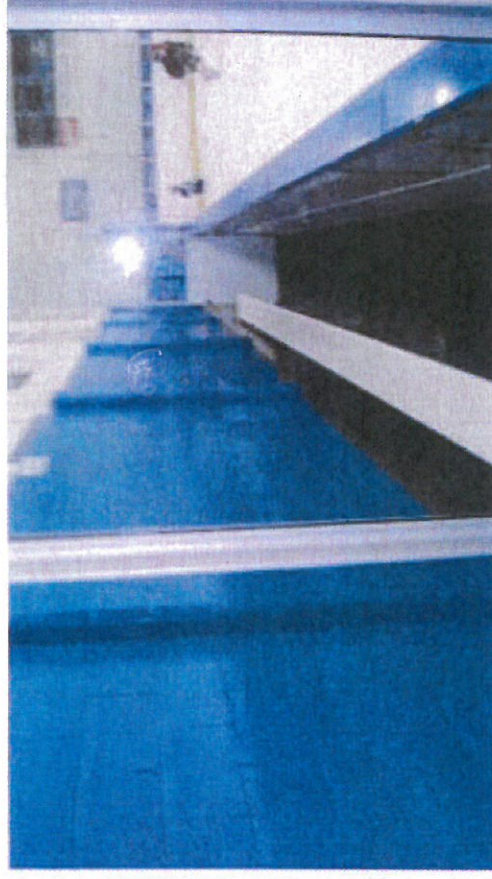
- A new Aluminum, removable, ProRink 181 ft x 81ft , 20 ft. radius dasher board system was installed with quick release removable sections for special events
- New gates and hardware were installed to ensure safe operations and security during activities
- The board height was adjusted to 48", slightly lower than the original boards to meet ORFA standards and were more conducive to spectators viewing in the lobby area
- New player and penalty benches, and timekeepers benches added , complete with coaches walkway, and critical access to the penalty boxes from the time keepers area.

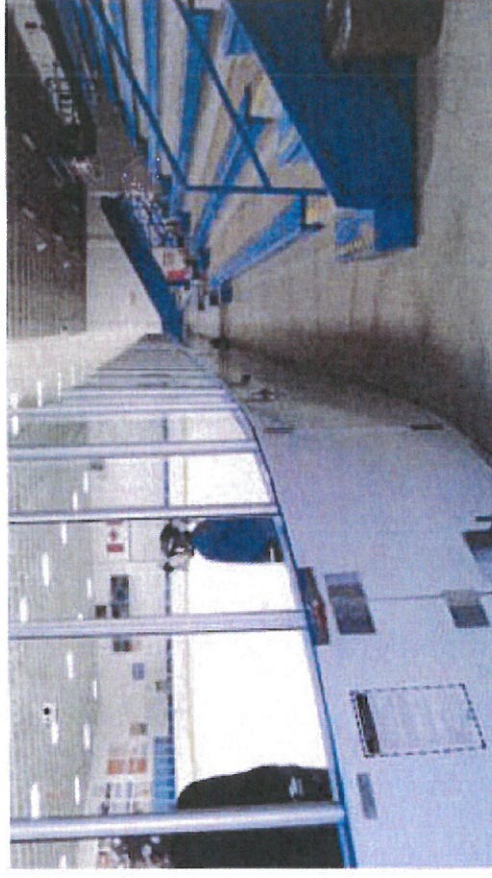
- Original 4' and 5' tempered glass was replaced with 5' and 6' foot 1/2" tempered glass with quick release supports
- The glass, players benches, and gates were brought up to ORFA Specifications for player safety
- The Aluminum board sections, gates and glass are all removable for future use
- The cost for the total Dasher board system was approx. \$ 135,000.00

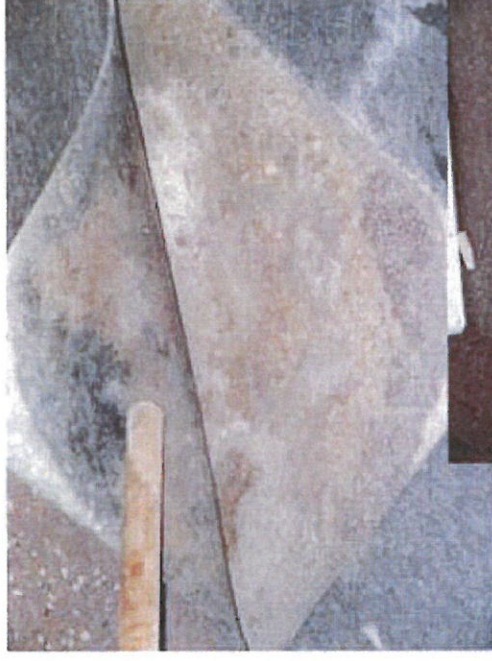
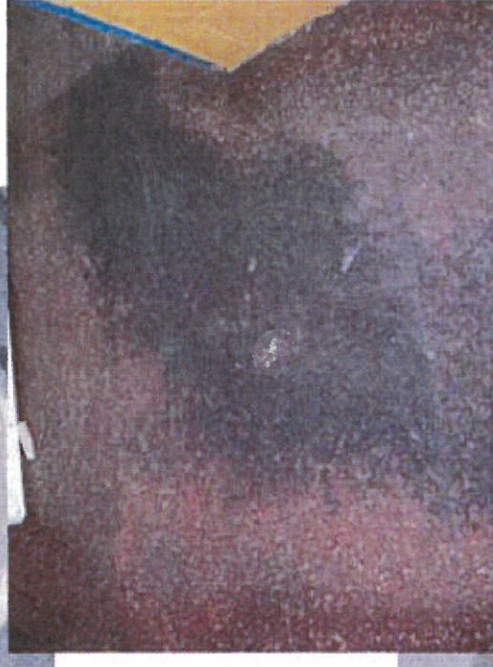
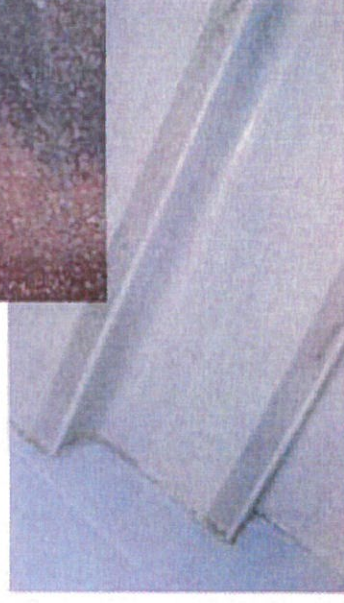
- 6,500 sq. ft of Johnson's resilient Rubber Flooring was installed, throughout the facility, front to back
- The existing flooring was worn through to the concrete in many areas and extremely difficult to maintain
- Many sections were loose with moisture trapped under the tiles creating mold and mildew concerns
- New flooring with nonslip stair treads, and visually enhanced steps were added for patron safety and visually impaired at the front entrance

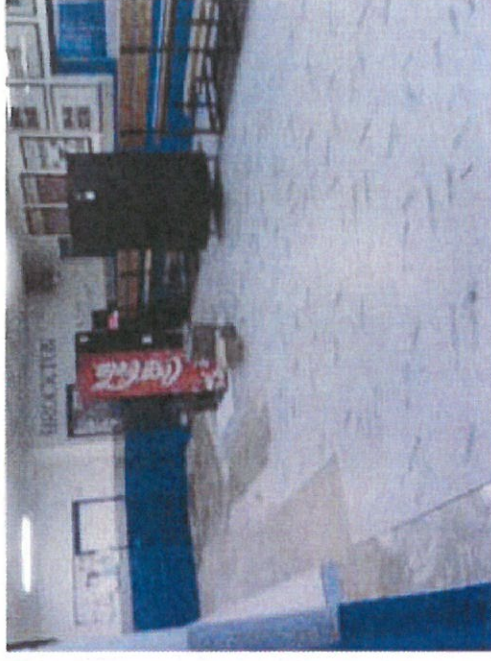
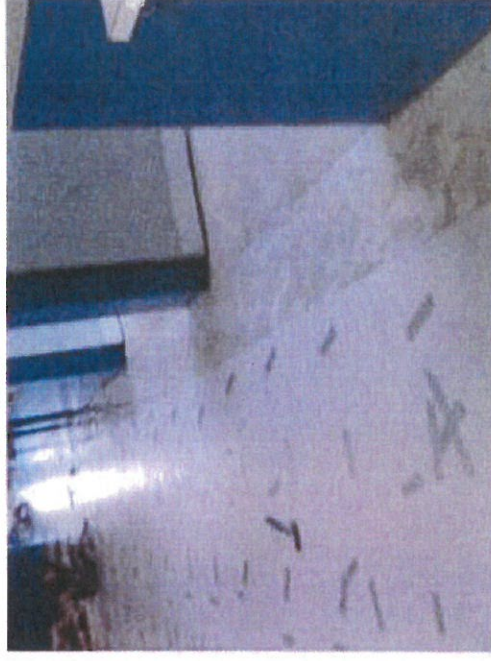
- Rubber flooring was installed throughout the entire facility.
- Patrons can move easily throughout the dressing rooms, lobby, players benches without damaging skates, while providing a seamless finish easy to maintain
- The grade of rubber flooring was carefully selected considering the life expectancy of the building and possible future uses
- The approx. cost for the rubber flooring was \$ 78,000.00.

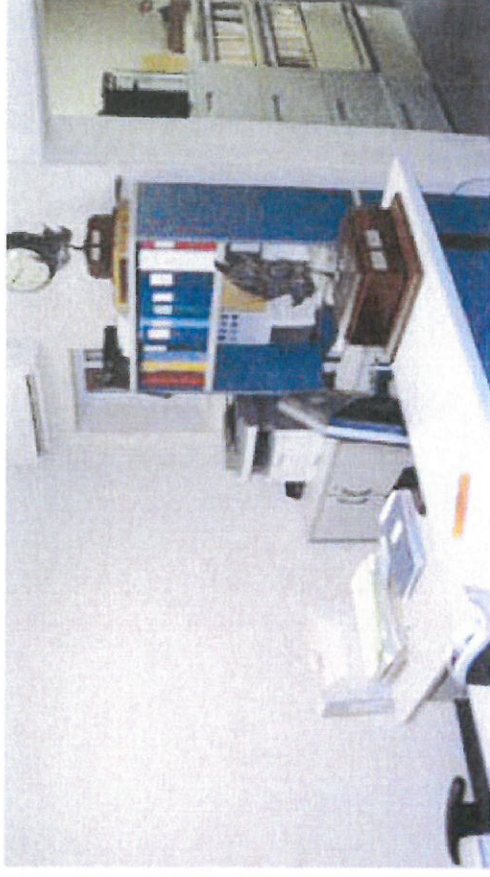
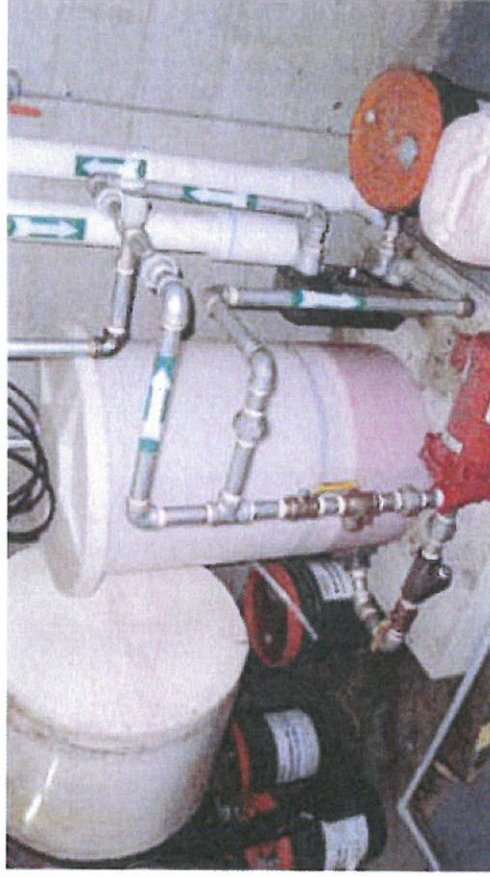
- A glycol cooling system was added to the refrigeration system resulting in 60 % reduction in water consumption
- Office renovations, and drainage improvements along the west side of the community center, shower saver faucets, and added auditorium storage areas, and ceiling tiles were also realized with RINC funding.

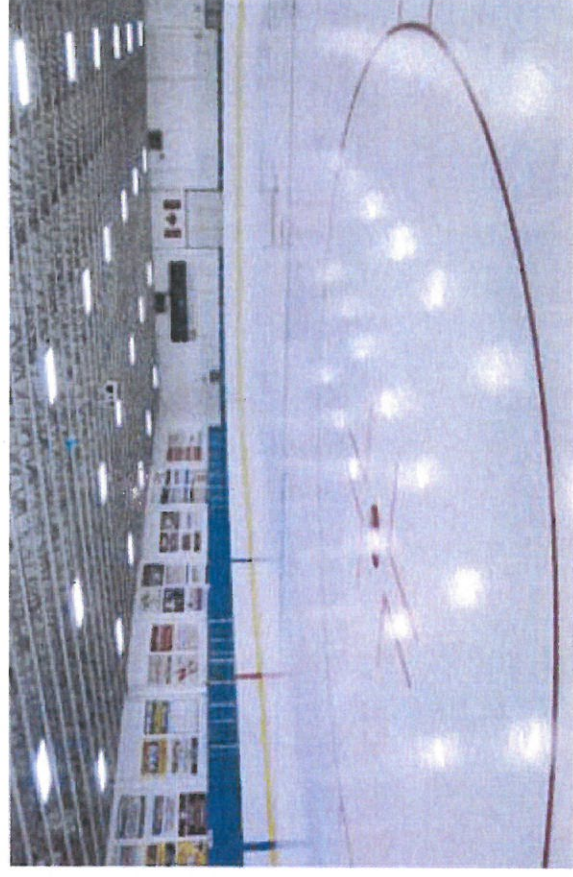
- The improvements to the Walkerton Community Center realized through government funding, will ensure a safe, and more energy efficient facility for the immediate future.
- RINC improvements also ensures the preservation of a valuable community asset for future use as a temporary second ice pad, or repurposing of the facility for future activities, or resale value
- RINC funding did not address existing structural or design deficiencies

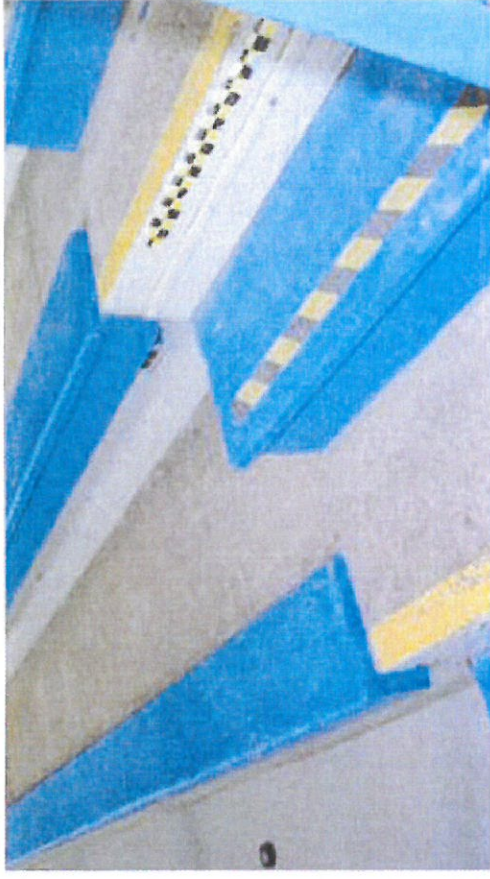
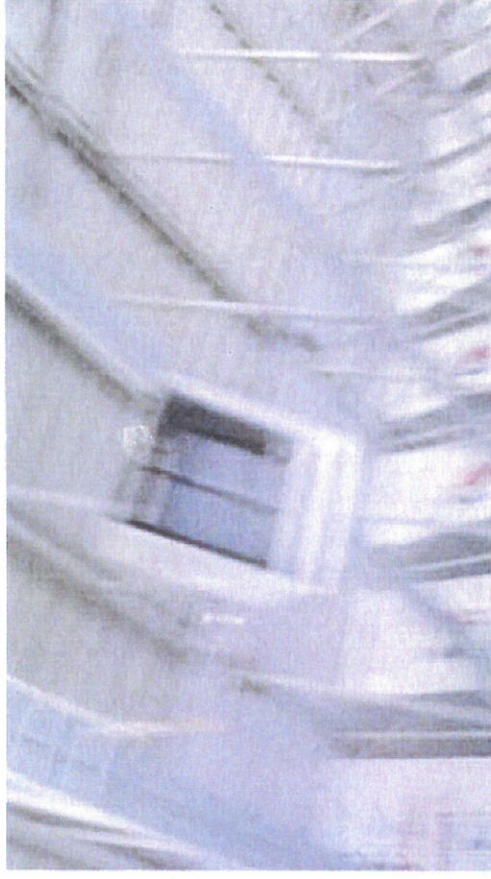
- Steps risers at the Community Center vary in height creating a Health and Safety Factor
- The wooden benches also create a trip hazard
- The spectator seating is also not conducive to persons with limited mobility
- Gas radiant heaters in the spectator area are not energy efficient, and could be replaced with in-floor heating generated by the refrigeration plant...

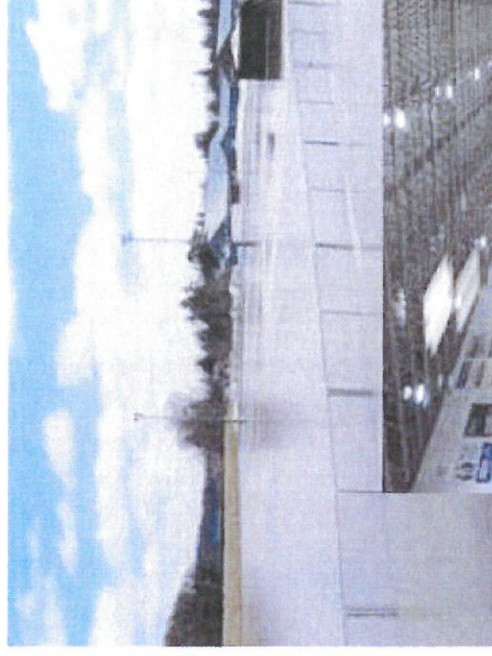
- The Community Center is built in a regulated area subject to potential flooding
- The Saugeen Valley Conservation Authority regulates the size and types of buildings that can be constructed in these regulated areas
- The SVCA would also be involved with any alterations, or additions to the existing structure
- It is anticipated that any alternations to the existing elevations would require additional engineering, architectural, and construction costs.
- The Community Center is also identified as an Emergency Evacuation Area/Warming Center in the Emergency Response Plan

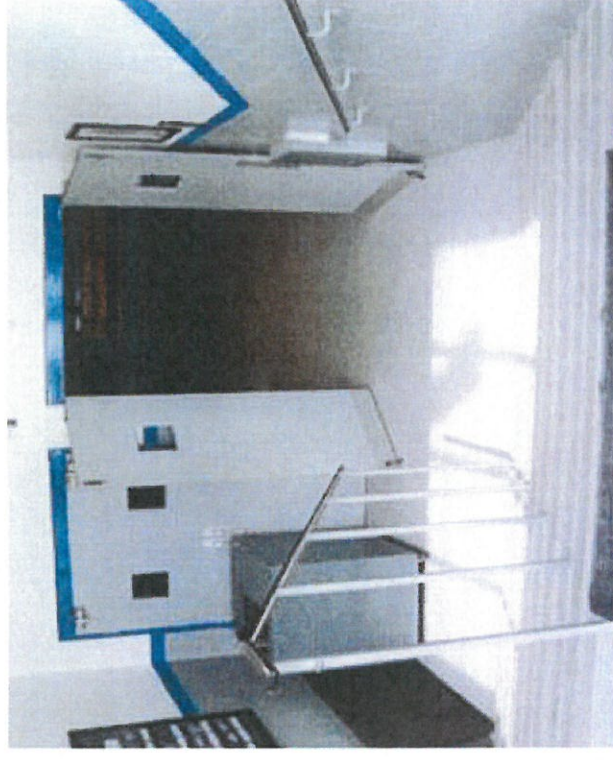
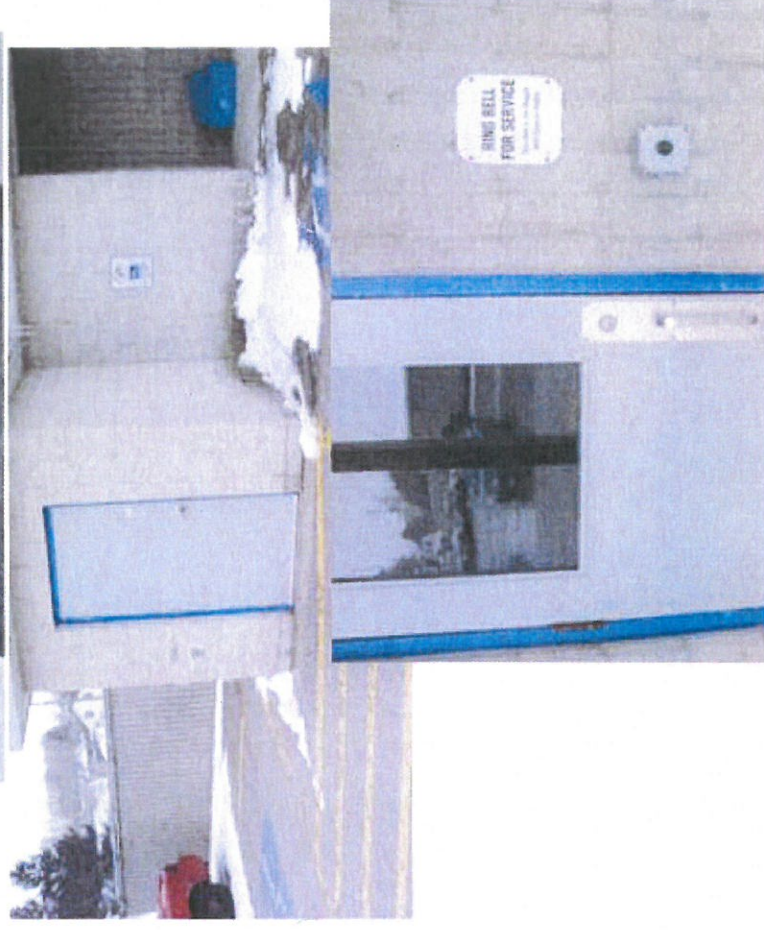
- Accessibility is a concern
- The only entrance accessible entrance without stairs at the east side of the Community Center
- The "Lift" requires staff assistance to gain access
- Form inside, patrons must leave the building to gains access to the elevator

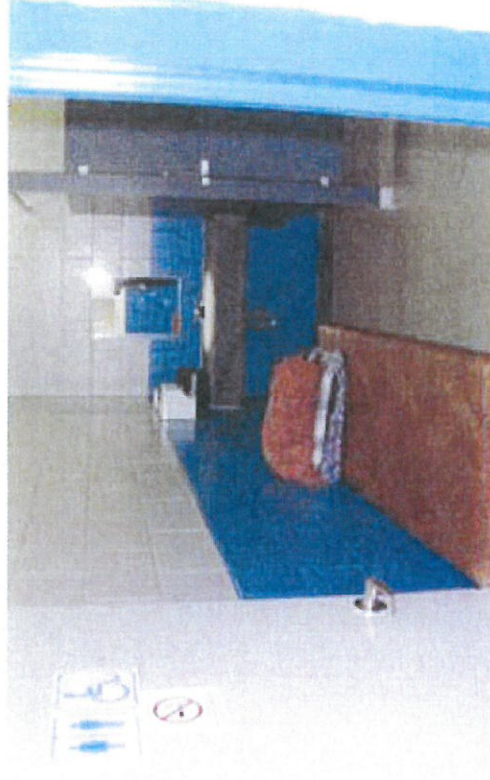
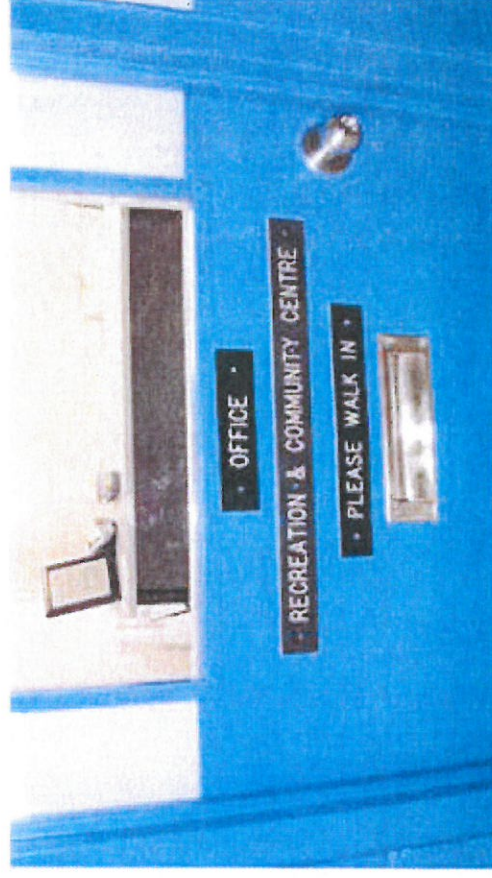
- There is one barrier free washroom located on the lower level near the east entrance
- This room doubles as a coaches change room, first Aid room, girls change room, and referees room on occasion.
- There is another Barrier Free washroom on the 2<sup>nd</sup> level
- It is questionable however, if the fixtures and counter tops are to acceptable standards

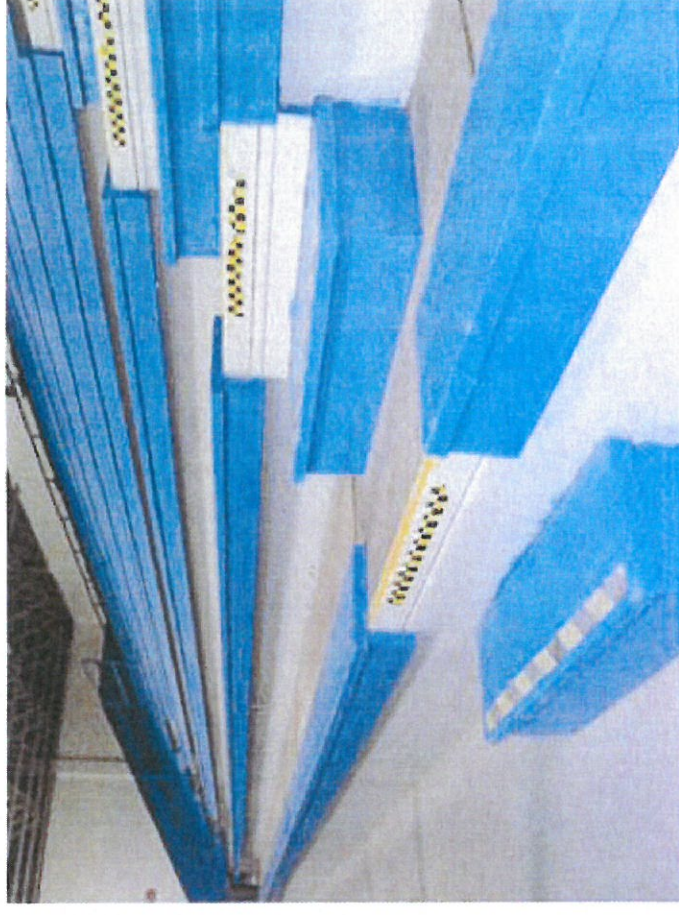
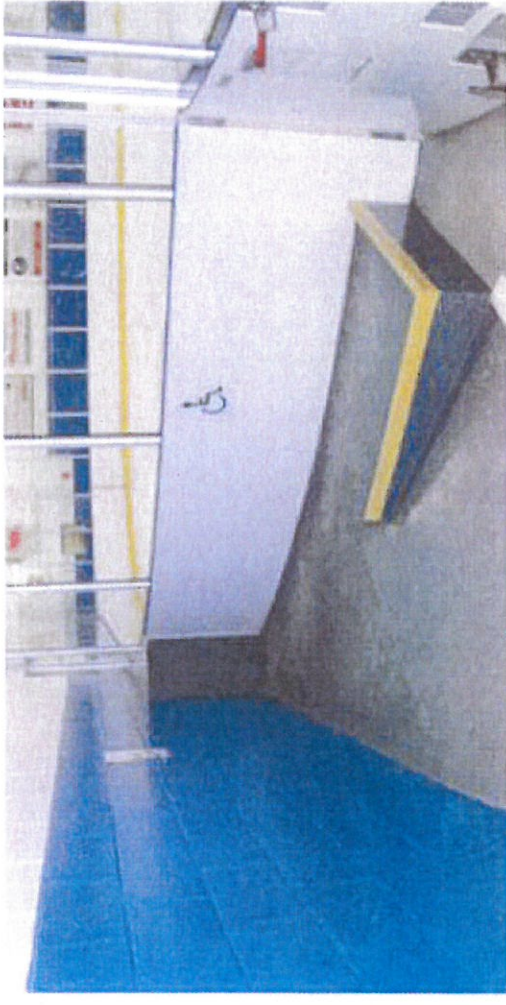
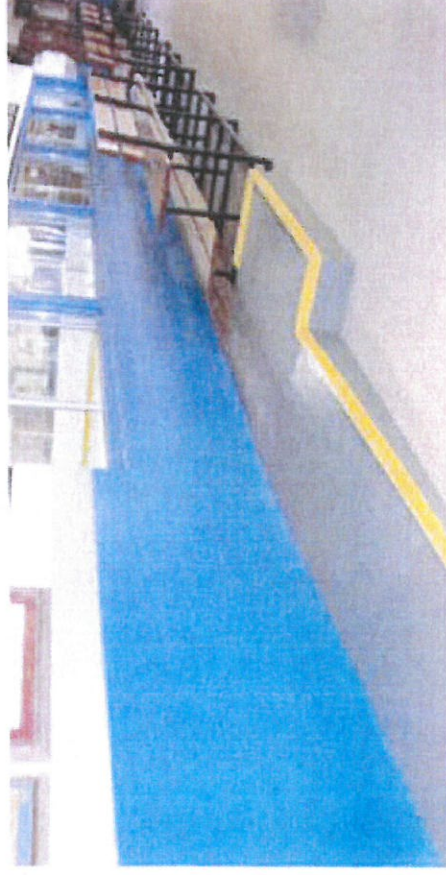
Other than the second level, there are only two viewing areas that are wheelchair accessible.

One is in the arena, and the other in the lobby. There is only one “unofficial” space in each area, typically occupied by able bodied persons.

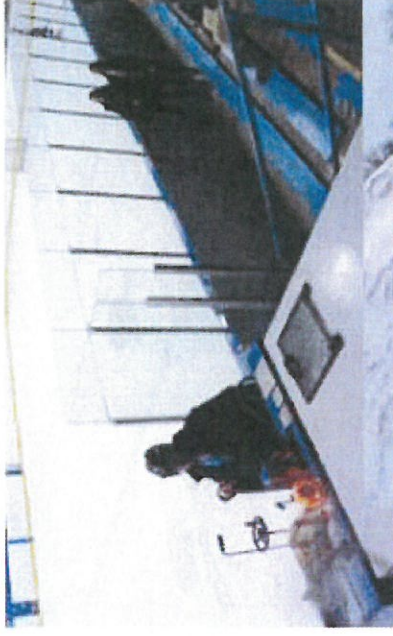
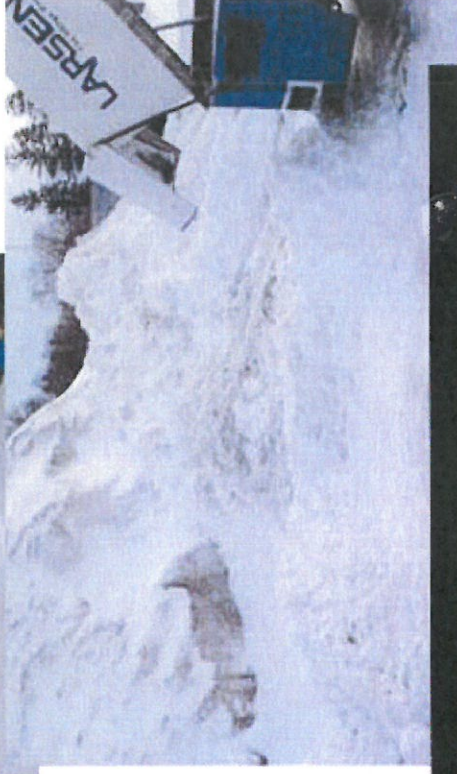
- The ice resurfacer is required to reverse on to the ice and exits the ice surface through heavy pedestrian traffic area in the spectator seating area
- There is also a concern when the ice resurface exits the building into the parking area, again through vehicular and pedestrian traffic
- Ice shavings from the ice Resurfacer are dumped outside through the parking lot area, which contain contaminants, such as blood or bodily fluids in the ice shavings are dumped outside

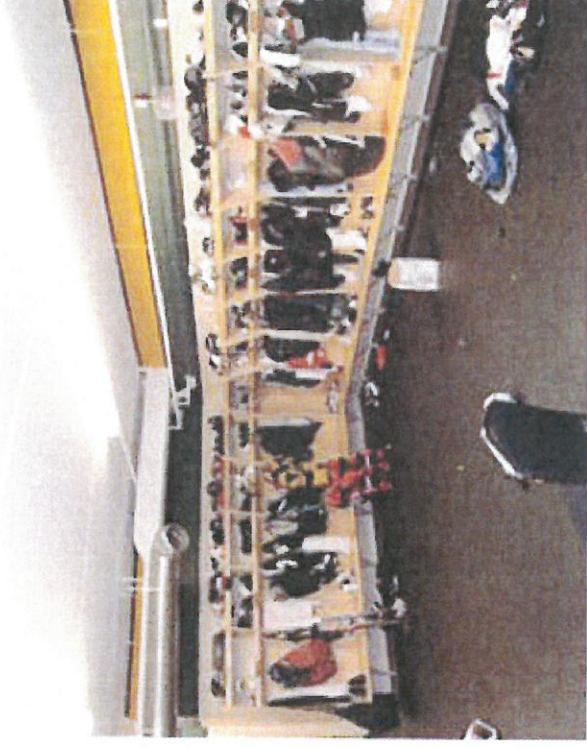
- There are 4 Dressing rooms, approx. 14 ft X 16", located in the front of the facility
- Rooms 5 and 6 were constructed in 1990's under the bleachers, and are typically used of the home teams
- The average dressing rooms for new facilities are closer to 30' x 40', with no blind spots and adequate showers, water closets and ventilation
- Width of the Hallways are unsafe in the event of Fire or emergency evacuation

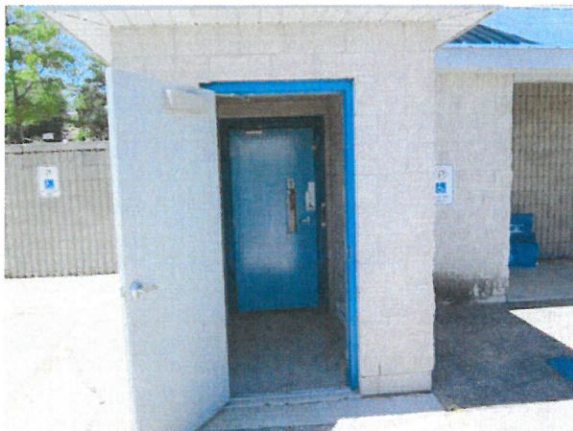
**Accessible Elevator**  
**(only accessible from exterior of building)**

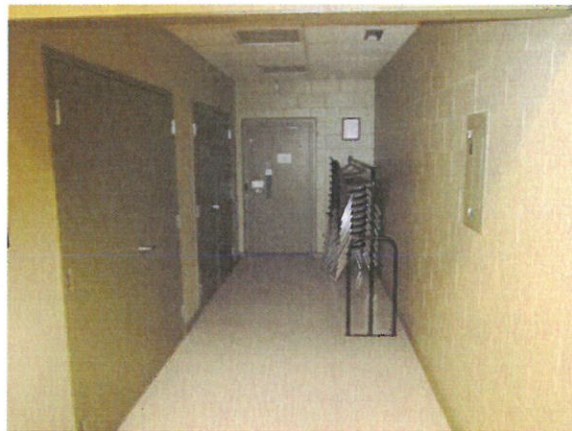
**Accessible Elevator**  
**(access to community hall used for storage)**

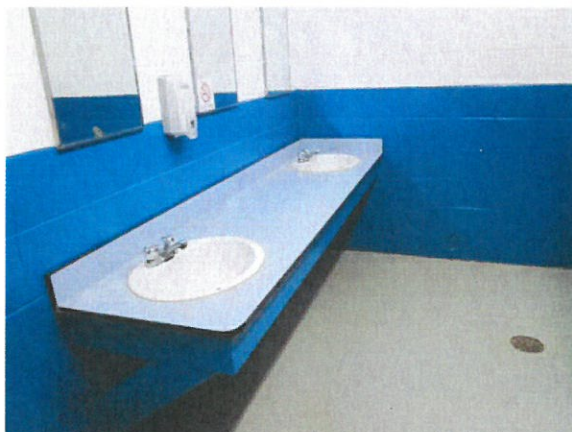
**Lower Level Male Washroom**  
**(no accessible sink)**

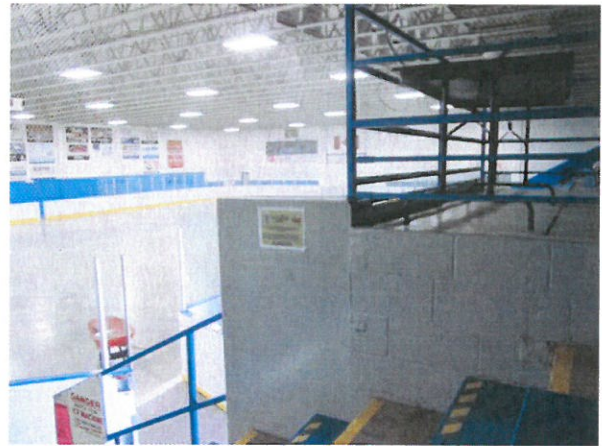
**Existing Bench Seating**

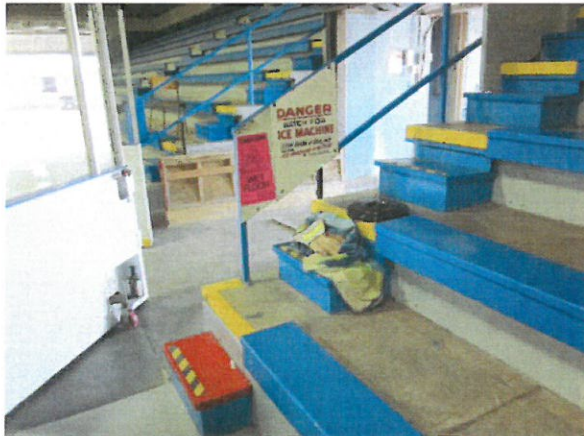
**Obstructed Seating**

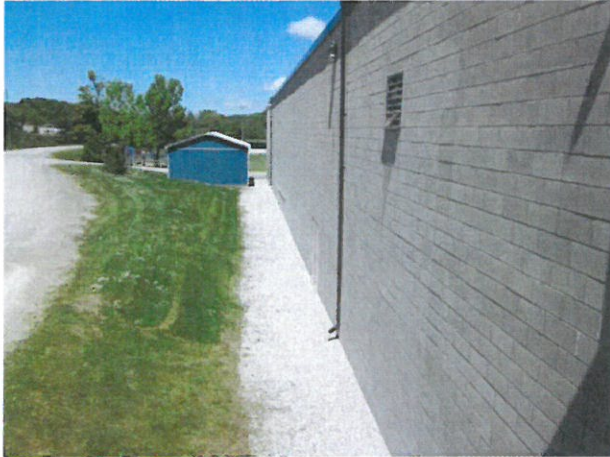
**West Wall of Arena and Elevated Ground Road**

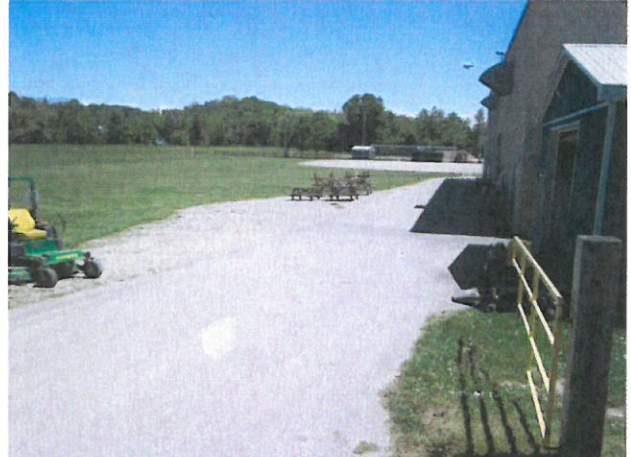
**North Wall of Arena and Proximity of  
Baseball Diamond**

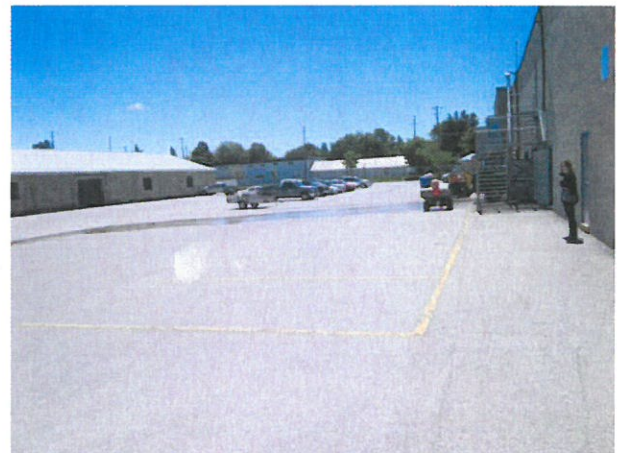
**Parking and Snow Dump**

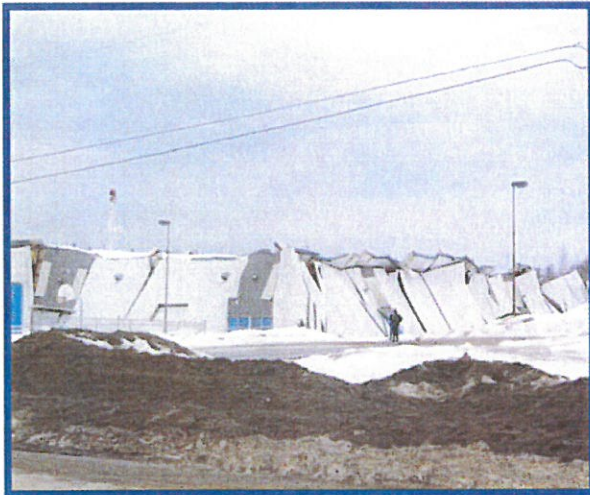
*Fort Nelson Arena Collapse 2007*

Snow combined with wind and ice build-up is most often the final stress needed to our aging infrastructure to cause disaster. Additional load that shifts due to weather that is unseasonal causes "moving loads" that can significantly contribute to roof failure. Further compounding of the problem may include innovative architectural design and advancements in building practices and materials. Some are producing unexpected or complex issues relating to the accumulation and control of winter precipitation on buildings. Increased awareness of the effects of snow, ice, freezing rain and melt-water accumulation on buildings is a greater requirement. While national building codes continue to advance, to keep up with the increasing creativity and complexity of modern building structures, there is still the need for expert interpretation of the code and ongoing review of the existing building. Facility managers

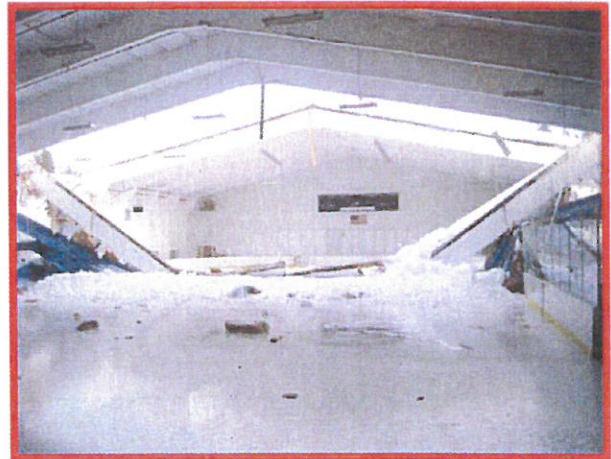
*US Rink Collapse 2009*
