# Brockton Multi-Use Recreation / Municipal Office Complex Project

## Report to the Project Management Committee Walkerton Community Centre Assessment

PRISM Partners Inc.

6/18/2014

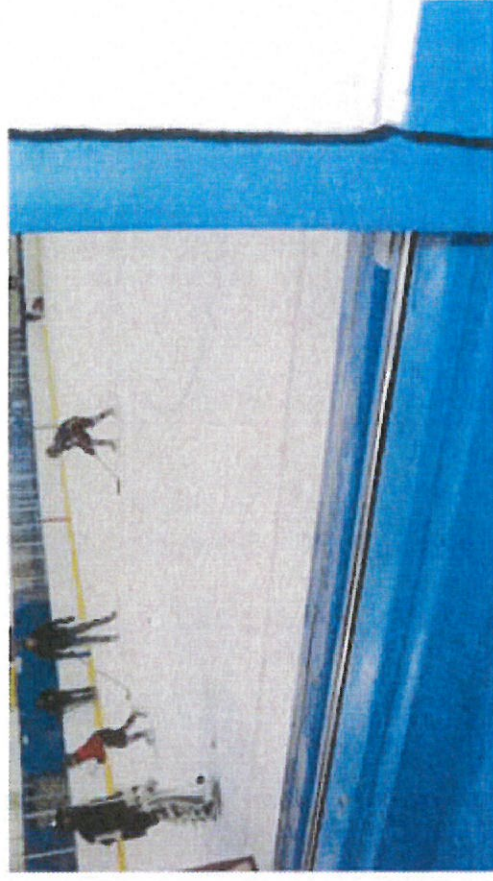
- A new Aluminum, removable, ProRink 181 ft x 81ft , 20 ft. radius dasher board system was installed with quick release removable sections for special events
- New gates and hardware were installed to ensure safe operations and security during activities
- The board height was adjusted to 48", slightly lower than the original boards to meet ORFA standards and were more conducive to spectators viewing in the lobby area
- New player and penalty benches, and timekeepers benches added , complete with coaches walkway, and critical access to the penalty boxes from the time keepers area.

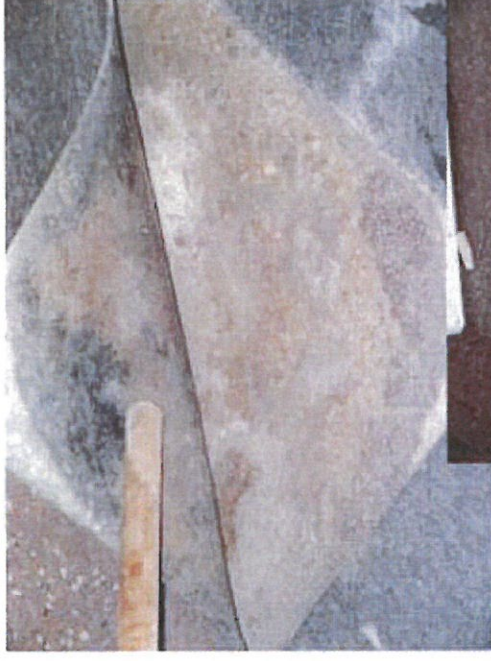
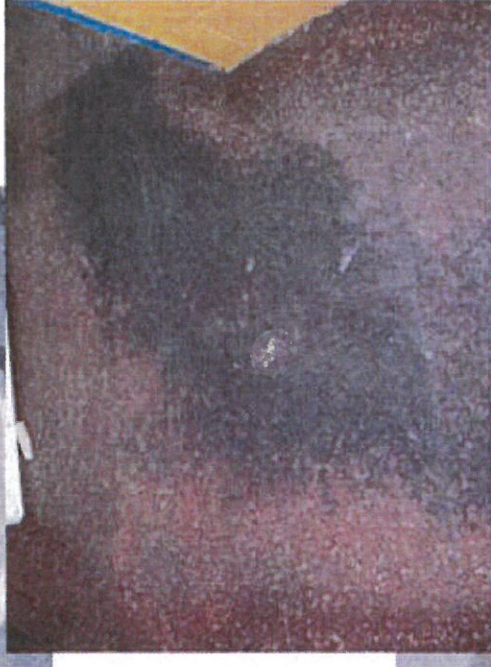
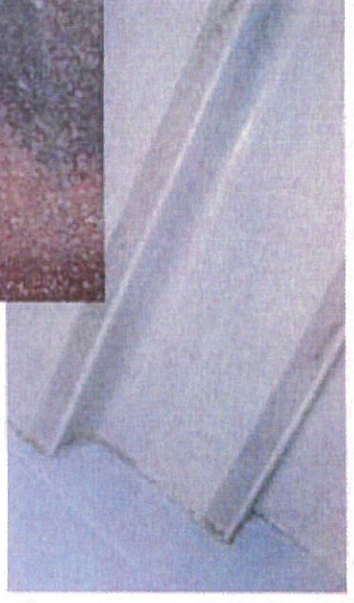
- 6,500 sq. ft of Johnson's resilient Rubber Flooring was installed, throughout the facility, front to back
- The existing flooring was worn through to the concrete in many areas and extremely difficult to maintain
- Many sections were loose with moisture trapped under the tiles creating mold and mildew concerns
- New flooring with nonslip stair treads, and visually enhanced steps were added for patron safety and visually impaired at the front entrance

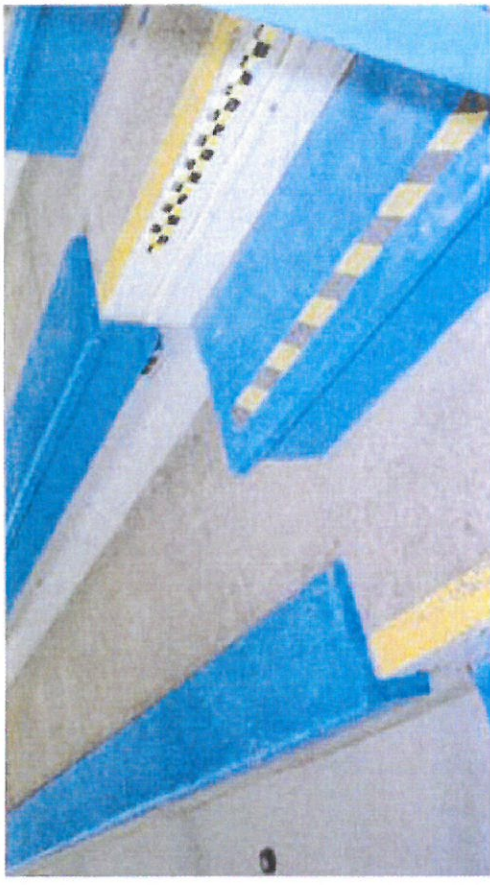
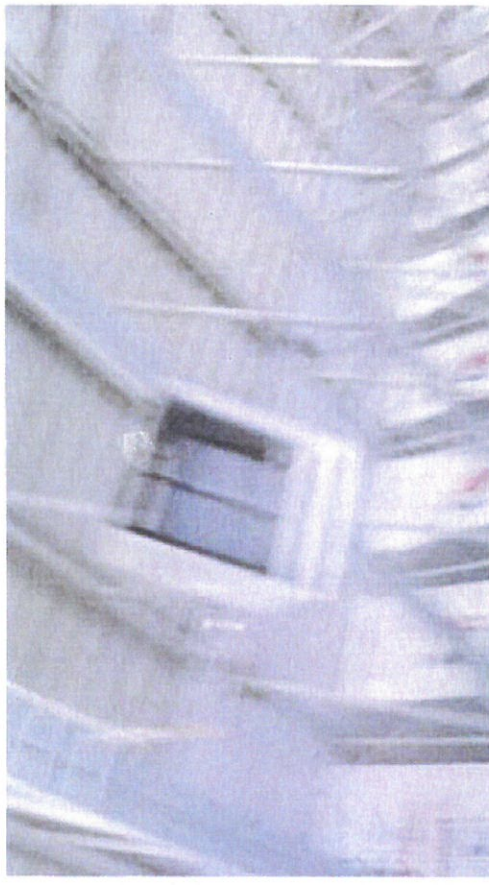
- Steps risers at the Community Center vary in height creating a Health and Safety Factor
- The wooden benches also create a trip hazard
- The spectator seating is also not conducive to persons with limited mobility
- Gas radiant heaters in the spectator area are not energy efficient, and could be replaced with in-floor heating generated by the refrigeration plant...

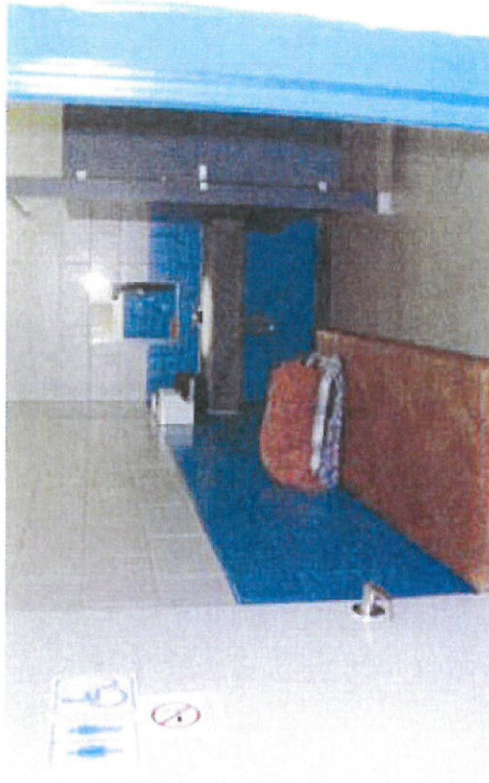
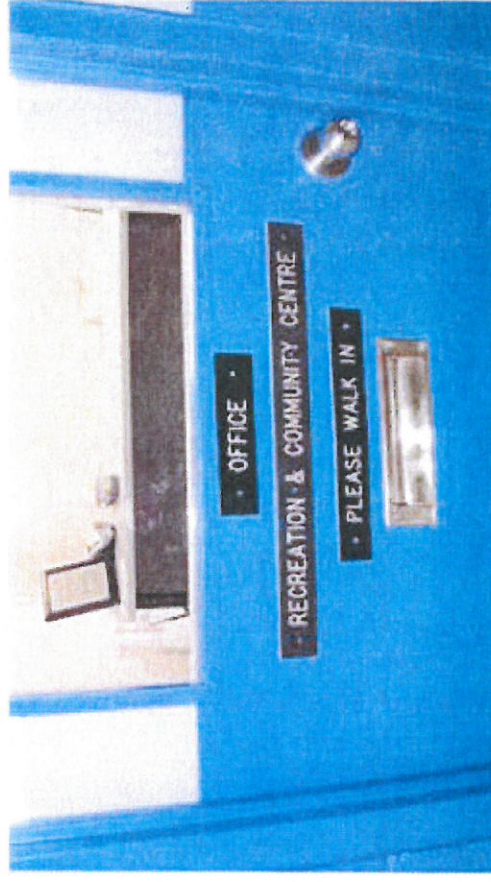
- There is one barrier free washroom located on the lower level near the east entrance
- This room doubles as a coaches change room, first Aid room, girls change room, and referees room on occasion.
- There is another Barrier Free washroom on the 2<sup>nd</sup> level
- It is questionable however, if the fixtures and counter tops are to acceptable standards

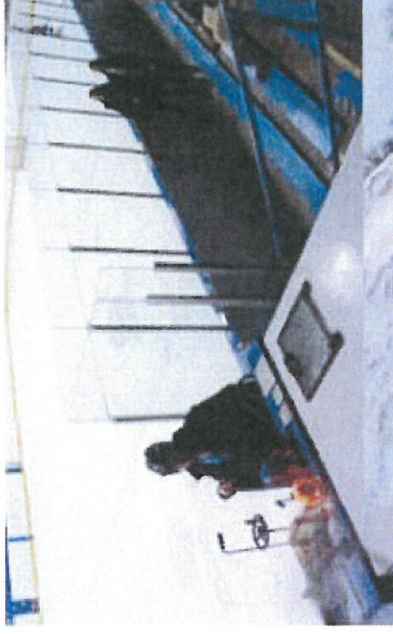
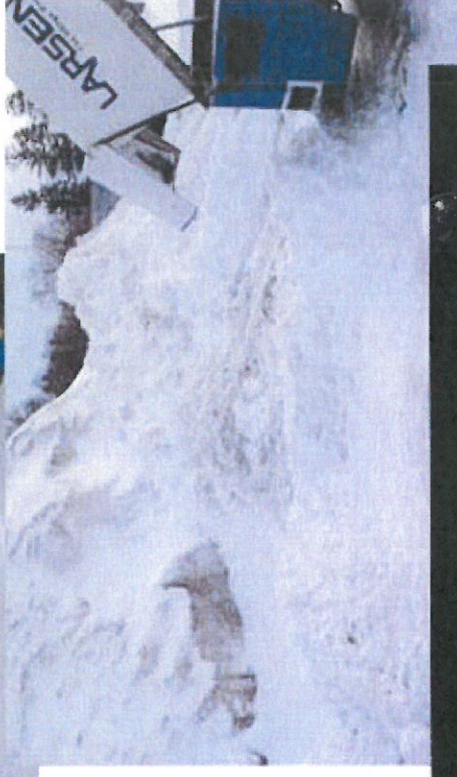
- The ice resurfacer is required to reverse on to the ice and exits the ice surface through heavy pedestrian traffic area in the spectator seating area
- There is also a concern when the ice resurface exits the building into the parking area, again through vehicular and pedestrian traffic
- Ice shavings from the ice Resurfacer are dumped outside through the parking lot area, which contain contaminants, such as blood or bodily fluids in the ice shavings are dumped outside

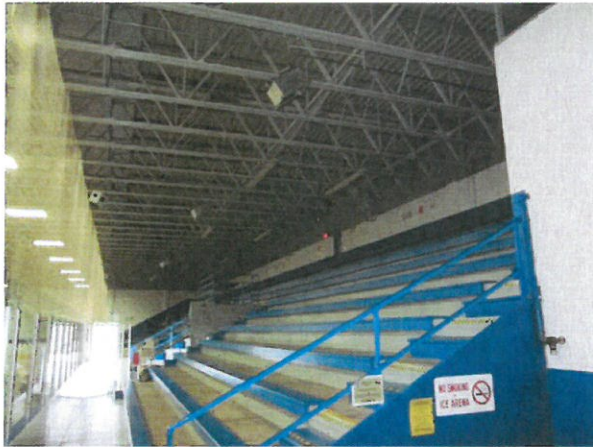
**Existing Bench Seating**

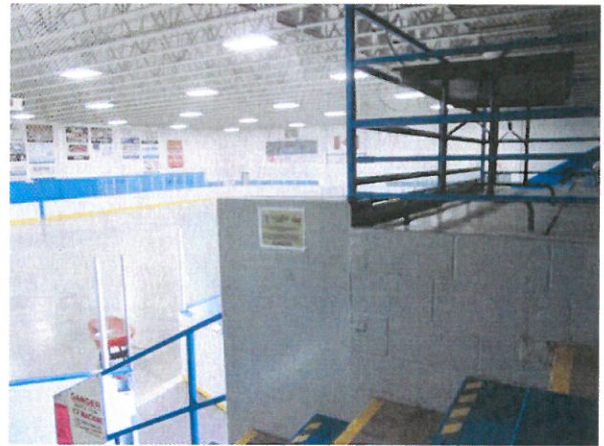
**Obstructed Seating**

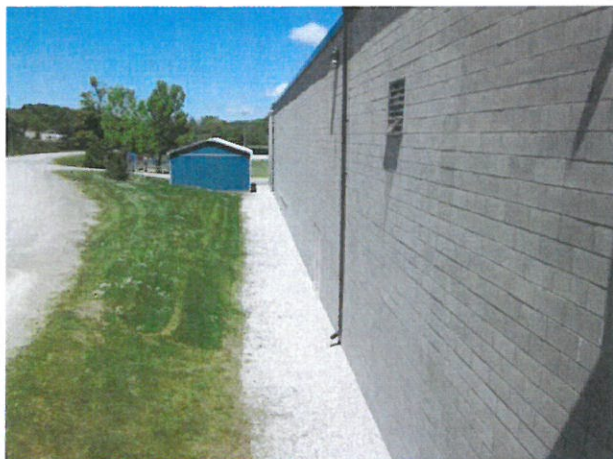
**West Wall of Arena and Elevated Ground Road**

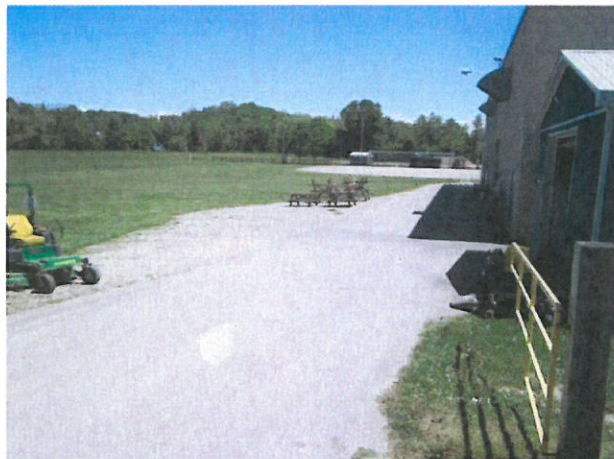
**North Wall of Arena and Proximity of  
Baseball Diamond**
