Report to Council

Report Title:	Future Municipal Complex Location		
Prepared By:	Sonya Watson, Chief Administrative Officer, Trish Serratore, CFO/Acting Director of Community Services, Fiona Hamilton, Director of Legislative and Legal Services (Clerk)		
Department:	Administration		
Date:	June 20, 2023		
Report Number:	CAO2023-11	File Number:	C11AD, A19MU
Attachments:	Map of East Ridge (lot 25B), PRISM Report-2014, Press Release, 2012

Brockton Multi-Use Recreation / Municipal Office Complex Project

Report to the Project Management Committee
Walkerton Community Centre Assessment

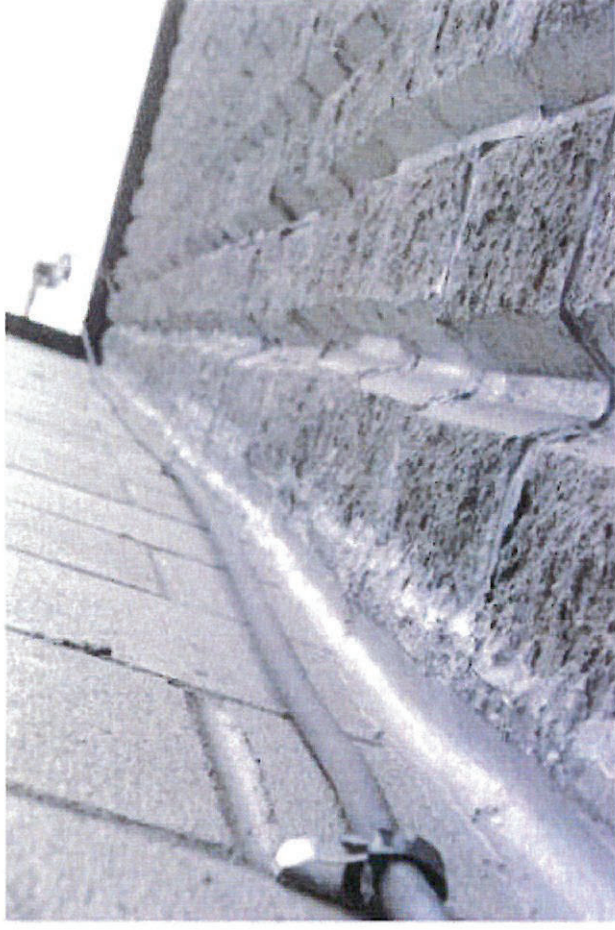
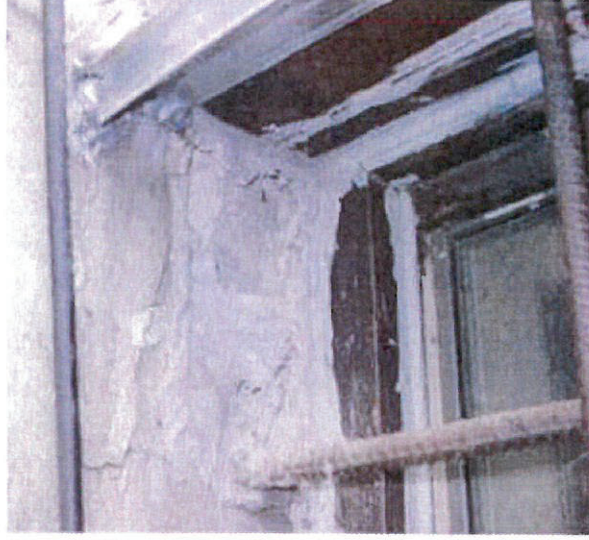
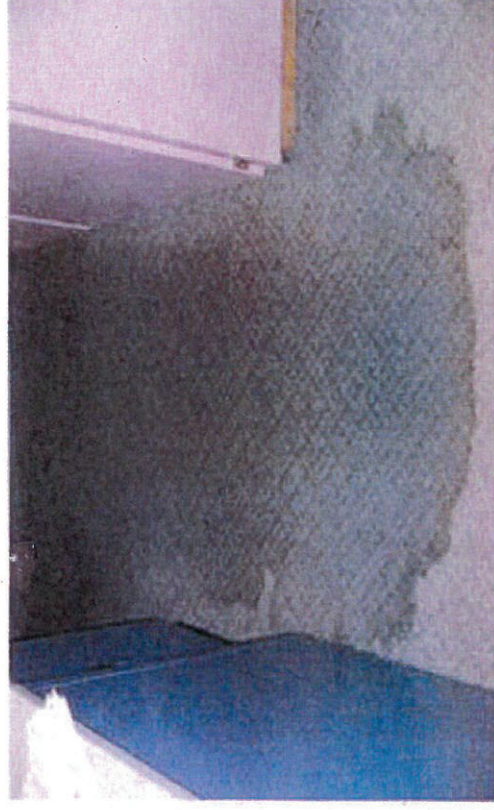
Community Center
RINC Improvements 2010

- **The improper drainage created premature corrosion of the block wall, and windows resulting in irreversible water damage to the offices and interior of the building**

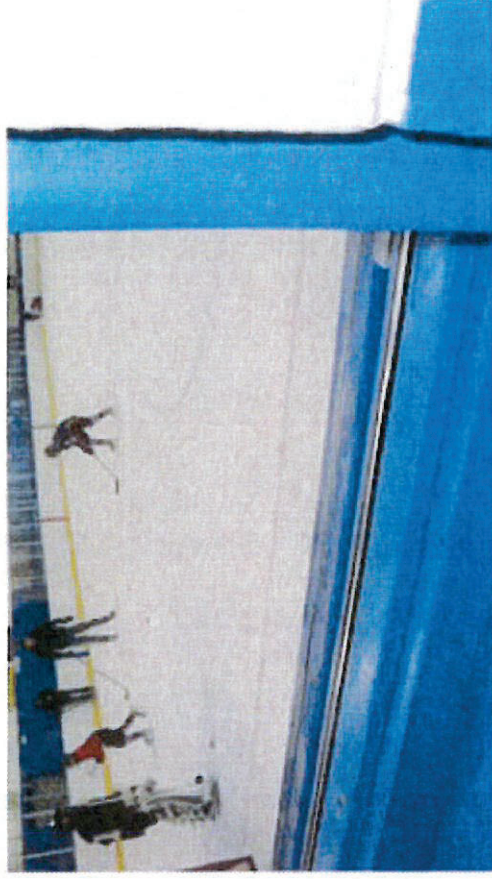
- A new Aluminum, removable, ProRink 181 ft x 81ft , 20 ft. radius dasher board system was installed with quick release removable sections for special events
- New gates and hardware were installed to ensure safe operations and security during activities
- The board height was adjusted to 48", slightly lower than the original boards to meet ORFA standards and were more conducive to spectators viewing in the lobby area
- New player and penalty benches, and timekeepers benches added , complete with coaches walkway, and critical access to the penalty boxes from the time keepers area.

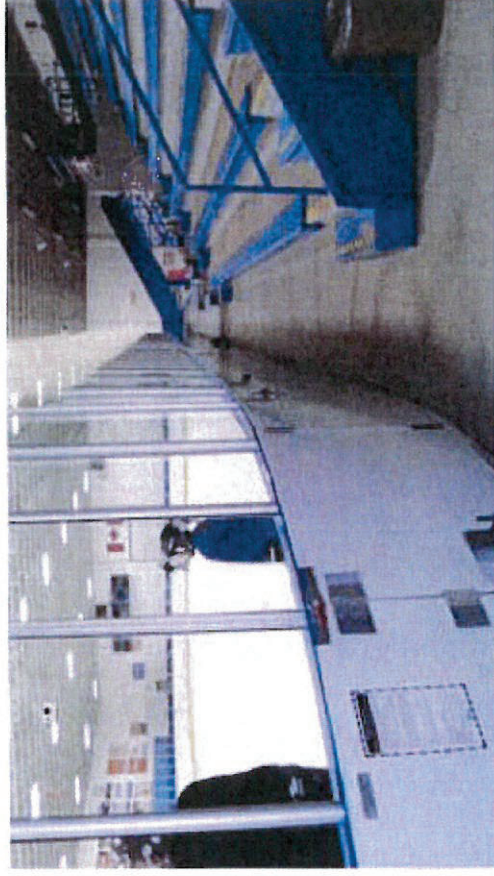
- Original 4' and 5' tempered glass was replaced with 5' and 6' foot 1/2" tempered glass with quick release supports
- The glass, players benches, and gates were brought up to ORFA Specifications for player safety
- The Aluminum board sections, gates and glass are all removable for future use
- The cost for the total Dasher board system was approx. \$ 135,000.00

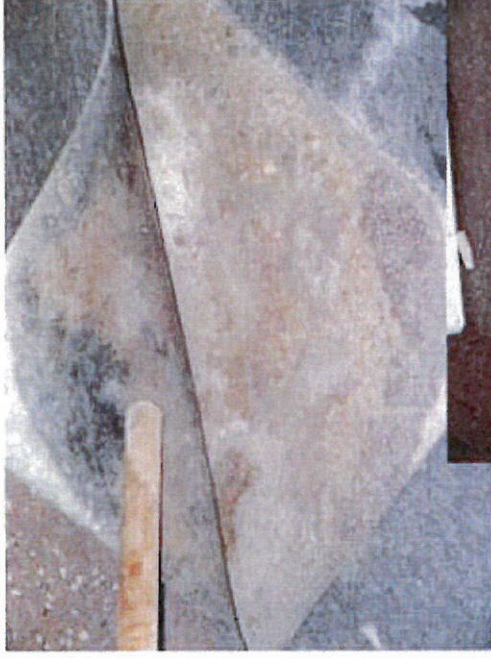
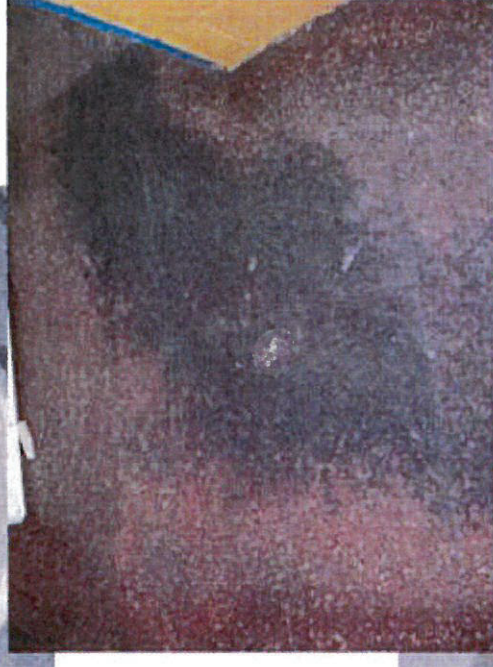
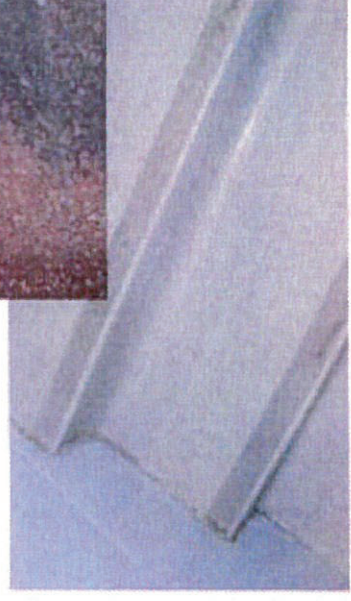
- 6,500 sq. ft of Johnson's resilient Rubber Flooring was installed, throughout the facility, front to back
- The existing flooring was worn through to the concrete in many areas and extremely difficult to maintain
- Many sections were loose with moisture trapped under the tiles creating mold and mildew concerns
- New flooring with nonslip stair treads, and visually enhanced steps were added for patron safety and visually impaired at the front entrance

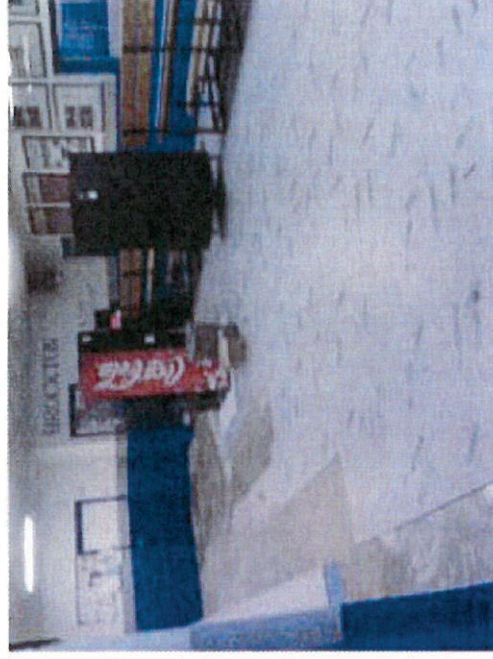
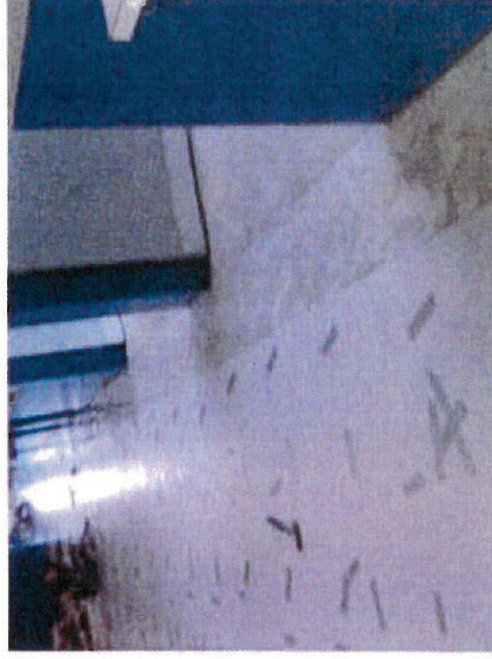
- Rubber flooring was installed throughout the entire facility.
- Patrons can move easily throughout the dressing rooms, lobby, players benches without damaging skates, while providing a seamless finish easy to maintain
- The grade of rubber flooring was carefully selected considering the life expectancy of the building and possible future uses
- The approx. cost for the rubber flooring was \$ 78,000.00.

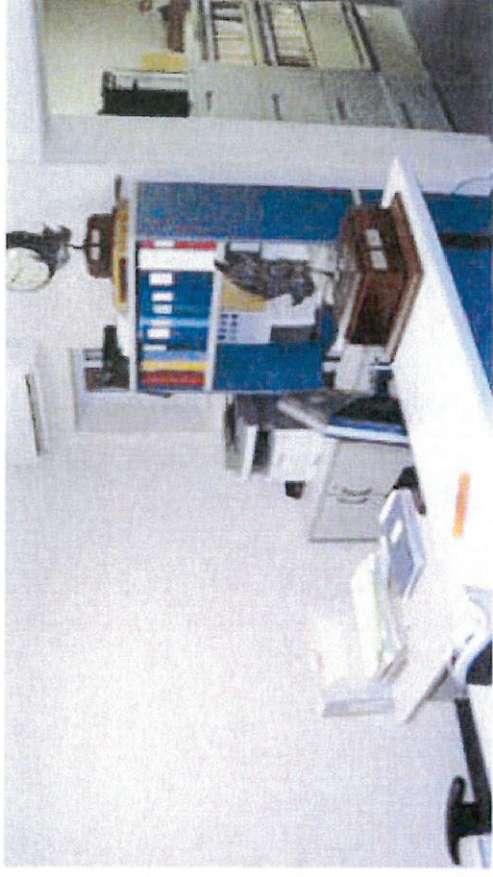
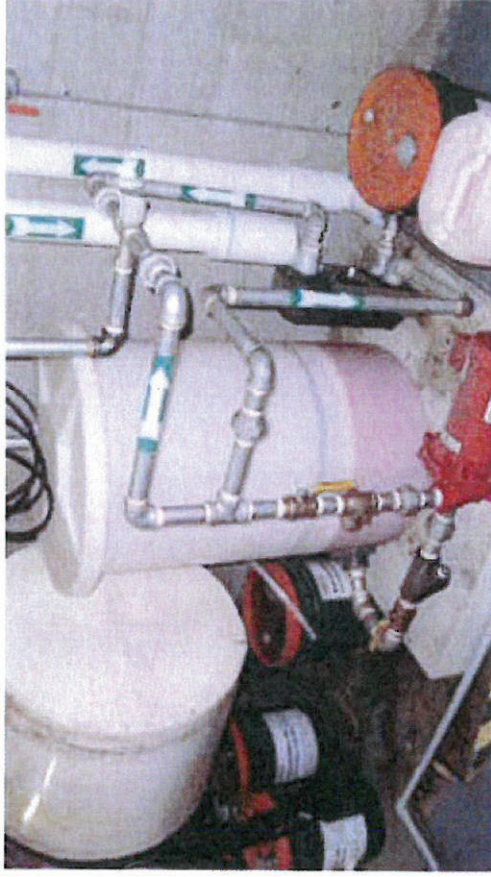
- Other improvements
- A glycol cooling system was added to the refrigeration system resulting in 60 % reduction in water consumption
 - Office renovations, and drainage improvements along the west side of the community center, shower saver faucets, and added auditorium storage areas, and ceiling tiles were also realized with RINC funding.

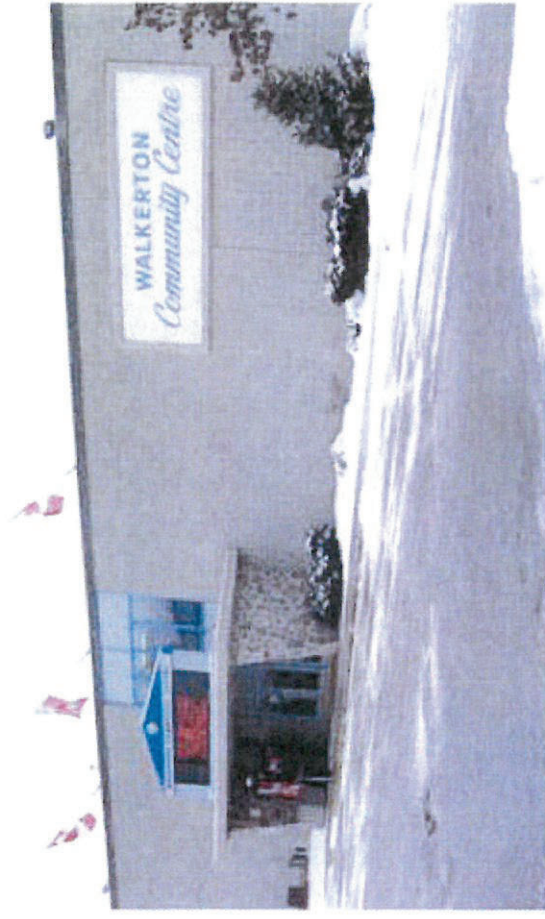
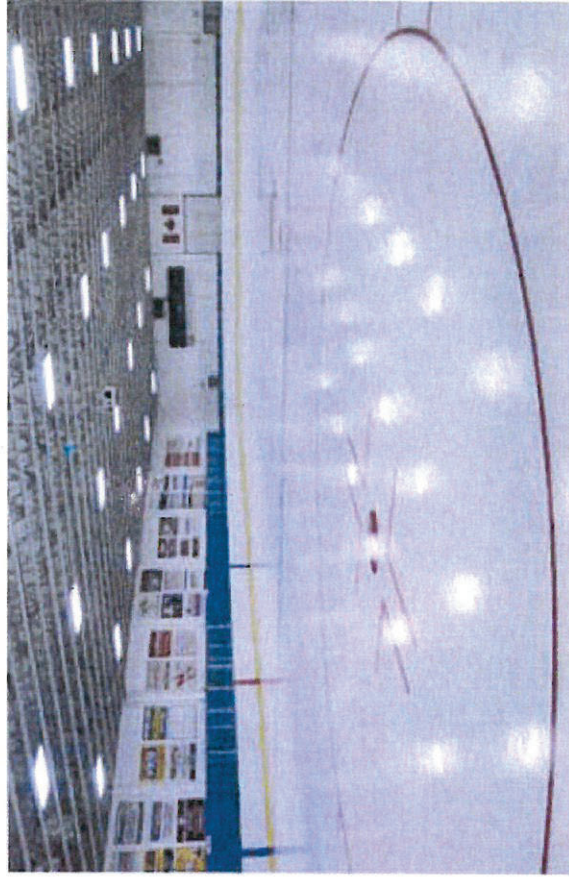
Current Structural and Design Deficiencies

- Steps risers at the Community Center vary in height creating a Health and Safety Factor
- The wooden benches also create a trip hazard
- The spectator seating is also not conducive to persons with limited mobility
- Gas radiant heaters in the spectator area are not energy efficient, and could be replaced with in-floor heating generated by the refrigeration plant...
