## Report to Council

<b>Report Title:</b>	Greenock Bridge Structure No. 0006 Closure		
<b>Prepared By:</b>	Gregg Furtney, Director of Operations		
<b>Department:</b>	Operations/Public Works		
<b>Date:</b>	October 13, 2020		
<b>Report Number:</b>	PW2020-30	<b>File Number:</b>	C11PW, T11
<b>Attachments:</b>	Load Evaluation Report – Greenock Structure 0006 G.M. BluePlan Recommendation Letter - Greenock Bridge Structure 0006 Bridge Structure 0006 Greenock Map

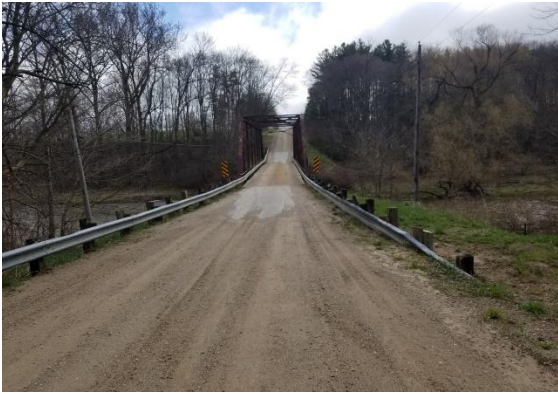
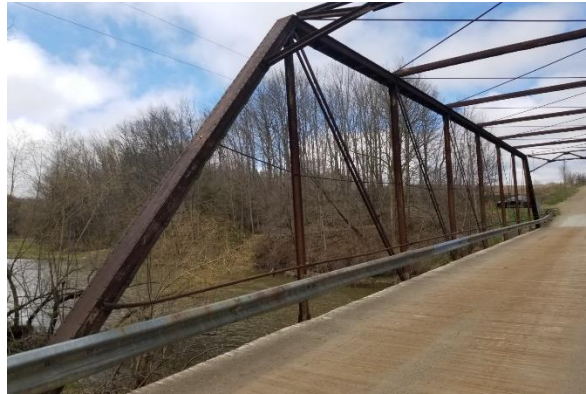
Greenock Structure 0006 is located on Lot 2, Concession 8/9, Greenock Survey. It is a single span and single lane steel through truss bridge. Construction of the bridge is estimated to be around 1920, based on the bridge construction method and the advanced level of deterioration. It is 4.2 meters wide and 35 meters long. It has an exposed laminated 2X6 timber deck. Concession 8 (Greenock) is a gravel road but the bridge has asphalt approaches on each end.
