## Report to Council

**Report Title:** Emergency George Street Water Main Replacement

**Report Number:** UT2020-17                      **File Number:** C11UT

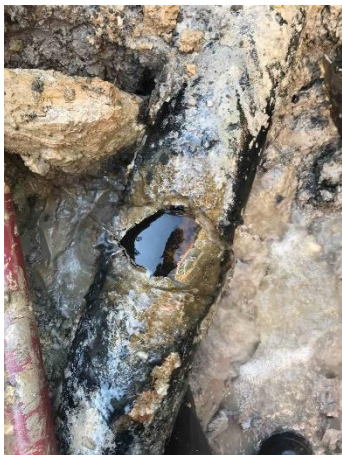
In July and August of 2020, the water main on George Street, Walkerton, needed three (3) separate emergency repairs. The water main has severely deteriorated in several spots. Both Brockton Staff and Veolia Staff are concerned that there will be more water main breaks on that same water main this coming winter. Winter water main breaks are significantly costlier as they are more time consuming. Residents can be out of water for significant periods of time.

The following picture is of the water main break in August. It is the same size, larger than a softball, as the two (2) previous water main breaks in July.

The water main is 6 inches in diameter, 210 meters long, and feeds 13 residential homes.

Staff would like to move forward quickly with this water main replacement on George Street in Walkerton. Exposed areas of water main, during the repairs, appeared to be very thin-walled. The idea is to replace the water main this fall and to leave George Street as a packed gravel road over the winter. As per Council's direction, budget 2021, staff would then, in the spring of 2021, replace the existing clay tile sanitary sewer, upgrade the storm water system, and resurface the street. This project was not a forecasted project.

That the Council of the Municipality of Brockton hereby receives Report Number UT2020-17 - Emergency George Street Water Main Replacement, prepared by Gregg Furtney, Director of Operations, and in doing so directs staff to proceed with the water main replacement on George Street this fall

The estimated cost of the 2020 water main replacement work is approximately \$120,000. BM Ross and Associates would be executing the engineering and project management side of the project. Brockton Staff would help with the procurement of the plumbing materials. Excavation work would be covered through our annual Time and Materials Vendor Agreement.
