**LAKE ROSALIND WELL 3
REHABILITATION AND
WELL 1 TESTING**

**THE CORPORATION OF THE
MUNICIPALITY OF BROCKTON**

Date: December 19, 2018

Reference: 248-026

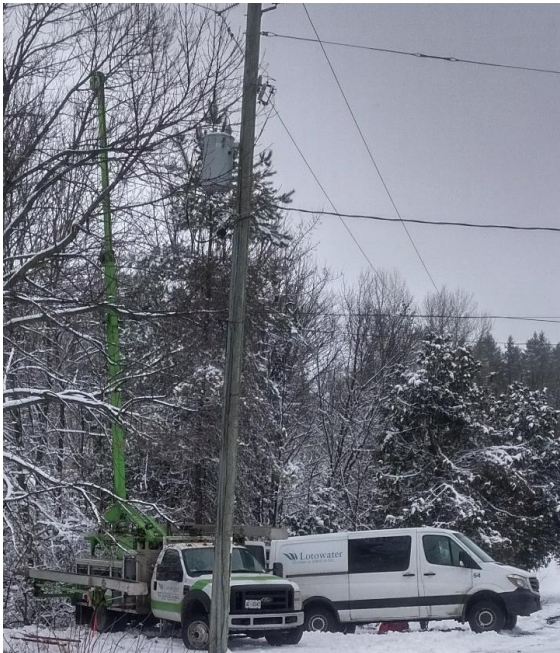
Photo 5: Set up on Well

The well rehabilitation was performed to remove the buildup on the screen and casing. The rehabilitation program utilized a dual tube airlift assembly and high pressure jetting system. The well was initially airlifted off bottom using a 50 mm x 10 mm dual airlift to remove sediment and debris in preparation of the jetting. After the initial airlift, the well was jetted with a high pressure rotating head jetting tool. The tool was raised and lowered over the casing and screen while jetting at 7,500psi @ 1.0 L/s, while simultaneously airlifting the well at a 1.0 L/s rate to remove material dislodged during jetting. The well was jetted and airlifted in this manner for two hours and produced a dark red to reddish brown discharge with some fine silt and sand. After the jetting, the well was airlifted off bottom until the discharge was clear and sediment free. Some photos of the rehabilitation setup and equipment are shown in (**Photos 5 to 8**).

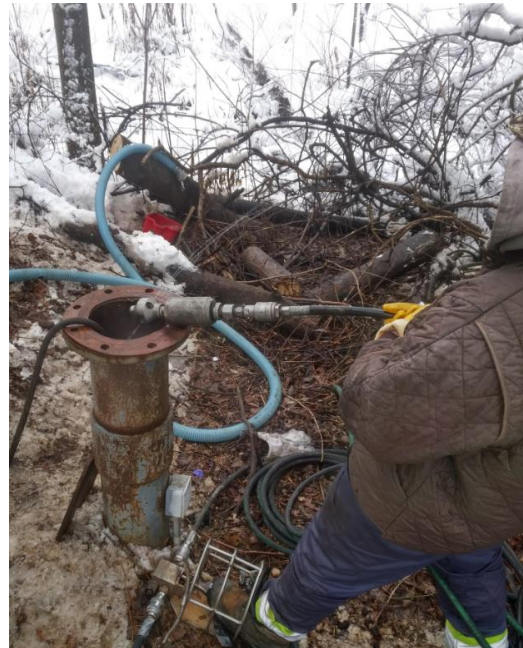
Photo 6: Jetting Tool

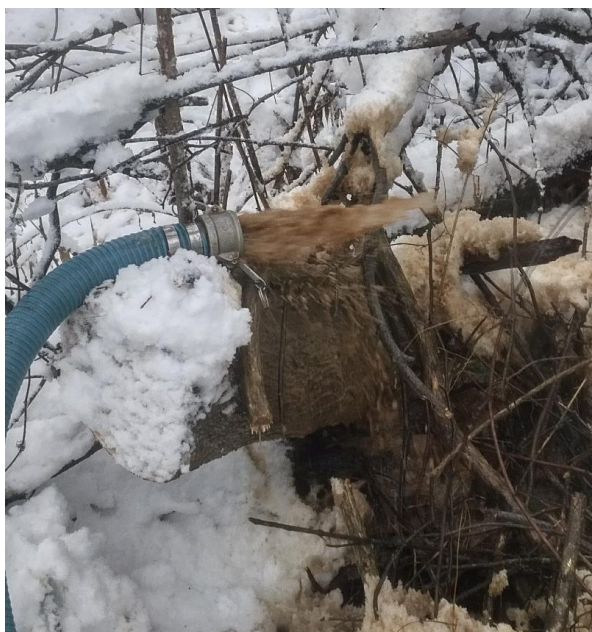
Photo 7: Airlift Discharge

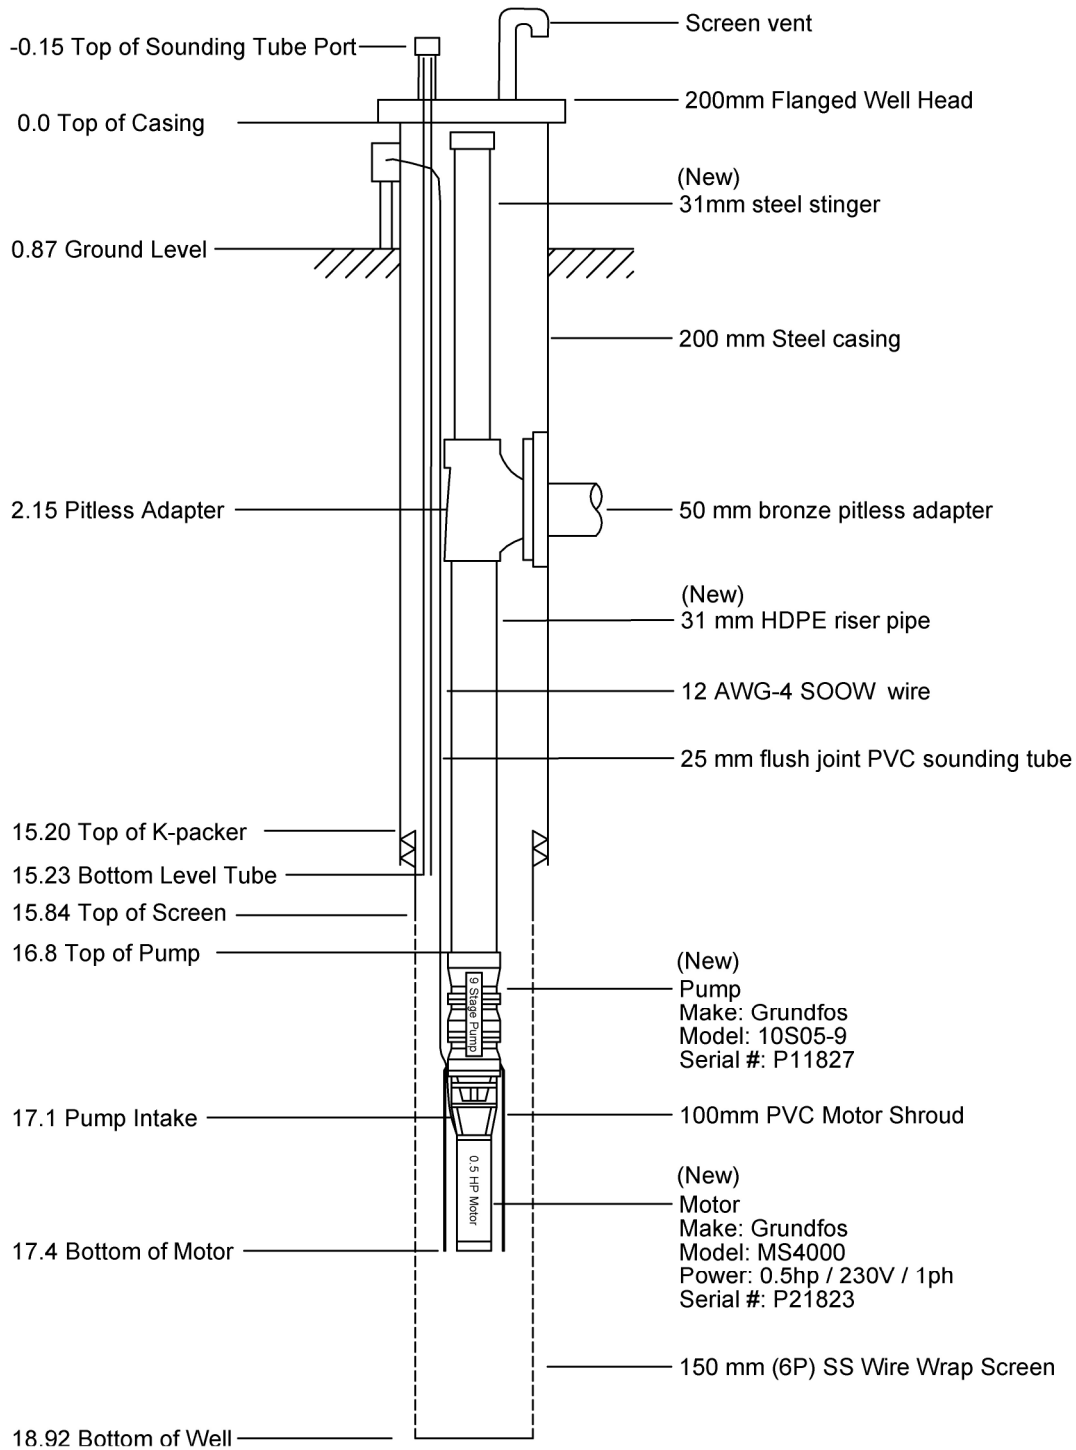
PROJECT #: 248-026			G:\Lotowater Projects\248 Municipality of Brockton\ Lake Roalind Well 3.dwg		
DESIGN			REVISION No. Dec 18, 2018	SCALE N.T.S	FIGURE 3
DRAWN	BP	2018/12/13			
CHECKED	.	.

Lotowater installed a new pump, motor and HDPE discharge piping on November 29, 2018. In addition, a new stinger for the pitless adapter was cut and threaded then installed on top of the pitless adapter. A pump installation drawing has been included as **Figure 3**, and a well disinfection record has been included in **Appendix B**. Testing of the pump was performed after installation, which showed it performing satisfactorily. In addition, testing also indicated that there are no significant leaks or plugging of the line that connects the well to the plant.
