Hazardous Building Materials Assessment

Pool House
1 James Street, Walkerton,
Ontario

June 25, 2019

Pinchin File: 238554

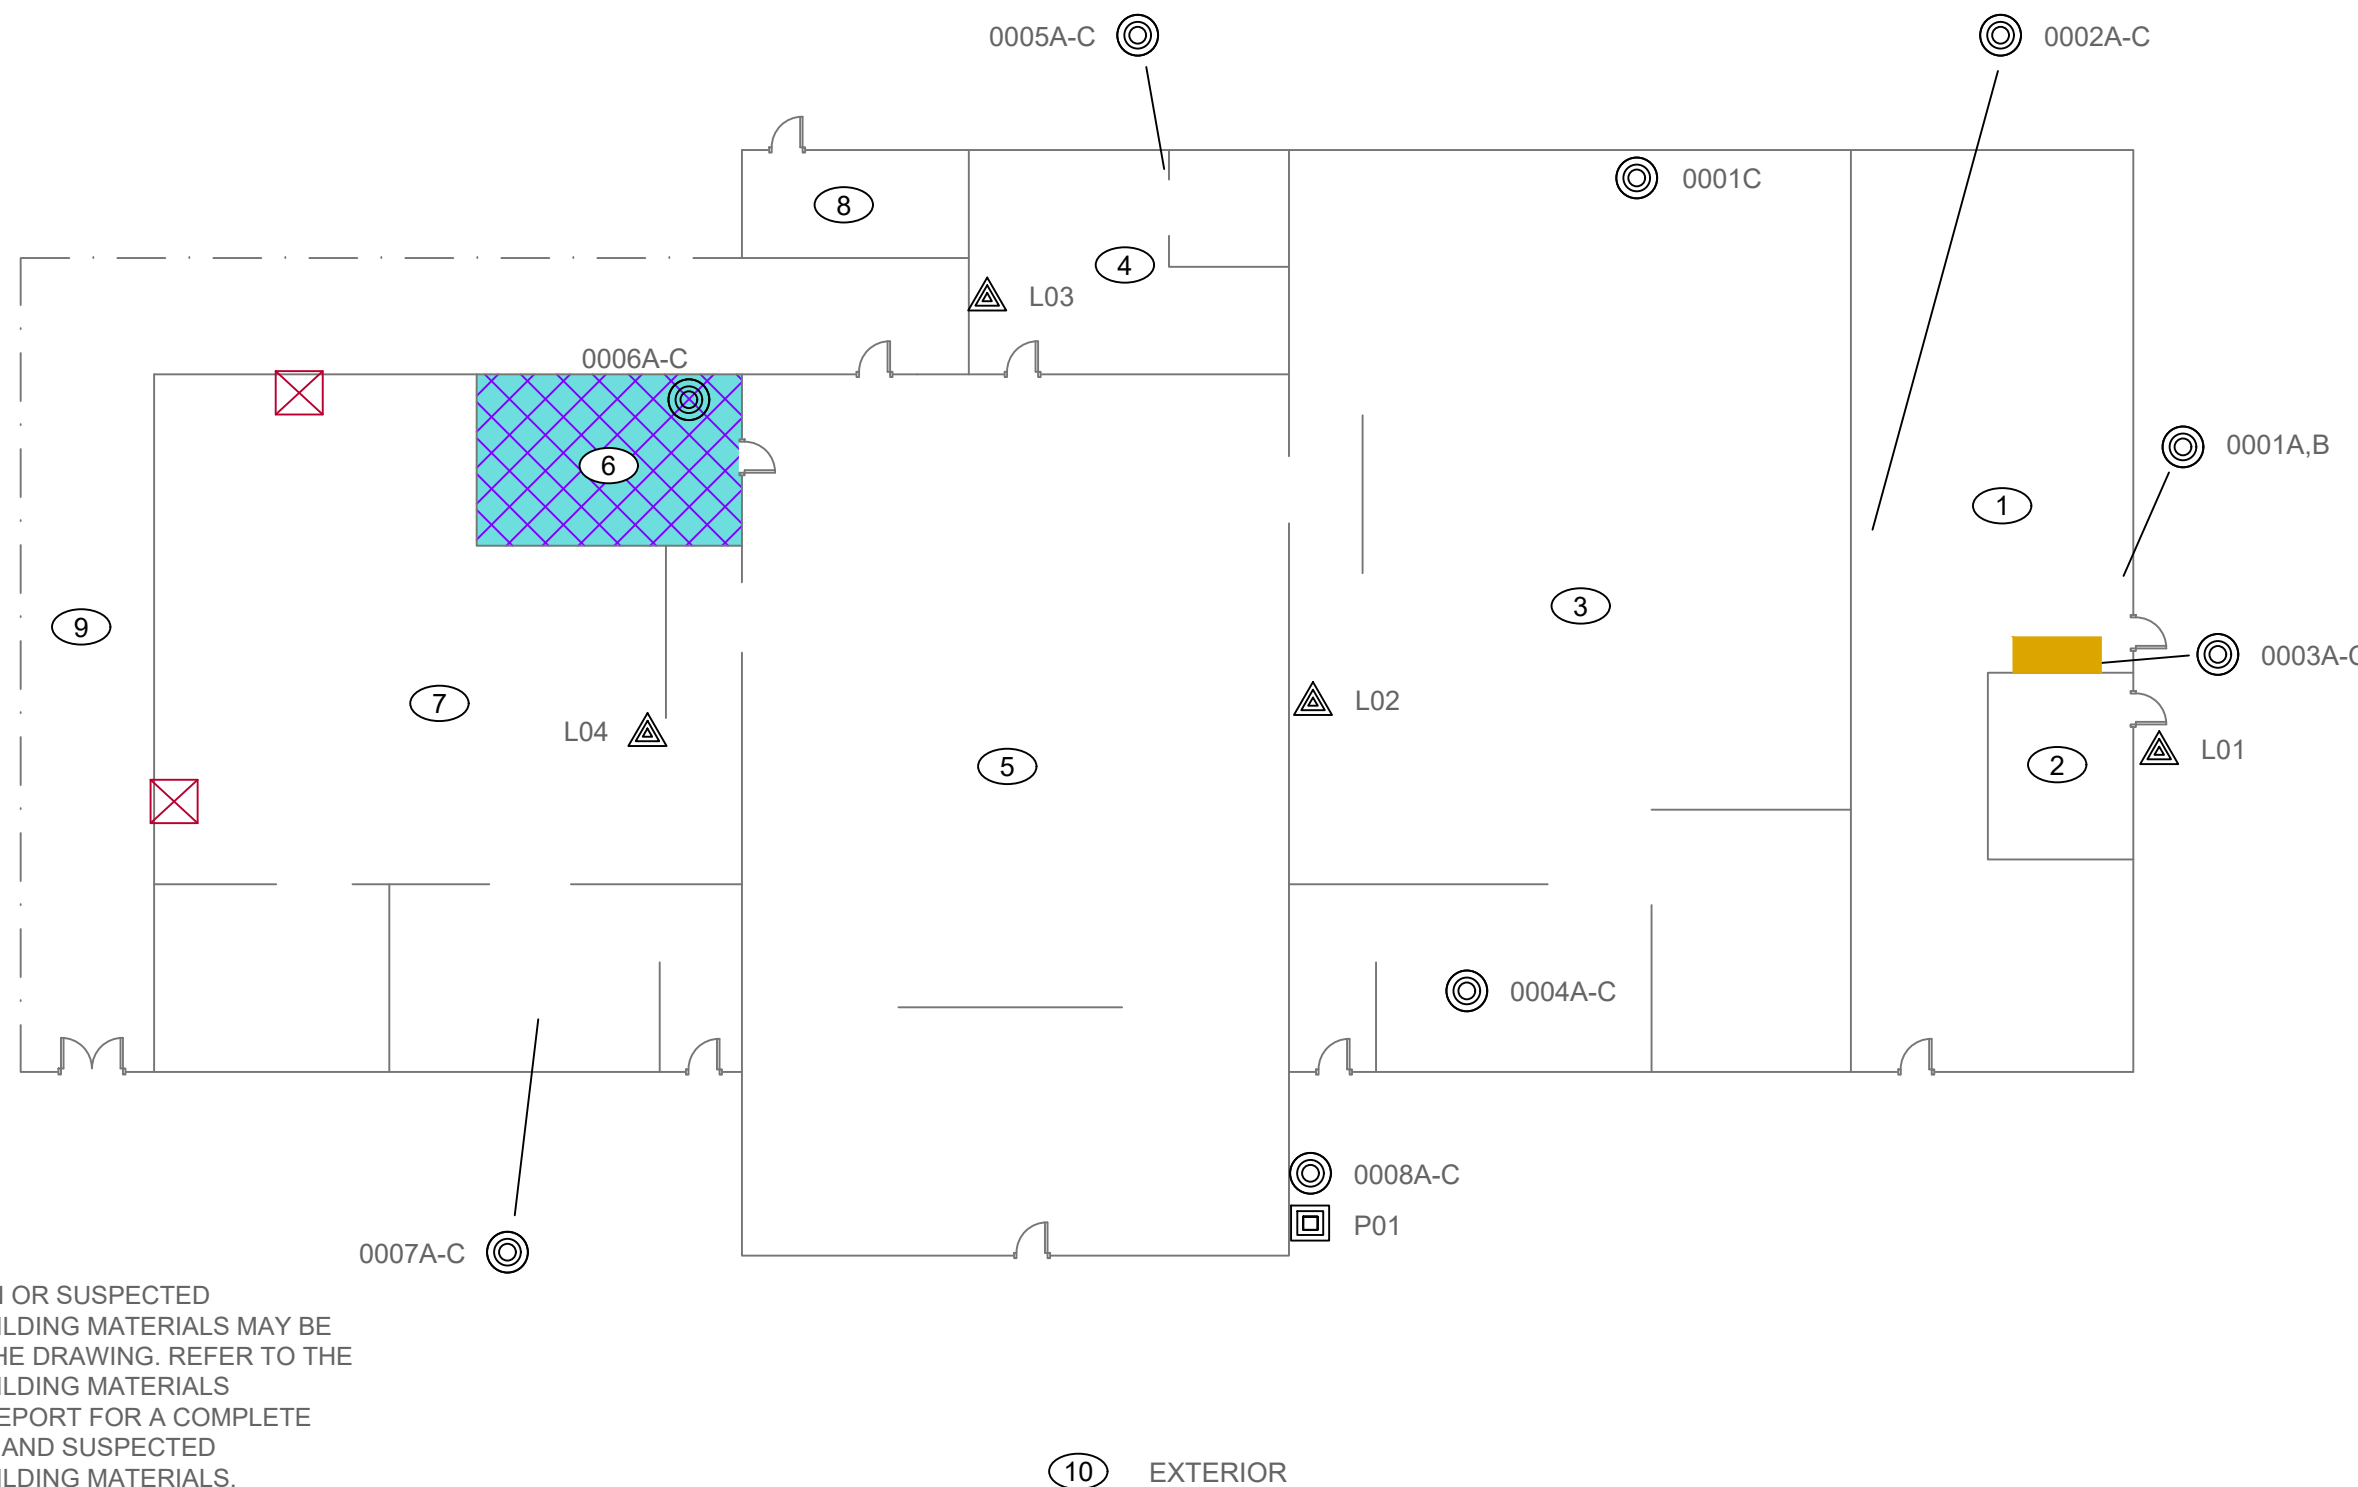
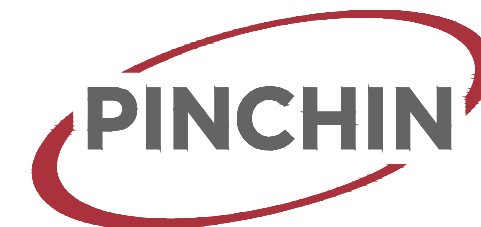
TITLE:
HAZARDOUS BUILDING
MATERIALS ASSESSMENT
GROUND FLOOR

Destructive testing was conducted of masonry block walls. The masonry block walls were penetrated in the women's washroom, location 7, loose fill vermiculite was not observed within the cavities. The locations of destructive testing have been indicated on the drawings in Appendix I.
