Report to Council

Report Title: D.S. Weis Memorial Bridge Rehabilitation Emergency Work
Prepared By: Gregg Furtney, Director of Operations
Department: Public Works
Date: June 15, 2021
Report Number: PW2021-15 **File Number:** C11, PW
Attachments: D.S. Weis Memorial Bridge Picture

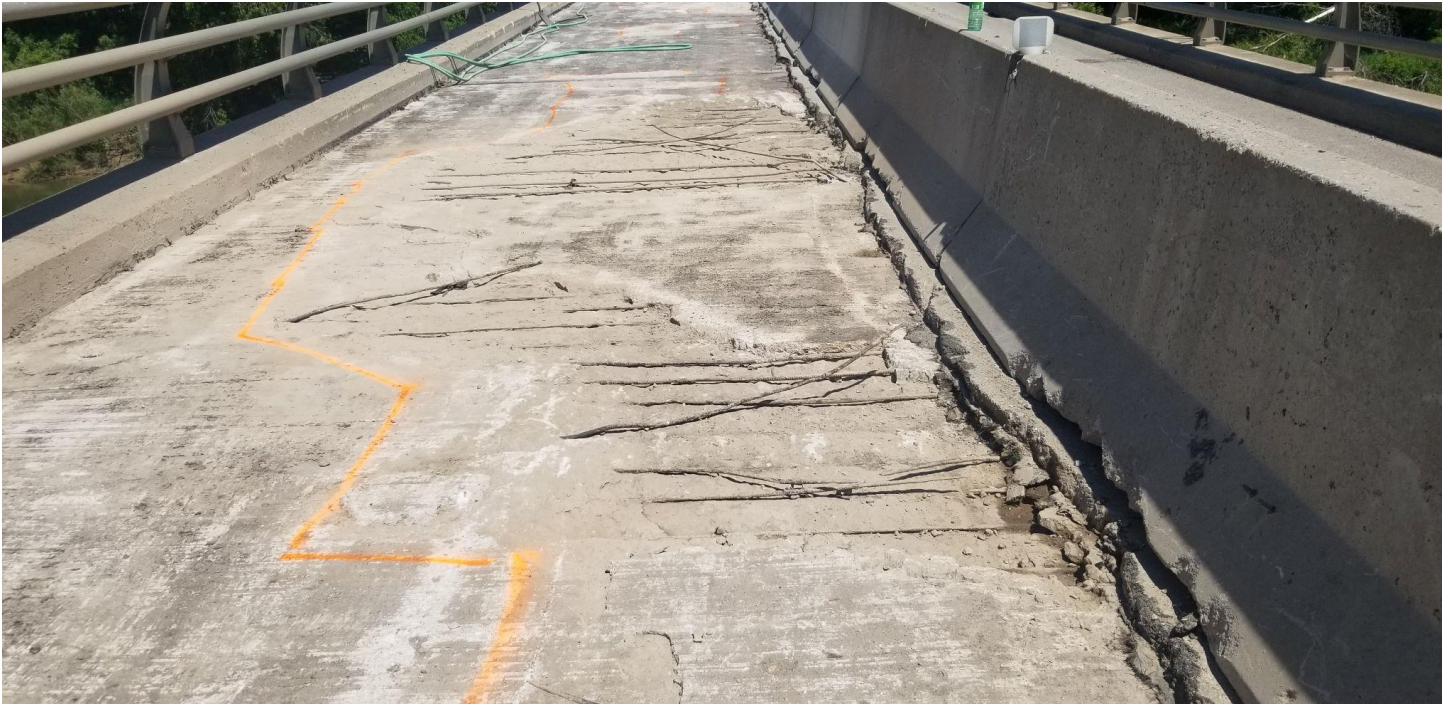
On June 3rd, staff from National Structures contacted GM BluePlan and Municipal Staff and asked for an Emergency Meeting. The Contractor had begun concrete chipping operations on the deck top of the bridge. After the asphalt was removed, it became very apparent that the amount of deterioration on the deck top was significantly more than expected. National Structures prepared a breakdown of two (2) options for GM BluePlan and Municipal Staff to review. Because work has commenced, a decision needs to be made quickly to keep the project on schedule. This is a major concern for the Contractor and staff.

Option One (1) – Patch Repair: Estimated cost = \$73,910.20 (11% increase)

This option is viable; however, it is very likely that in 5 to 10 years there will be the need to do future rehabilitation to the bridge which would again facilitate the need to close the bridge as work is being completed. The patch repair will extend the project completion timeline as they will have to do one lane and then eventually have to move over and do the opposite lane. The seam in the middle is a concern for the Engineers and Contractors.

Option Two (2) – Full Concrete Overlay: Estimated cost = \$188,361.80 (27% increase)

On the advice of the Contractor, Engineers, and Senior Municipal Staff, this option makes the most sense. This will increase the longevity of the bridge, at least two (2) to three (3) times as long as Option One (1). Future rehabilitation of this same bridge will certainly cost more than \$188,361.80, if Council were to choose Option 1 and rehabilitate the bridge in a few years. The Contractors are already onsite and prepared to do the work, as directed. The Bridge will likely need to be closed completely, sooner than expected, however there is a good chance that the overall project will take less time than originally anticipated and the seam in the middle of the bridge will not be a concern. The detour on Concession 10 is already established. Bridge Rehabilitation work, unlike most other projects, often have these kinds of issues arise as a typical inspection can only see what is on the surface.
