File No. 17245

September 25, 2017

**RE: Walkerton Flood Control Dyke Repairs  
Catherine Street Storm Sewer Outlet  
Engineering Fee Estimate**

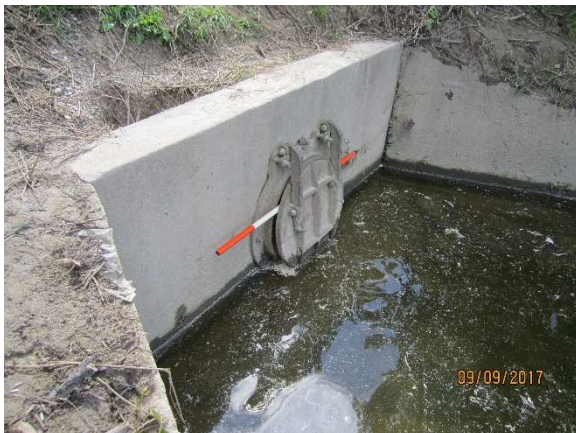
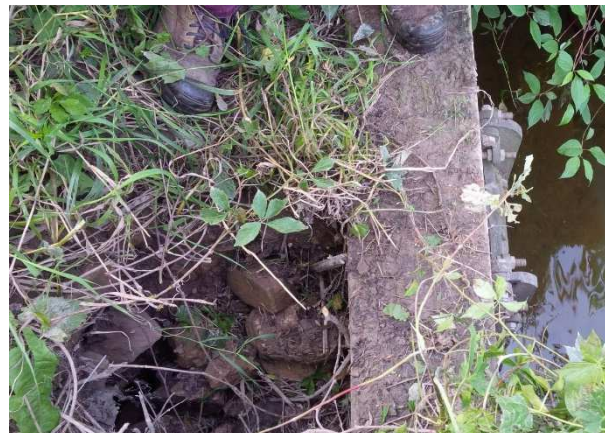
Based on our recent site visit, completed on Sept. 9, 2017, the existing pipe is a 600 mm dia. corrugated steel pipe that connects to a concrete headwall and flap-gate on the river side of the dyke. Recently, the storm sewer outfall has been repaired to address concerns related to the condition of the existing pipe under the dyke including issues with bottom and top pipe rot. The repairs were completed to address washout from behind the headwall that we suspect were formed as a result of the rotted openings in the pipe. The following photographs were taken showing the washout from behind the wall.

Recognizing that the repairs only cover the area that was immediately accessible from the pipe opening at the headwall, and we could not see beyond the repair, we expect that the repaired pipe will last over the winter months. That said, a more permanent fix is required to ensure that it will continue to effectively operate during all runoff events.

- Replacement of storm outlet pipe by open-cut methods of construction. It is suggested that the replacement extend from the existing storm structure on the south side of the dyke to the existing headwall on the north side (approximately 20 metres of pipe);
- Re-use of the headwall and flap-gate;
- Full restoration of dyke slopes including erosion protection as may be required;
- Full restoration of the walking path;
- Minor regrading and rip-rap placement at the outlet location.

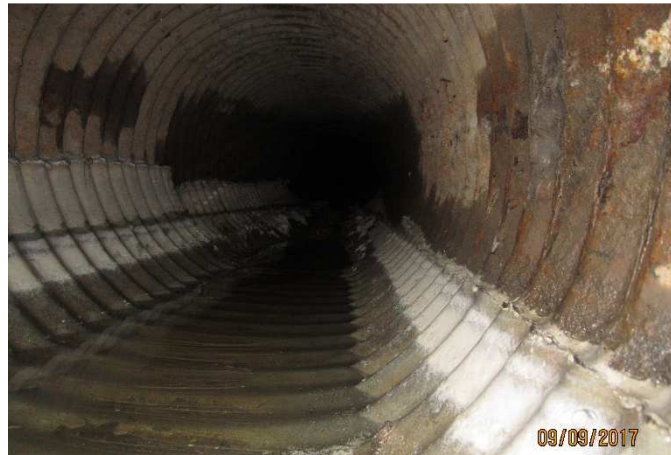
Although the repairs were undertaken in advance of our visit, from what we can see, the temporary remediation work was done in a professional manner:
