FINAL
Building Condition Assessment
1 James Street, Walkerton, Ontario

Corporation of the Municipality of Brockton
Box 68, 100 Scott Street,
Walkerton, ON

July 31, 2019

Pinchin Ltd. File: 238064

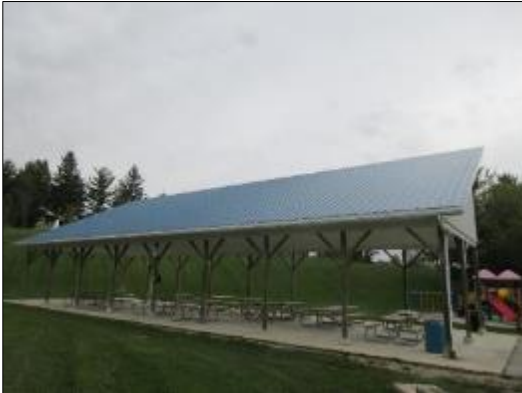
View of the sloped metal roof serving the pavilion outbuilding.

The sloped metal roof systems appear to be in satisfactory condition. Repairs to the damaged downspout should be completed as part of regular maintenance.

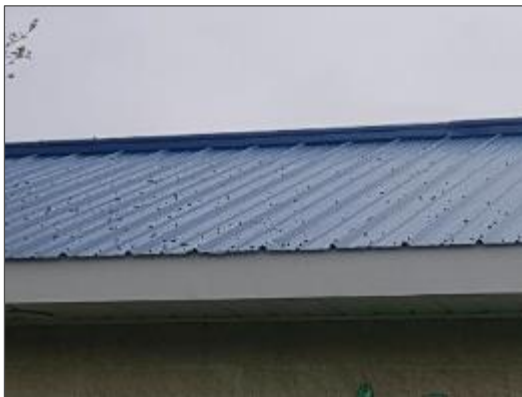
View of the sloped metal roof serving the splash pad outbuilding.

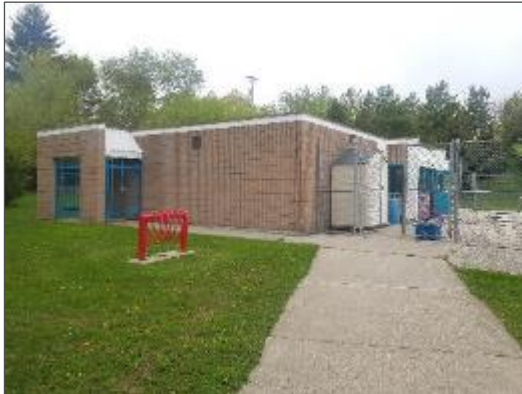
The mortar was noted to generally be in satisfactory condition with localized areas of deteriorated mortar that will require repointing. Localized areas of staining were also noted.

General view of the exterior wall systems.

We have included a localized repair allowance for the wall systems for completing repointing, removing staining and miscellaneous repairs to the cladding.

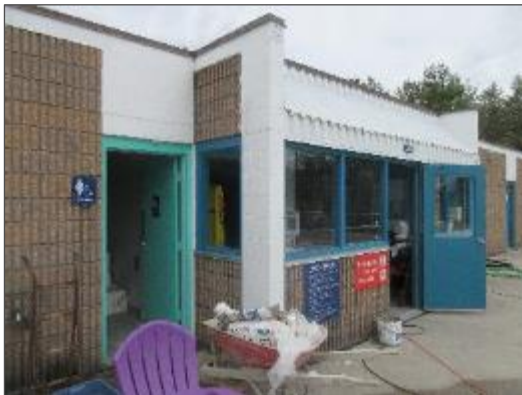
The exterior doors of the Site Building appeared to be in fair condition with peeling paint and surface corrosion noted at the base of the door frames in isolated areas. Doors at the splash pad outbuilding appeared to be in good condition. It is recommended to sand and repaint the deteriorated areas as part of regular maintenance.

View of the east entrance doors.

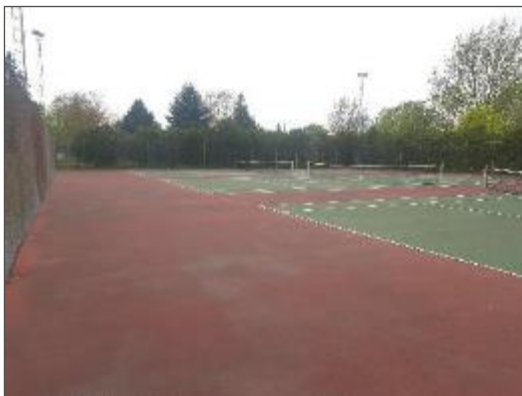
View of the hard court tennis court.

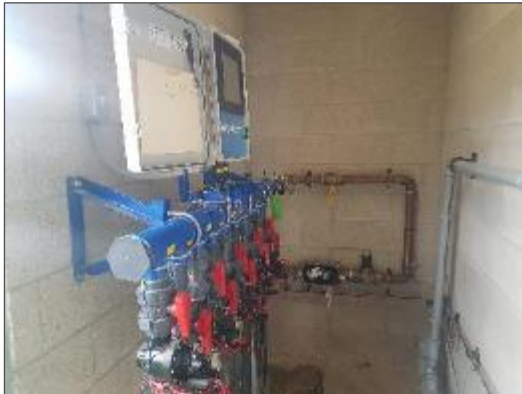
View of the "Vortex" mechanical system noted serving the splash pad.

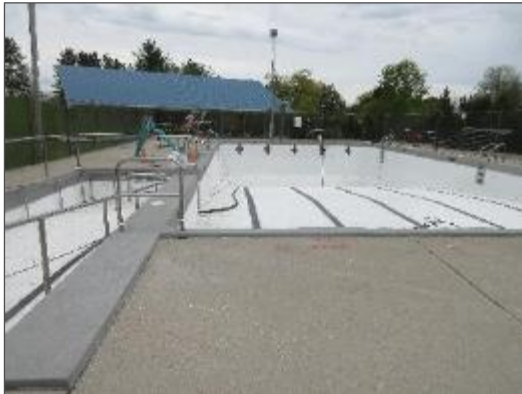
View of the in-ground pool.

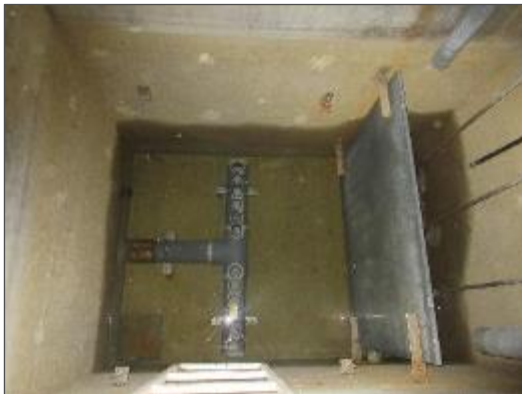
View of the in-ground water treatment tank noted serving the pool.

Note: Filters are currently removed for cleaning.

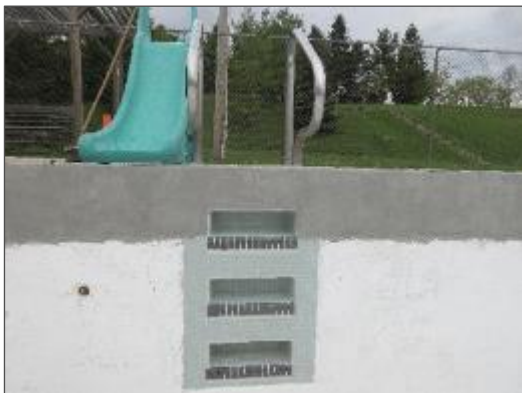
View of a typical metal ladder and steps serving the pool.

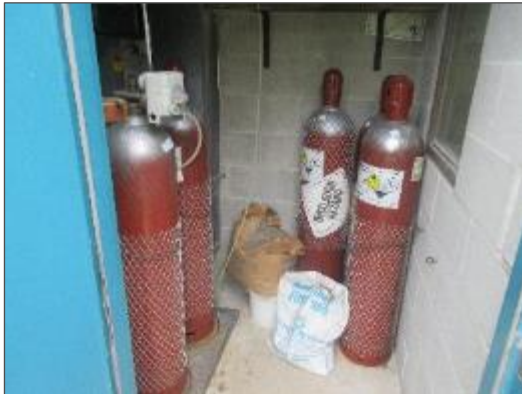
View of the chlorine gas treatment system serving the pool.

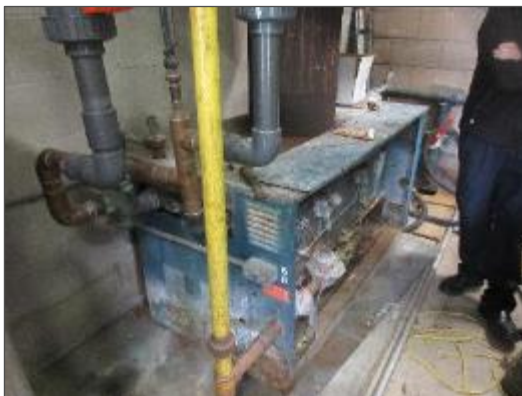
The heating boiler (S# 05317522) serving the pool is a natural gas boiler with 1,235,600 BTU/HR output. The boiler appears to be original and has likely surpassed its PUL. Pinchin has included a project to replace this heating boiler in the early portion of the assessment term. In the mechanical room a

View of the heating boiler serving the pool.

The Pool features appear to be in satisfactory condition with the exception of the above referenced deficiencies. Pinchin has carried an allowance for replacement of the heating boiler serving the pool. Replacement of the vacuum and filter pump is also anticipated. Refinishing or upgrading of pool fixtures should also be considered. Pinchin recommends that regular annual maintenance of the Pool features be performed throughout the term of the analysis. Assessment of or comment upon concealed deficiencies and any buried/concealed utilities or components are outside the scope of work.

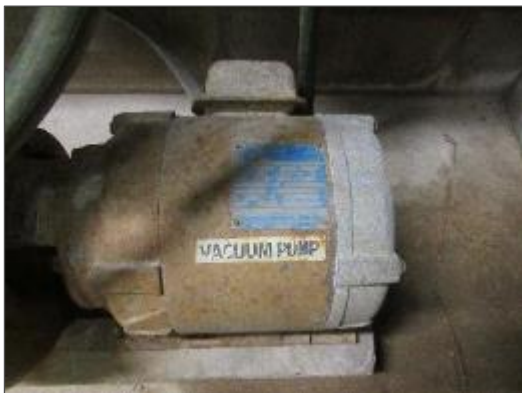
View of the vacuum pump serving the pool.

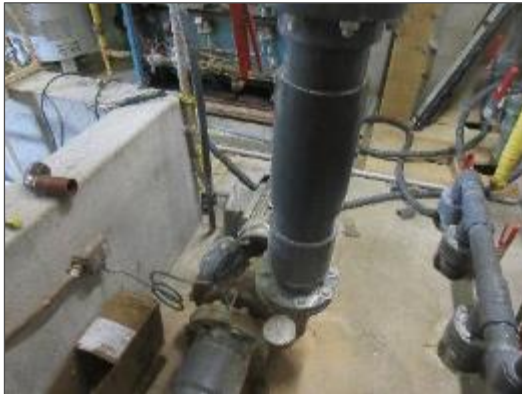
View of the filter pump serving the pool.

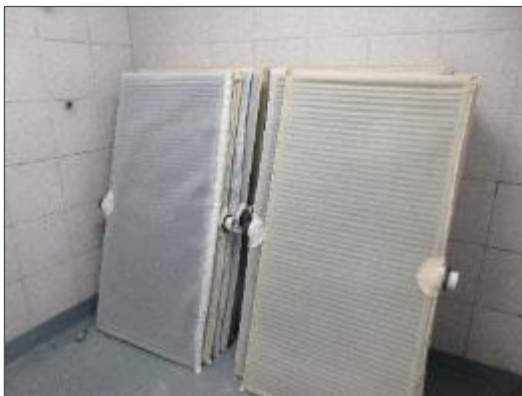
View of the stored filters serving the pool.

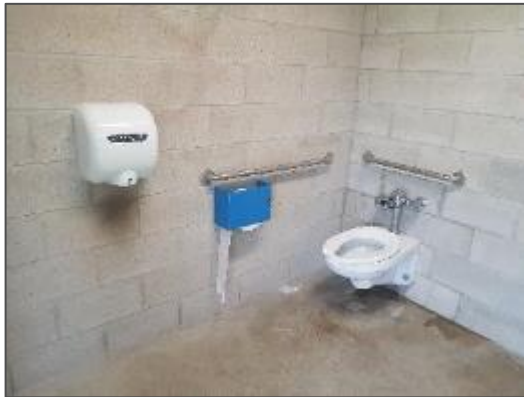
View of a typical porcelain toilet in a washroom area.

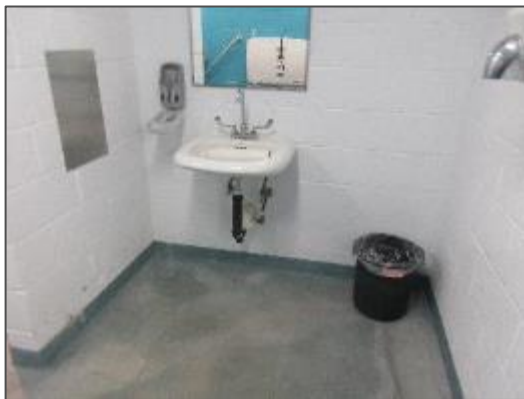
View of porcelain sink with manually operated faucet in washroom area.

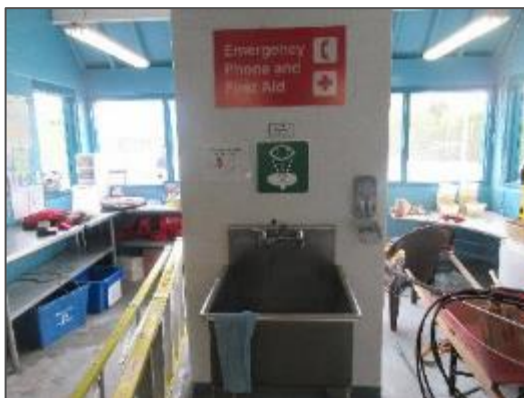
View of the stainless-steel sink serving the emergency eye wash station.

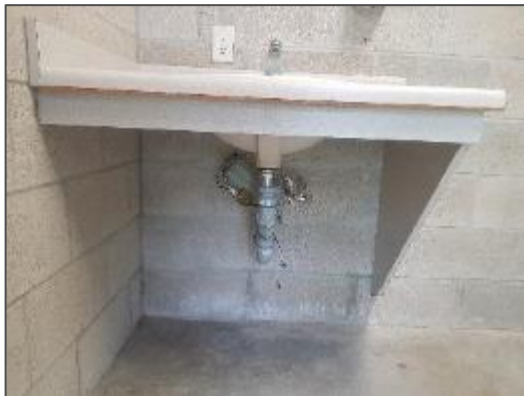
View of existing plumbing below a sink within a washroom.

No significant deficiencies were reported or observed at the time of the assessment. Based on age and observed conditions, no significant capital expenditures other than routine maintenance are anticipated during the evaluation period. However, careful monitoring, repair, and partial replacement should be considered. A cost has not been included.

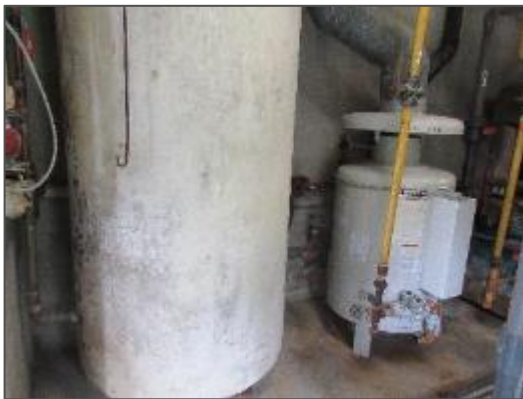
No significant deficiencies were reported or observed at the time of the assessment.

View of typical gas piping in the mechanical room.

Significant replacement of the gas supply system is not anticipated during the evaluation period. It is recommended that the gas lines be cleaned and painted on a regularly scheduled basis, as part of general maintenance.

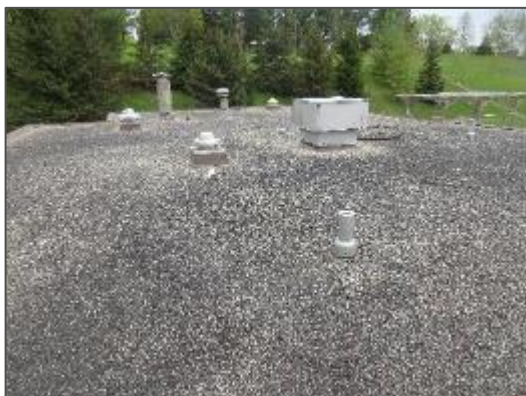
The exhaust systems at the Site Building consists of various exhaust fans for the changerooms, showers, mechanical areas, washrooms, electrical rooms, and some common areas. The exhaust fans are vented to the atmosphere through the exterior walls or through the roof. The fans were observed to be in serviceable condition.

View of the various rooftop exhaust units and vents.

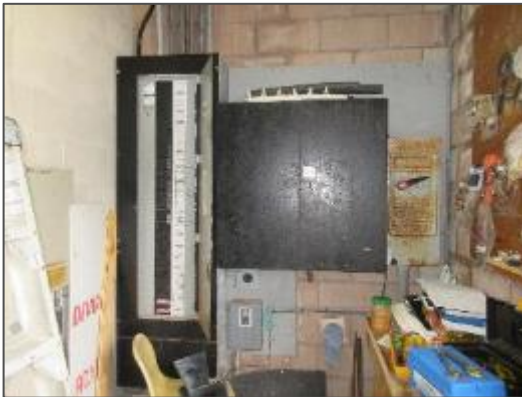
The electrical systems were noted to be in serviceable condition at the time of the Site assessment. The main electrical disconnect switch was noted to be corroded. Pinchin has included an allowance to complete infrared scanning at all electrical systems on the site. Once reviewed, it is anticipated that the electrical switch may require replacement. Pinchin has included a project to replace the switch but it is anticipated that the replacement is below the threshold of the report.

View of the main electrical disconnect noted within the Site Building.

Based on the age and observed conditions, it is recommended that an infrared scan of the electrical distribution system be completed annually as part of preventative maintenance program to check for any issues related to overloading, loose connections, or other related issues.

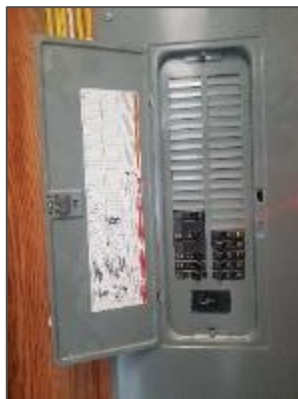
View of an electrical panel within the splash pad outbuilding.

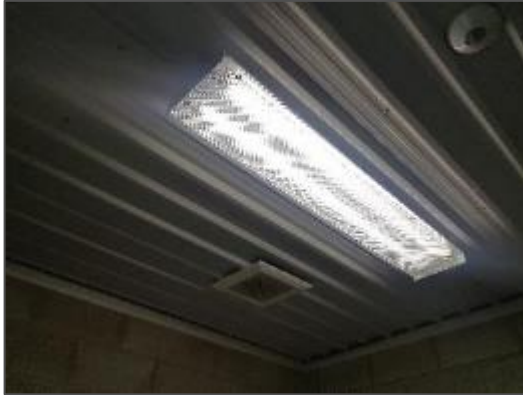
The projected useful life of T8 lighting (specifically the ballasts) is 25,000 hours. The age of the existing lighting fixtures and lamps could not be confirmed.

Typical T8 fluorescent tube lighting fixtures within the splash pad outbuilding.

Pinchin recommends replacing the interior lighting at the end of its PUL. Also, the lights should be changed on a 4-year rotation to attempt to avoid bulb failure and multiple interruptions.

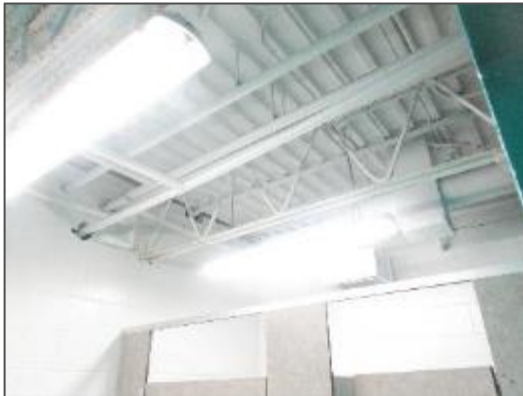
Typical T8 fluorescent tube lighting fixtures within the Site Building.

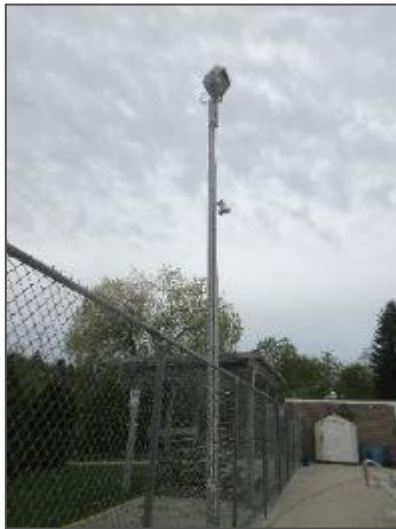
Typical pole mounted lighting at the pool area.

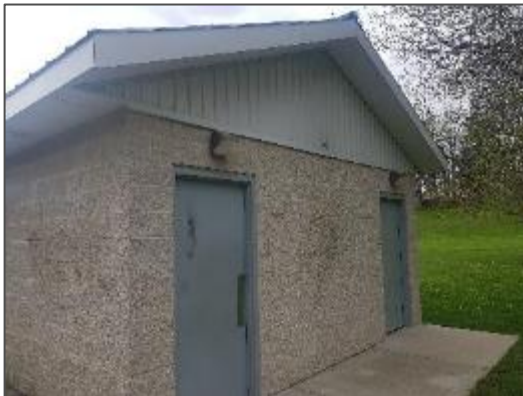
Typical wall-mounted exterior lighting on the splash pad outbuilding.

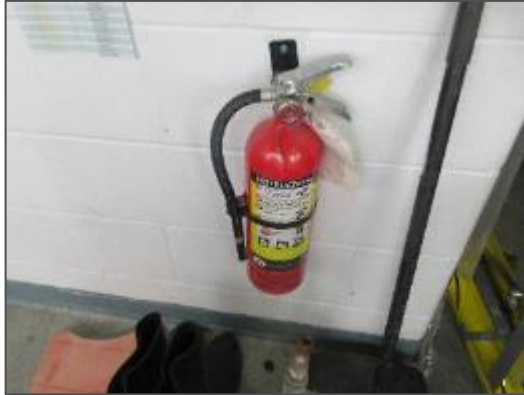
The fire extinguishers were generally noted to be charged to sufficient levels and possess inspection tags dated May 2018 by “Robson Extinguisher Service”. The inspection dates were noted to be outdated, immediate re-inspection should be completed. An additional fire extinguisher should be provided at the outbuilding.

View of fire extinguisher observed within the Site Building.

Subsequent to Pinchin's site visit, the Brockton Fire Prevention Officer has indicated that the fire extinguisher inspection date has been updated.

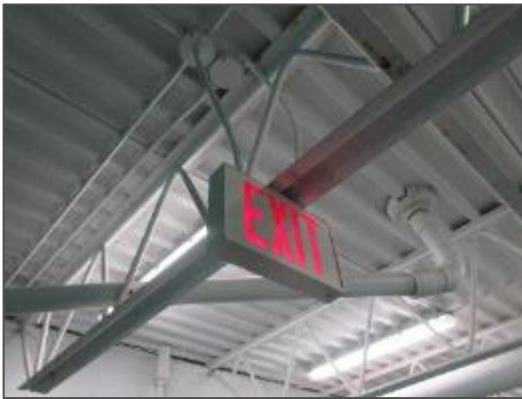
View of the typical illuminated exit signage noted within the Site Building.

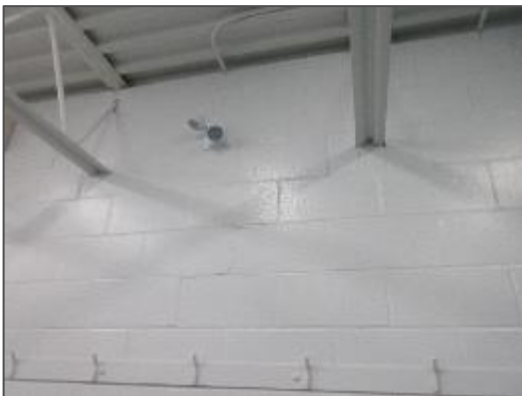
View of the typical emergency lighting noted within the Site Building.
