**FINAL**  
**Building Condition Assessment**  
290 Durham Street West, Walkerton, Ontario

**Corporation of the Municipality of Brockton**  
Box 68, 100 Scott Street,  
Walkerton, ON

July 31, 2019

Pinchin Ltd. File: 238065

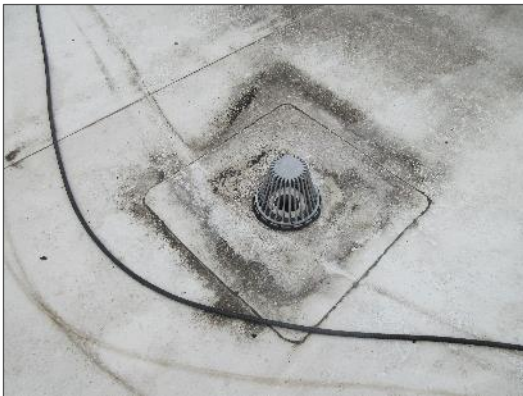
View of typical roof drain atop Site Building.

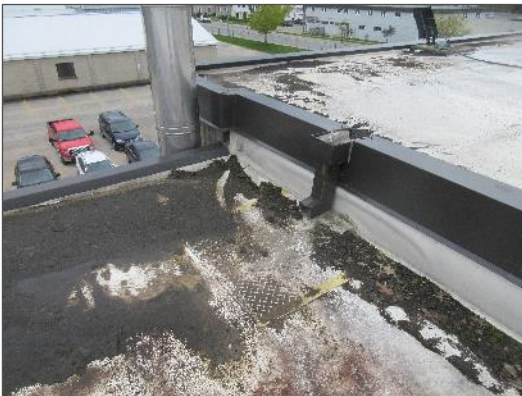
View of a scupper and downspout draining to the lower level.

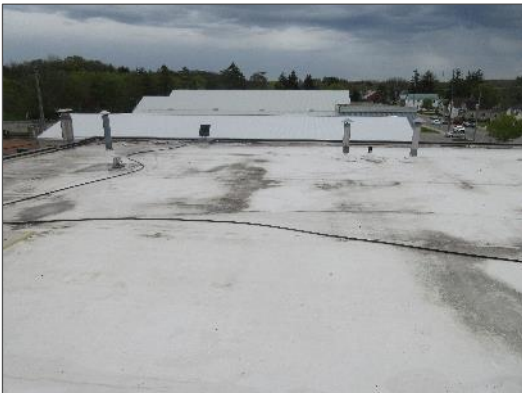
View of an unsecured conduit atop the roof system.

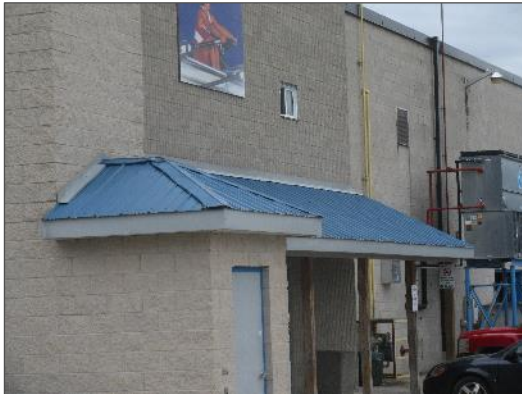
View of the sloped metal canopy serving the east entrance of the Site Building.

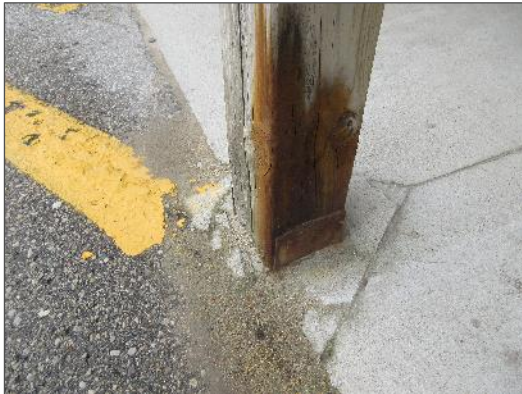
View of stained wood columns serving the east metal canopy.

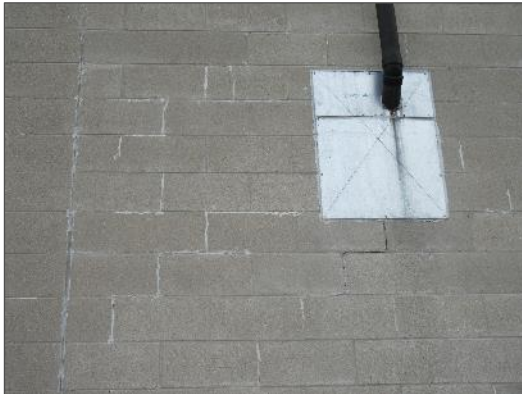
View of a location of previously repointed mortar at the concrete block masonry walls.

We have noted miscellaneous damage and deterioration that would generally be completed by building maintenance. We have included a project to remove staining, replace damaged masonry block and a general allowance for repointing at localized areas. We have included a project to install a protective sealer on the exposed concrete block walls to increase the longevity and service life of the masonry walls.

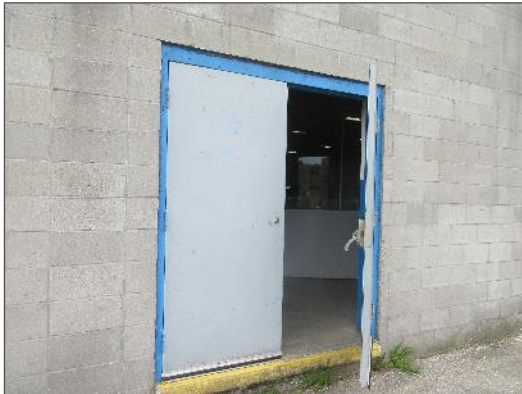
Minor surface corrosion was noted at the base of the exterior door frames. It is recommended to sand and repaint these areas as part of regular maintenance. In addition, the exterior doors appear to be missing or have damaged door sweeps and weather stripping in select locations. We have included an allowance to address door deficiencies and painting to prolong the life of the door systems until replacement is required.

Typical view of the secondary doors at other elevations.

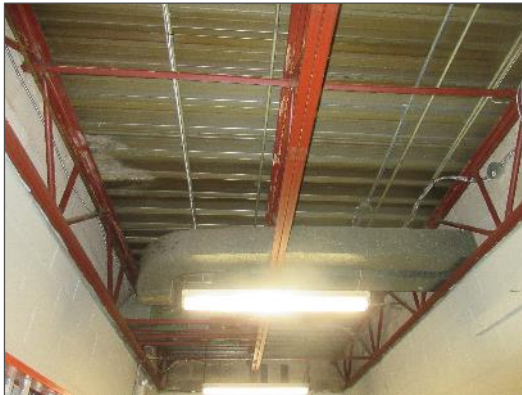
Table 3.4 – Structural Elements	
Findings	Remarks/Recommendations
<b>Major Deficiencies/Findings</b>	
<ul style="list-style-type: none"> <li>An area of isolated corrosion was noted within change rooms # 1&amp;2. As reported by the Site Representative this is due to a plumbing leak from the above floor which has since been repaired.</li> <li>Site representative has expressed concerns over separation of building components at the 2<sup>nd</sup> floor walkway (Hawks nest)</li> </ul>	<ul style="list-style-type: none"> <li>Inspect the section loss of the decking. Remove and replace the corroded steel decking and any members recommended by a structural engineer.</li> <li>Pinchin has included an allowance to complete a structural review at this location.</li> </ul>
<b>Minor Deficiencies/Findings</b>	
<ul style="list-style-type: none"> <li>N/A</li> </ul>	<ul style="list-style-type: none"> <li>N/A</li> </ul>

View of the underside of the steel decking serving the second-floor areas.

- Inspection and repair of the corroded metal decking noted within Change Rooms 1&2.
- Site management has expressed concern over the 2<sup>nd</sup> floor walkway (hawk's nest) that was constructed. Pinchin has included a project to complete a structural review at this location.

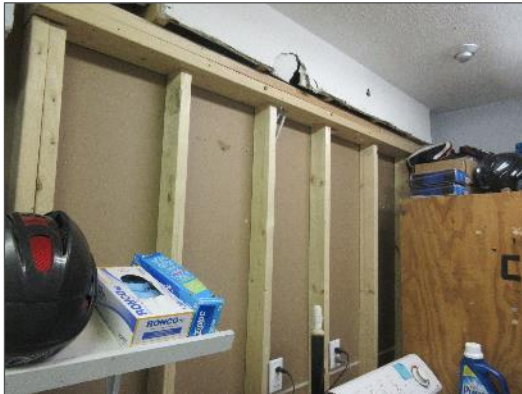
View of recent repair work within a change room area.

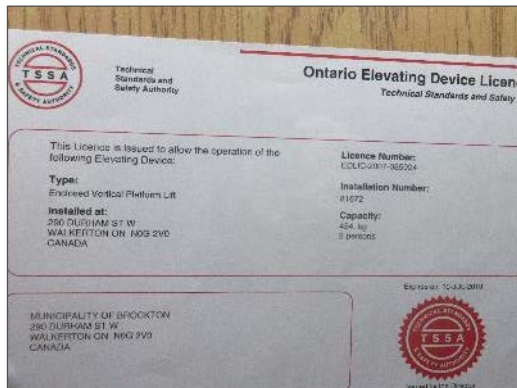
View of the updated TSSA tag posted within the elevator cab.

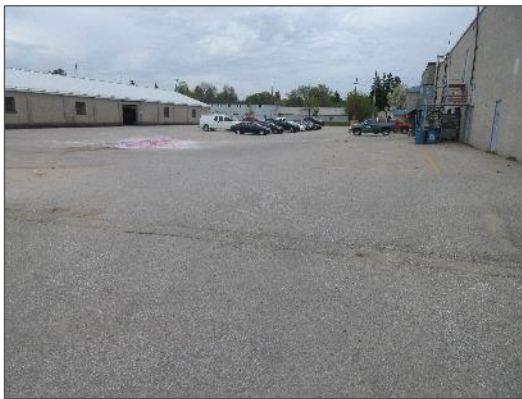
View of the asphalt paved parking areas on the east portion of the Site.

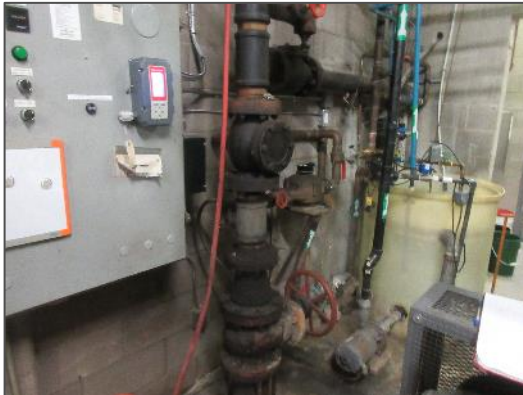
However, the Site Building does possess empty fire hose cabinets. The risers and fire hoses have reportedly been decommissioned.

View of the decommissioned riser.

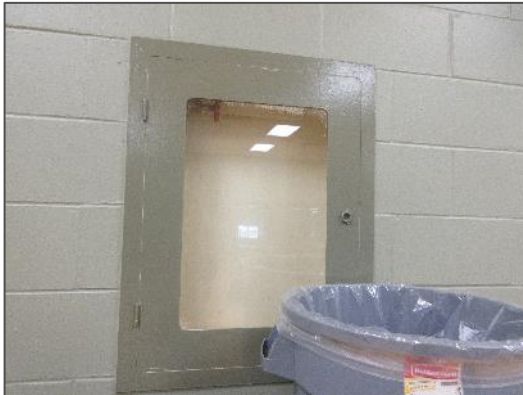
View of the decommissioned fire hose cabinet.

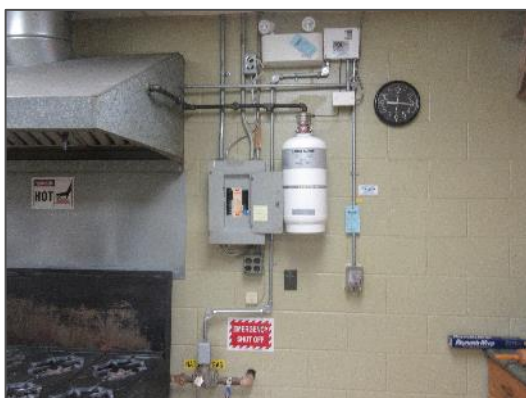
In addition, chemical overhead fire suppression was noted at the oven hood within the second-floor kitchen and the ground floor kitchen. Both systems were noted to be “Range Guard” with updated inspection tags dated May 2019 by “Bluewater Fire & Security”.

View of the range guard chemical fire suppression system noted within the second-floor kitchen area.

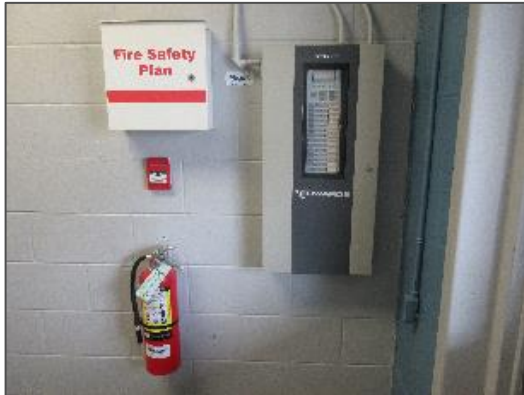
View of the fire alarm panel and a manual pull station noted within the Site Building.

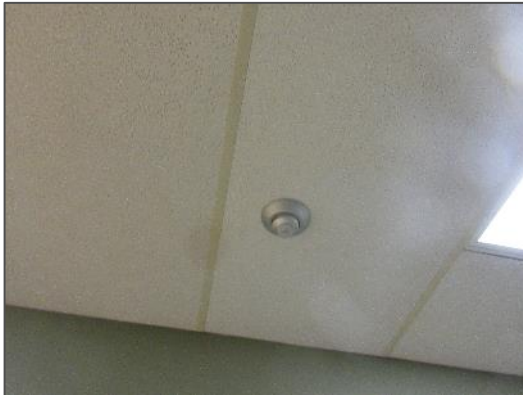
View of a typical heat and smoke detector noted within the Site Building.

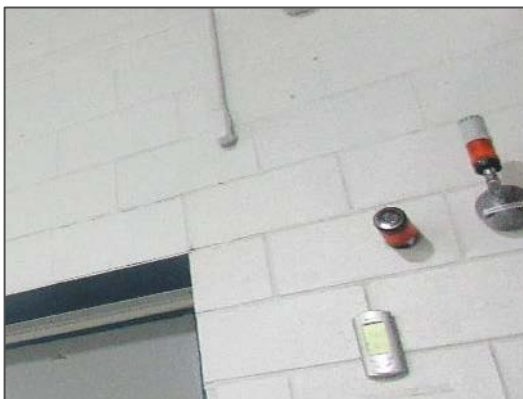
Emergency audio and visual fire alarm observed.

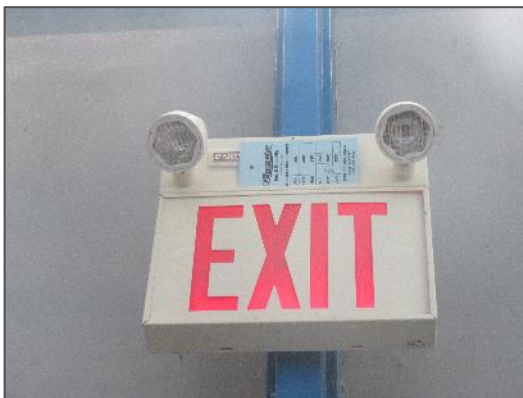
Illuminated exit signage and emergency lighting noted throughout the Site Building.
